Colin Gamble & Associates
Consultant Engineers Ltd

Property Condition Report

Date of Inspection: Sunday 10th February 2019

Property Address: 123 The House, Naas, Co. Kildare

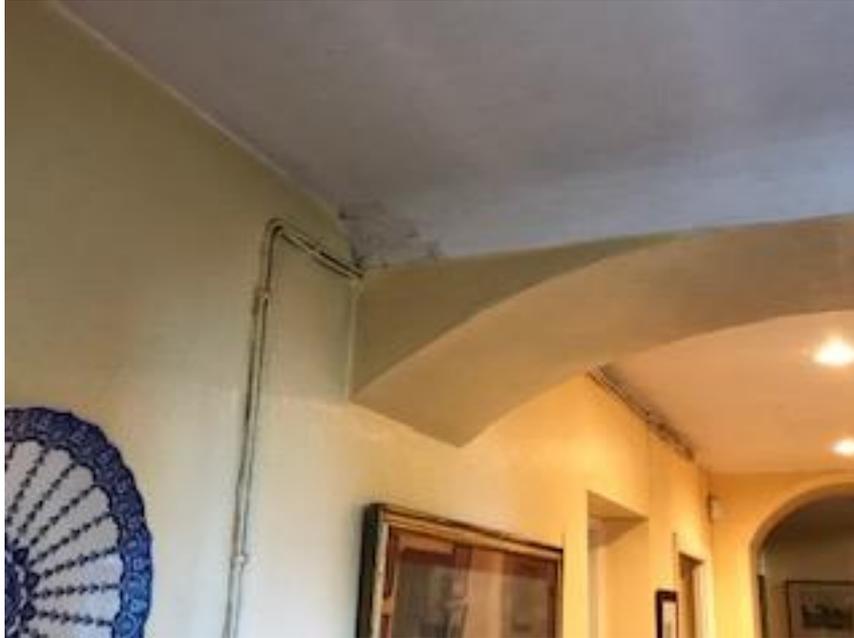
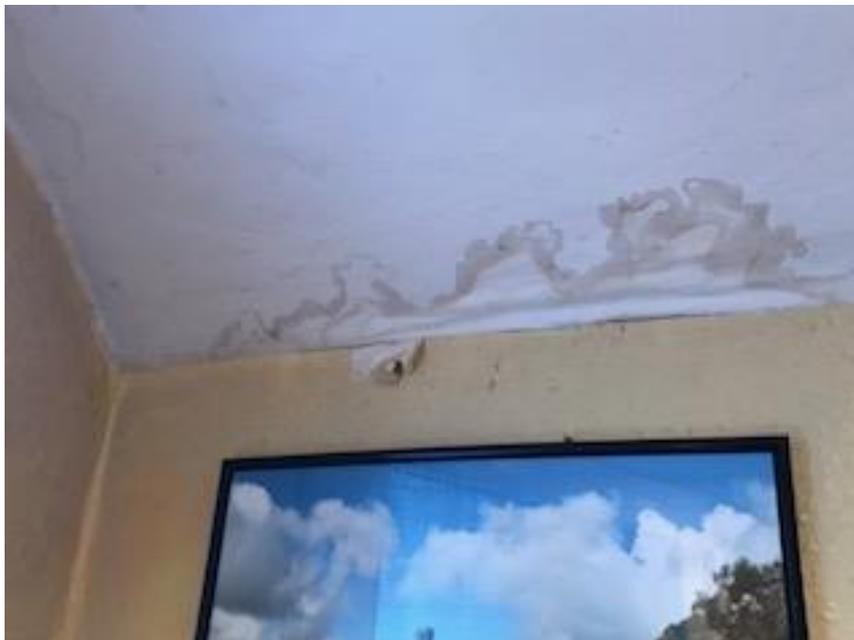
- Leaks were noted from the ceiling at the basement level entrance hall. These leaks are from the junction of the entrance steps to the front door and the area underneath. The client is advised to obtain the services of a general contractor to seal these sections and to replace any effected plaster and timber work. The client is advised that timber rot may be present at this location. If this is confirmed the affected timbers should be removed. [Photograph 1 and 2](#)

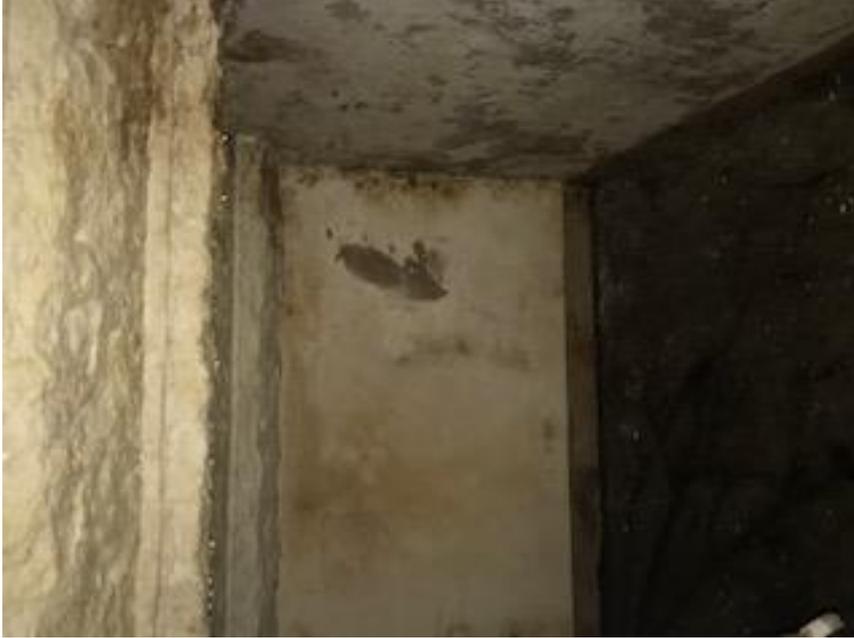
Photograph 3

- The under section of the stairs would appear to be best suited as a storage area however, the client is advised that the levels of moisture noted in the walls and floor here are relatively high. These levels of moisture could be addressed by installing a chemical damp proof course. Any rendering of the walls should be completed with a lime-based render that allows for the historical construction of this wall to migrate water up and down and allows the walls to breath. [Photograph 3](#)

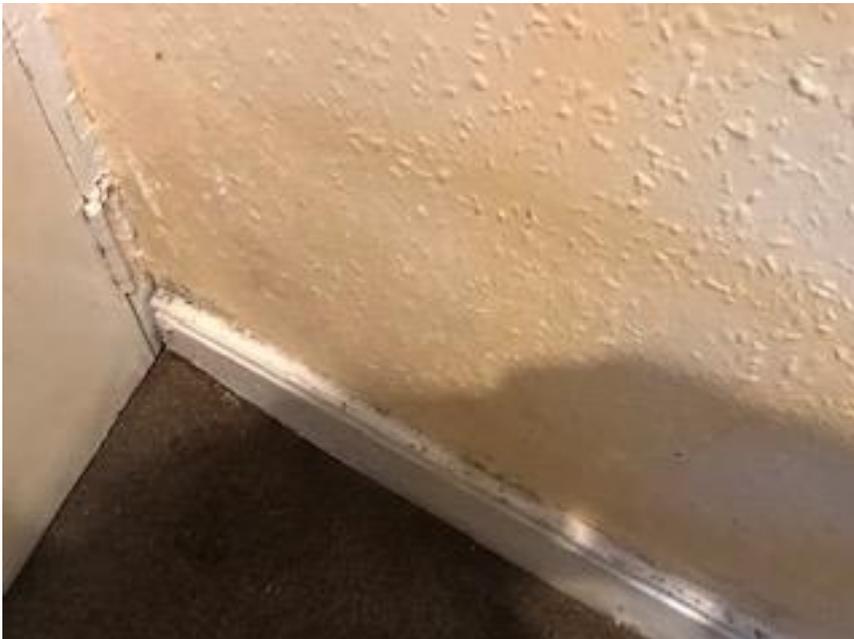
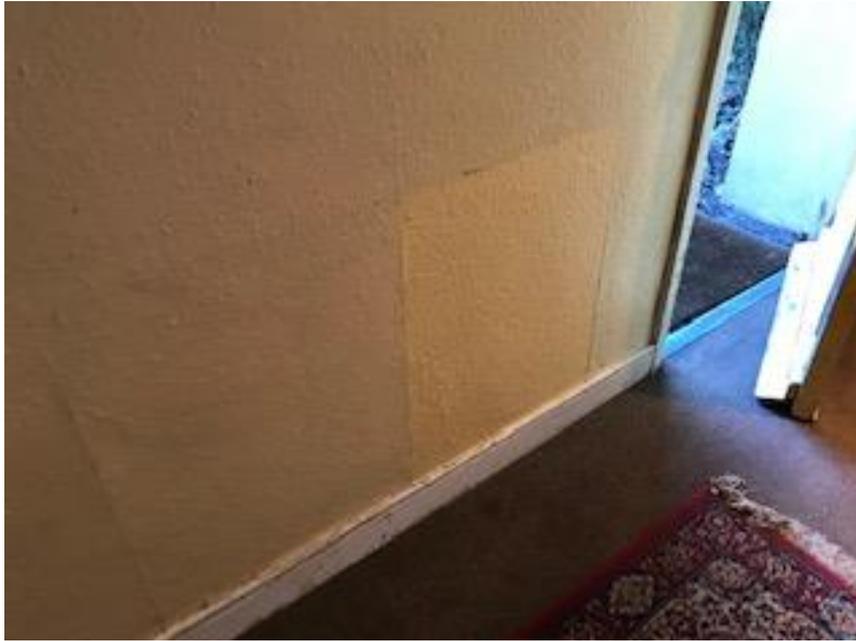
- Moisture readings approaching 1.5% were noted in many of the external walls at basement level on the internal side. Although this property would be expected to have a higher moisture reading in the external walls than a modern construction due to the fact that dwellings constructed in this era were constructed with a design philosophy that moisture would rise and drop on the external walls. We would advise the client to insert a chemical damp proof course and an appropriate internal lime-based render to promote the preservation of the wall and extend the lifetime of the wall. This is a commonly completed task on buildings of this type in the Naas area. [Photograph 4 and 5](#)

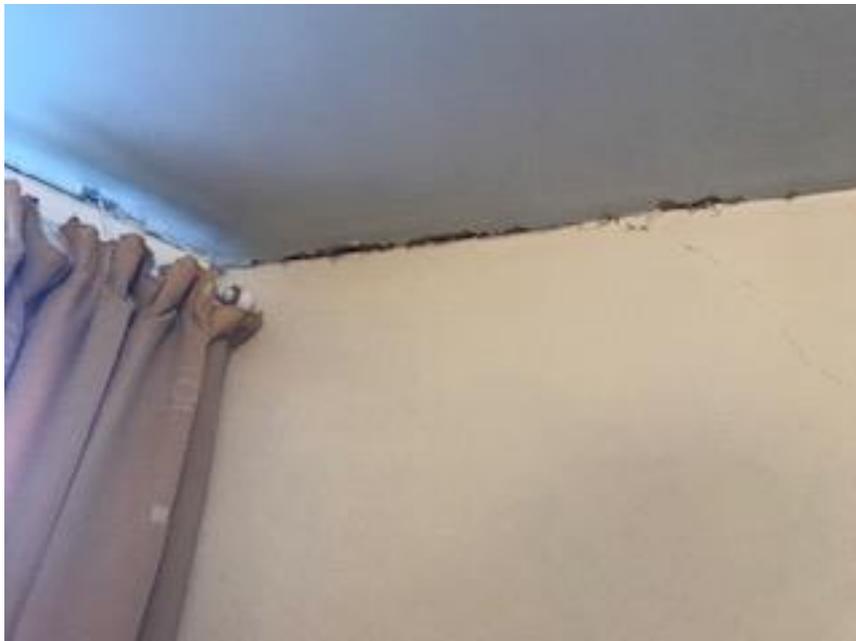
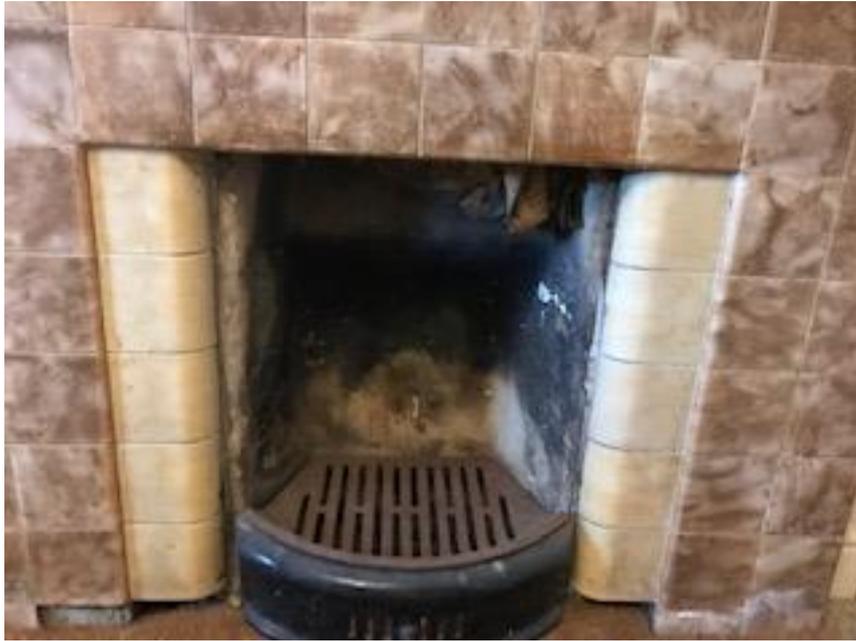
- Cracking was noted at the junction of the ceiling and the walls and water ingress is most likely due to water traversing through the chimney. The client is advised to allow for the sealing of the flashing at the chimney and to allow for localised reparation works to any affected plaster work and timber. The

client is advised that timber rot may be present at this location. If this is confirmed the affected timbers should be removed. [Photograph 6 and 7](#)

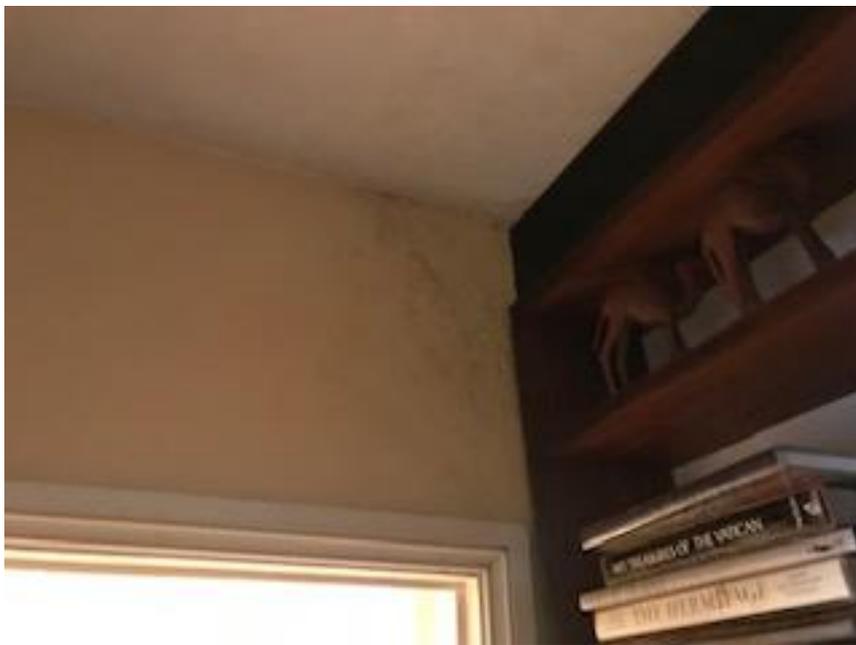
Photograph 8

- Leakage was noted from the floor above which has permeated into the reading room area. The client is advised to obtain the services of a general contractor to repair the leak from above which has most likely emanated from one of the flashings. The client is advised to allow for localised reparation work to any affected timber and plaster work. Timber rot may be present at this location. If this is confirmed the affected timbers should be removed [Photograph 8](#)

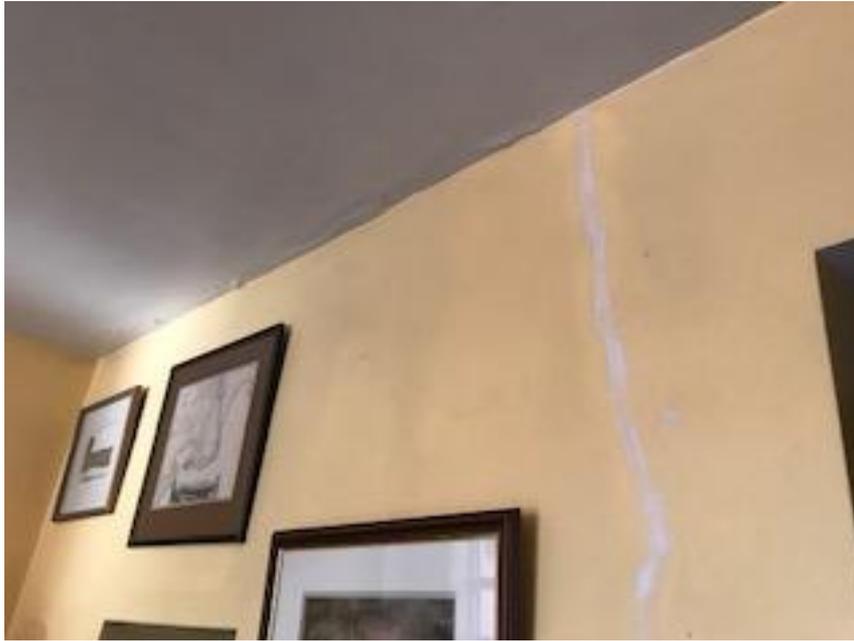
Photograph 9

- Structural cracking was noted on some of the support walls in the living room at basement level. Some of the cracks were noted as having a magnitude of up to 4-5 millimetres in diameter. It is unlikely that structural failure will occur however, the client is advised to monitor this structural crack. If propagation of the crack does occur, reinforcement would be required at this location. The client is advised to note that the property has been in situ for quite some time and structural failure is most unlikely. [Photograph 9](#)

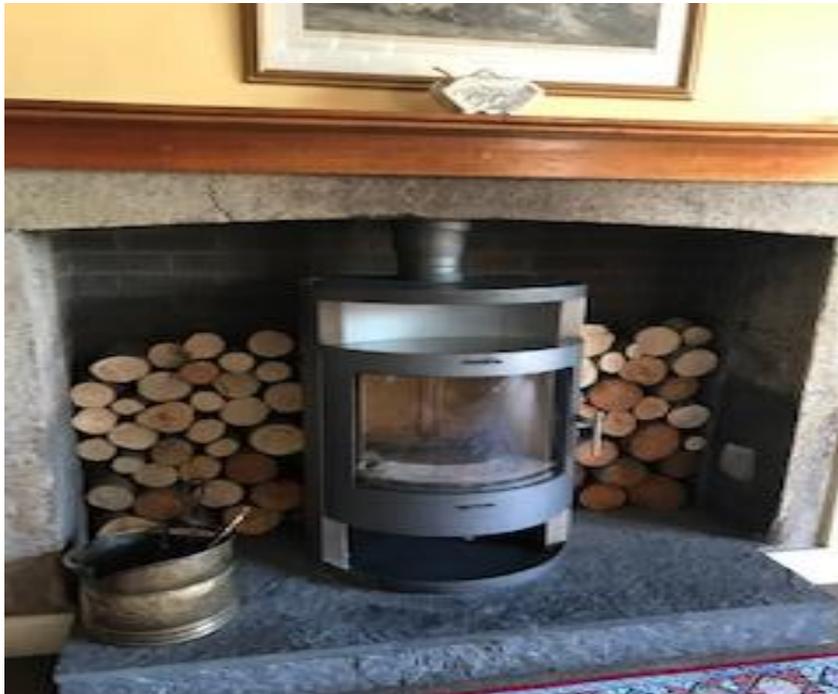
Photograph 10

- A retrospective wood burning stove was noted in situ. The client is advised to obtain confirmation from the vendor that the correct flue liner has been installed to cope with the high gas temperatures produced by the stove when it is operated. [Photograph 10](#)

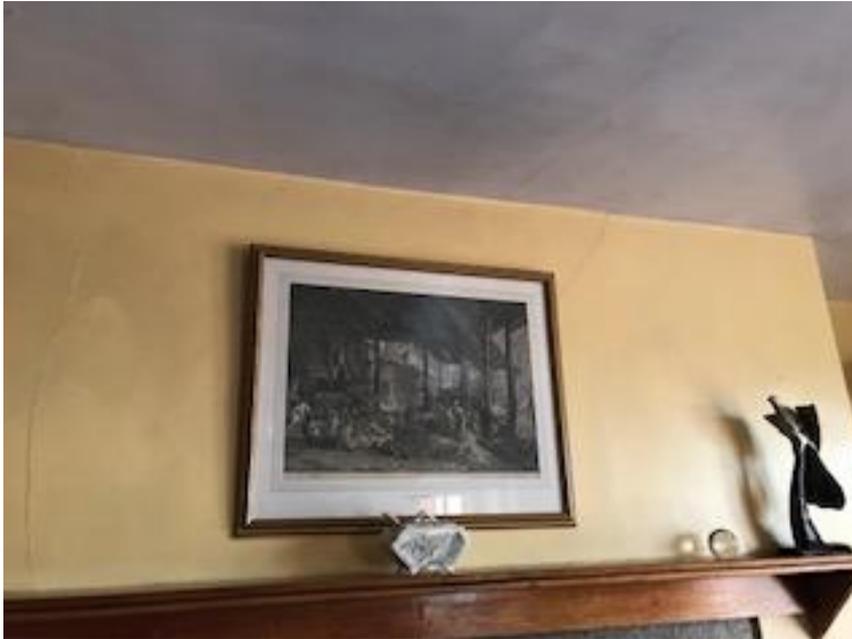
Photograph 11

- Thermal cracking was noted on the chimney breast as a result of the high temperatures. This is most likely due to the heat radiating from the flue. [Photograph 11](#)

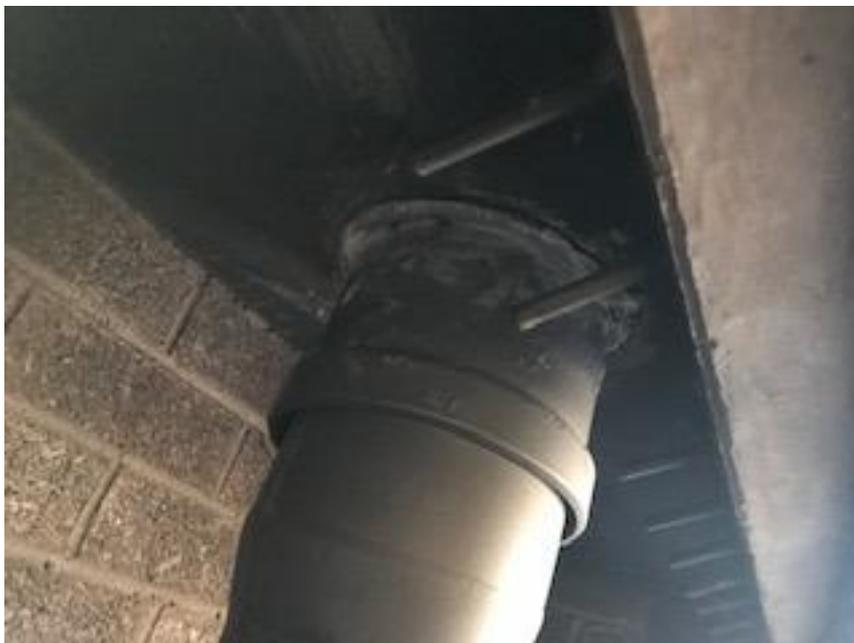
Photograph 12

- The client is advised to seal the junction of the flue with the manifold. [Photograph 12](#)

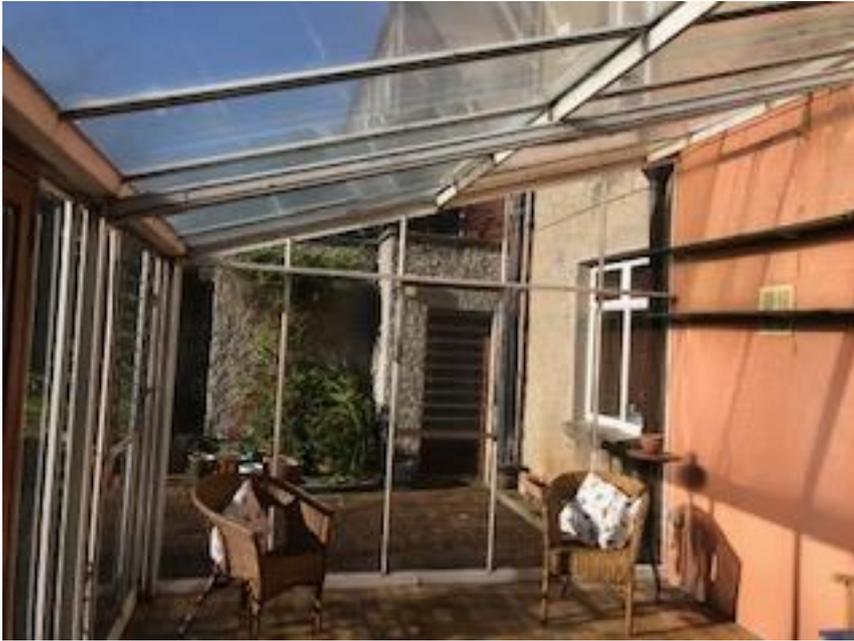
Photograph 13

- The client is advised to obtain a Certificate of Compliance/Exemption with the Planning and Building Regulations for the glass conservatory extension to the rear. [Photograph 13](#)
- The conservatory roof is poor and should be replaced as signs of water ingress were noted. [Photograph 14](#)

- The client is advised that 123 The House, Naas, Co. Kildare is recorded on the Protected Structures of Kildare County Council. As such we would advise the client to ensure that the appropriate certificates are in place for the addition of any structures including the glass conservatory. [Photograph 13](#)

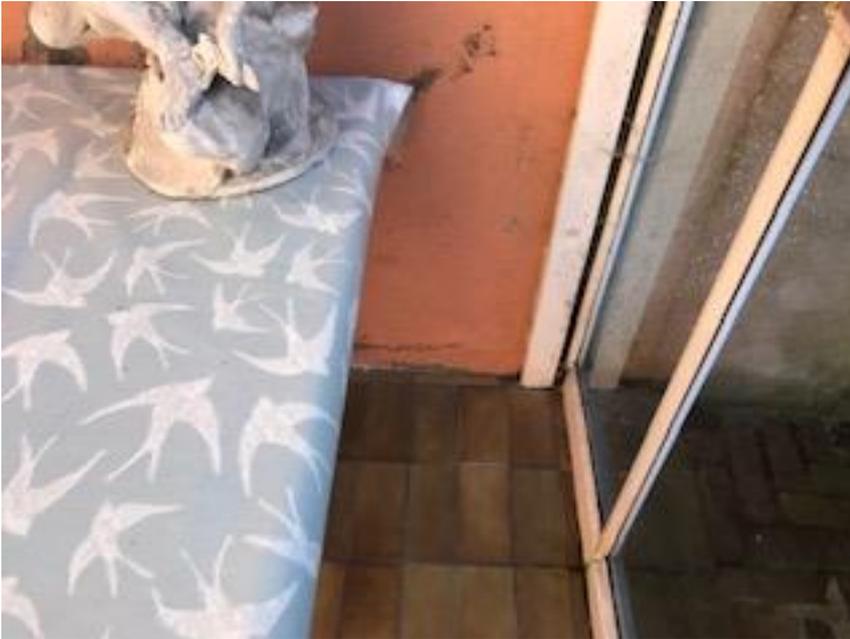
Photograph 15

- Evidence of rising damp was noted on the external conservatory wall which would appear to be the original boundary wall. [Photograph 15](#)

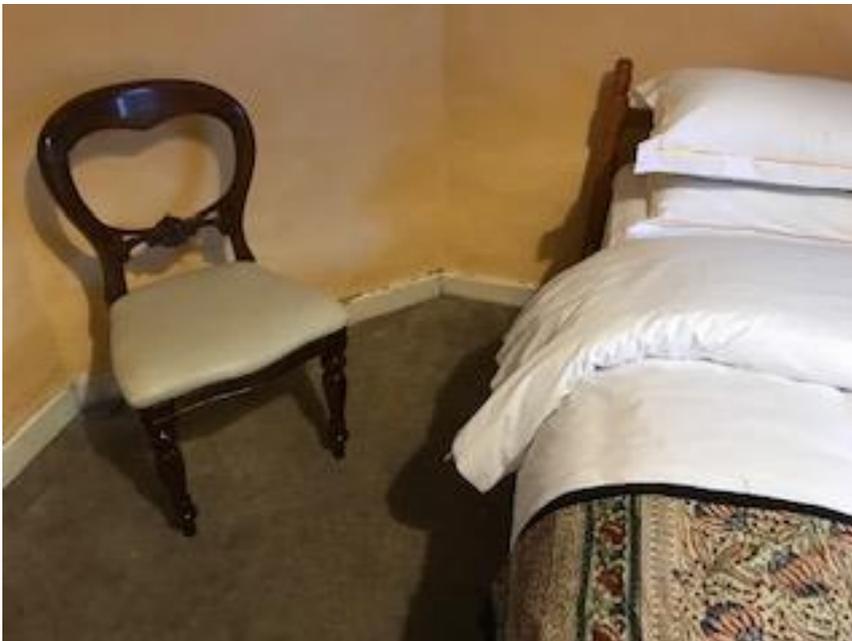
Photograph 16

- Evidence of rising damp was noted on the walls. [Photograph 16](#)

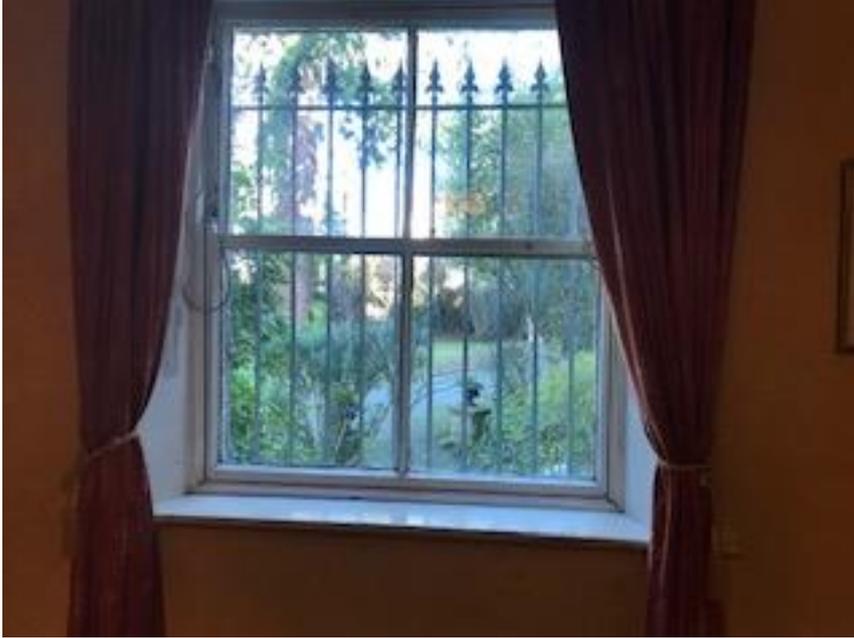
Photograph 17

- In the interests of fire safety, the client is advised that the security precautions are removed from the bedroom windows. [Photograph 17](#)

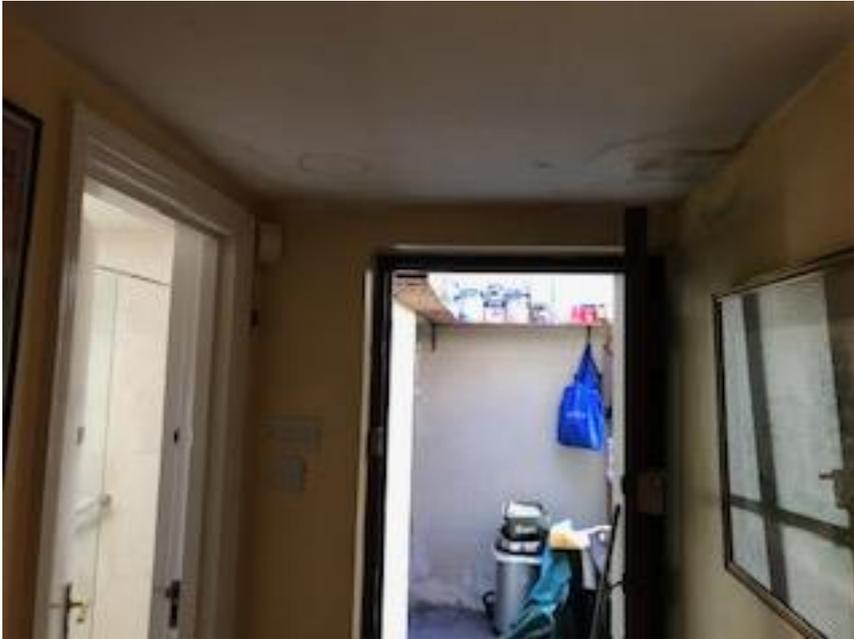
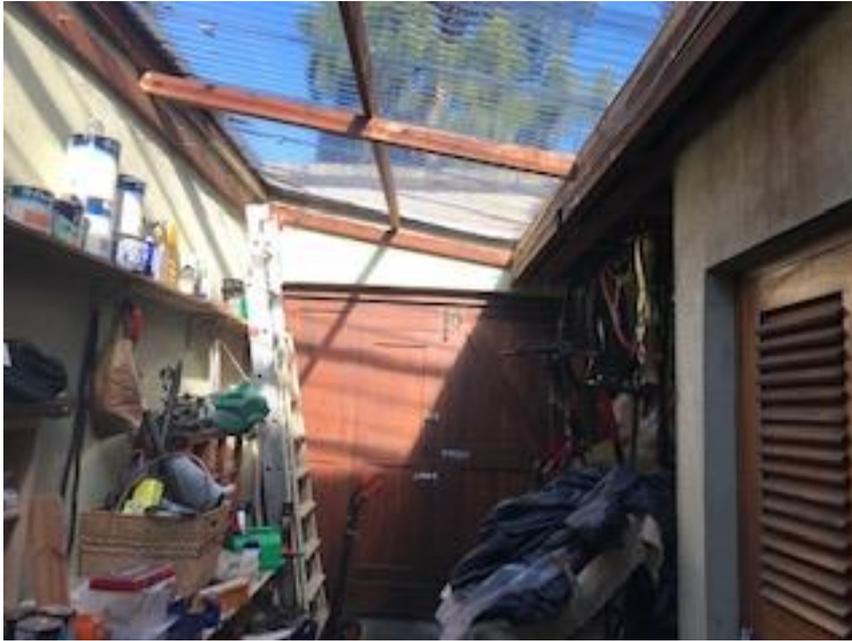
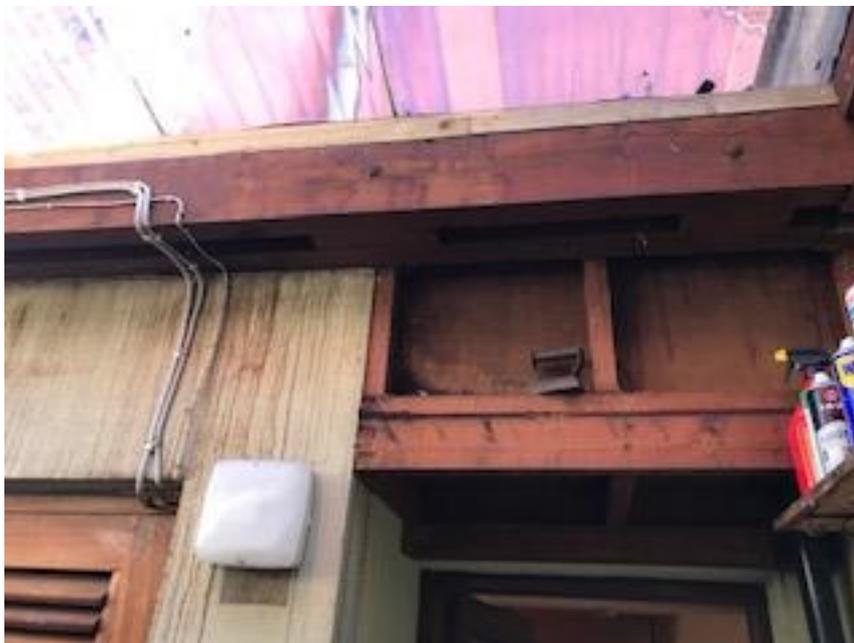
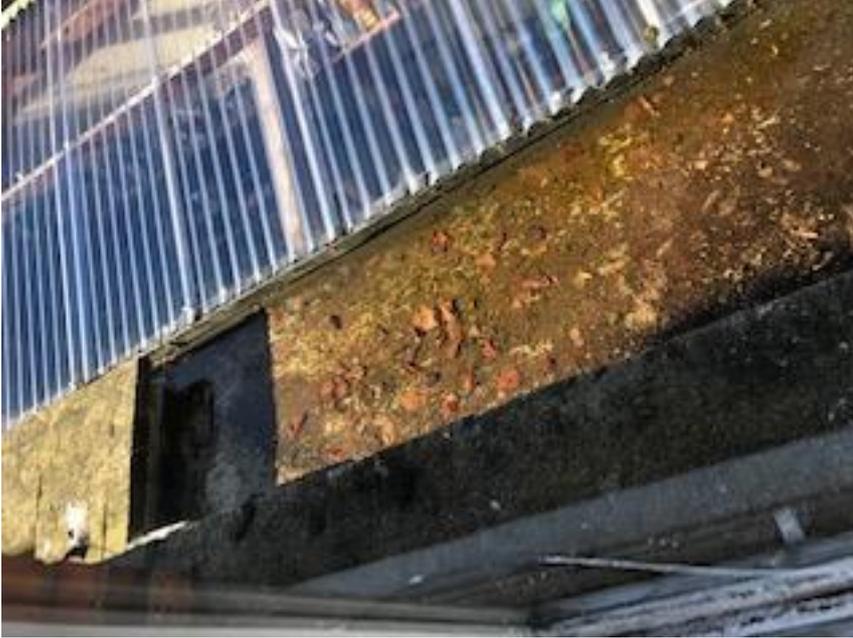
- Multiple leaks were noted in the basement hallway ceiling that leads onto the garage/storage area to the side of the dwelling. These leaks correlate with the valley that has been constructed above and joins the roof of the dwelling and the roof of the storage area. The client is advised that this valley is re-designed and re-laid. The client is advised that timber rot may be present at this location. If this is confirmed the affected timbers should be removed. [Photograph 18, 19, 20 and 21](#)

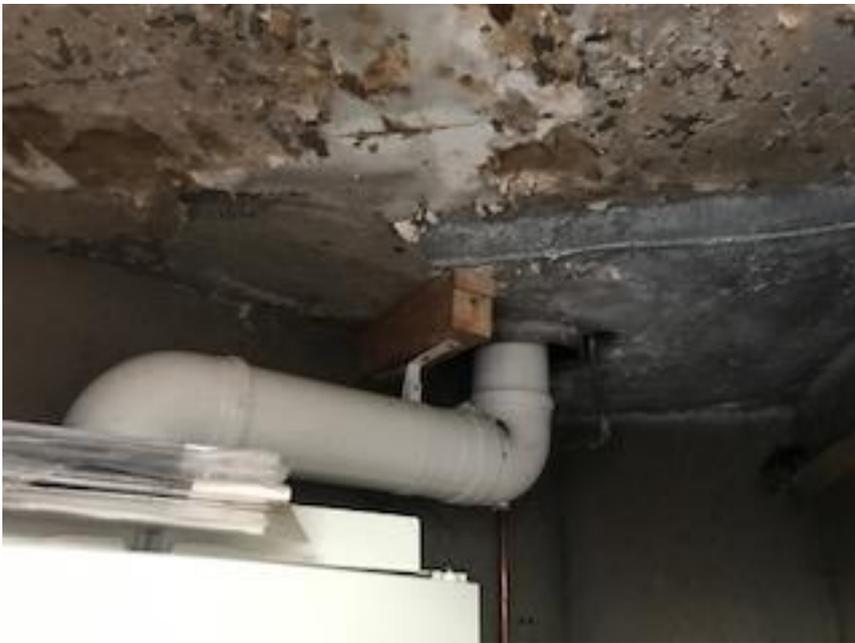
Photograph 22

- The heating system activated on the day of the survey and the boiler appeared to work well. The boiler appeared to be a relatively new entity. We would advise the client to seal the exhaust flue from the boiler with the ceiling to avoid the build-up of carbon monoxide in the boiler room. [Photograph 22](#)

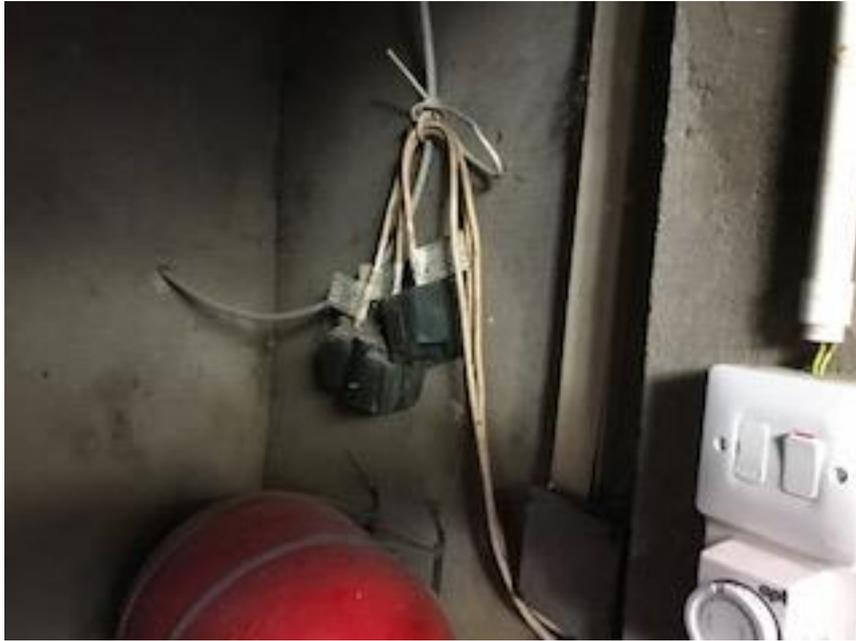
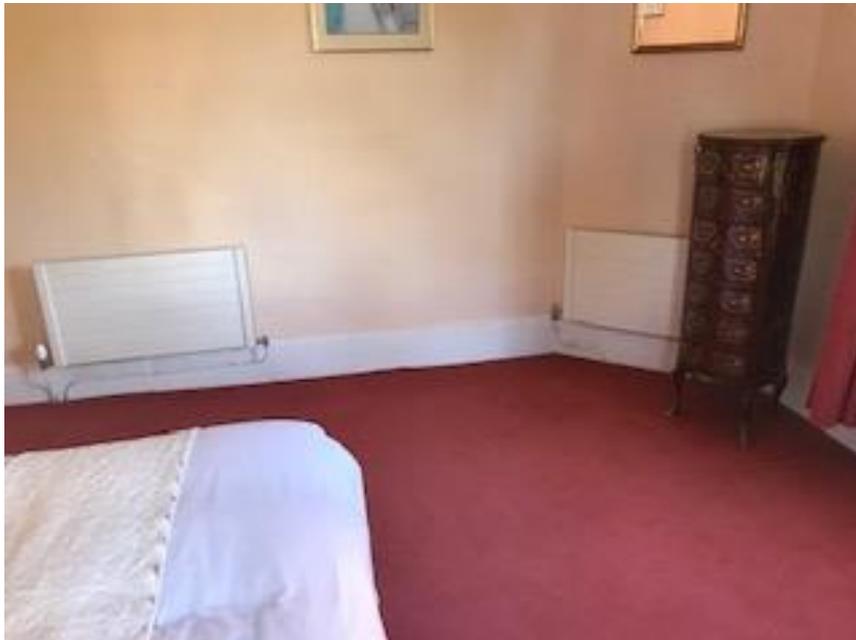
- The client is also advised that the actuator valves are anchored appropriately to the wall to avoid failure of same. [Photograph 23](#)
- It was noted that the basement level and ground floor radiators reached acceptable temperature within one to two hours. The radiators on the second floor did not warm up quickly. The client is advised to allow for flushing out of the systems and possibly de-zoning the systems. The capacity of the boiler may also require reviewing to allow for greater heat output. [Photograph 24](#)

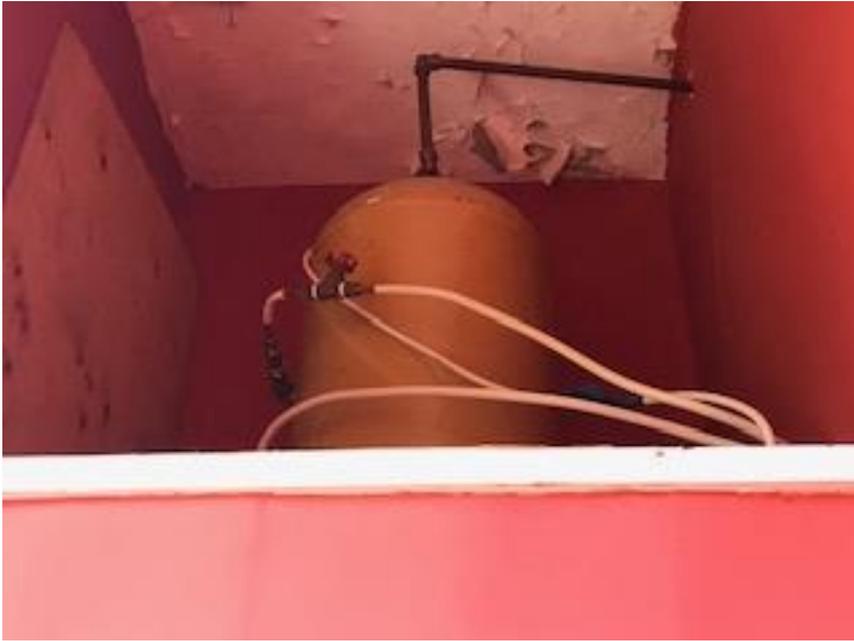
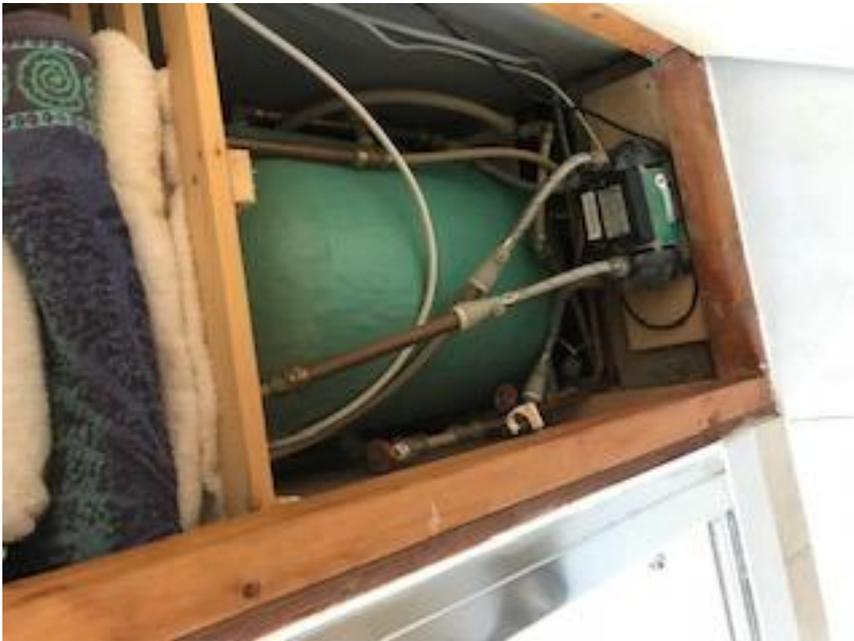
- It would appear that there is a separate cylinder on each level for the domestic hot water system. The client is advised to consider replacing the separate hot water cylinders on each level with a single high efficiency domestic hot water system complete with solar heating panels or air to heat pump. [Photograph 25 and 26](#)

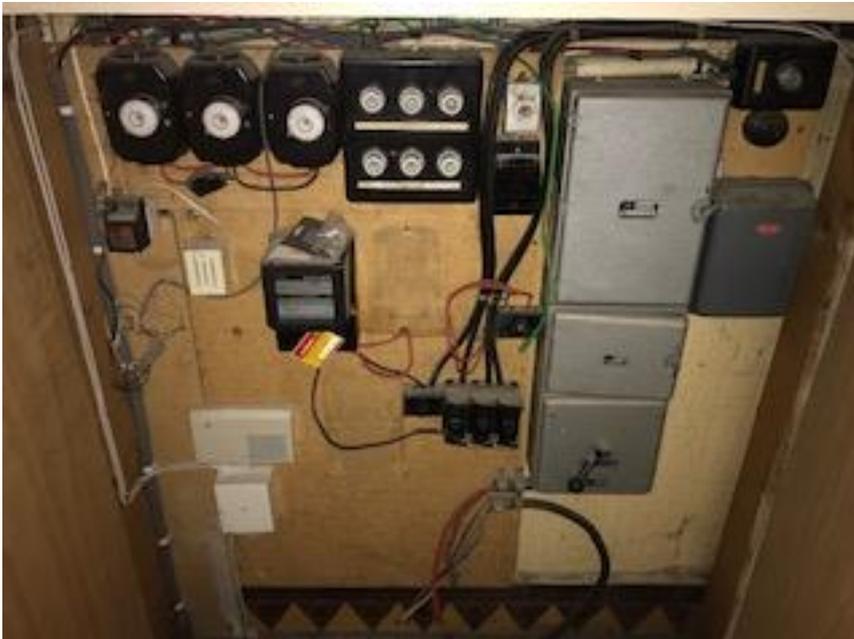
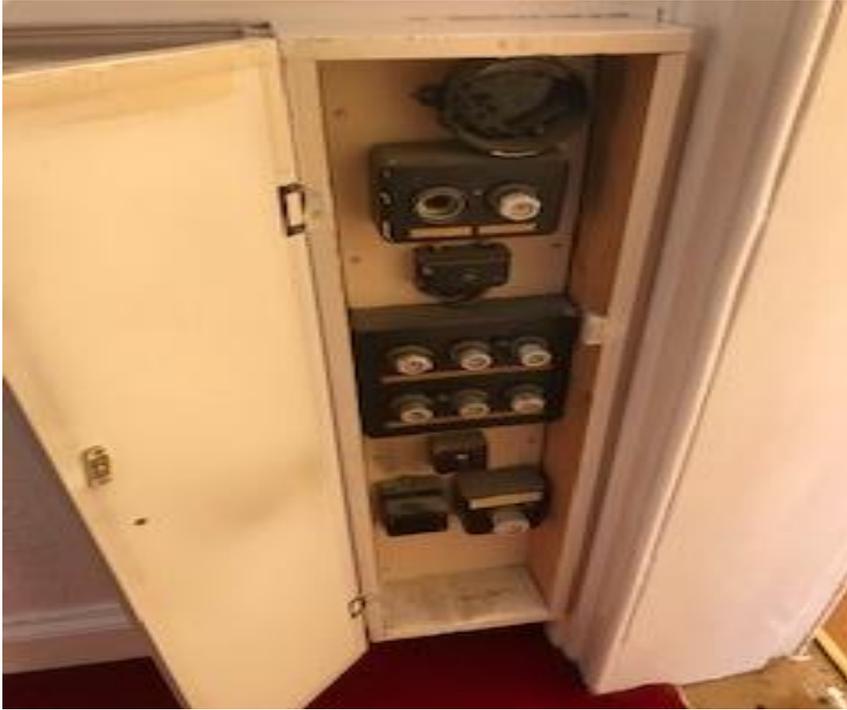
- The electrical system would appear from a visual survey to be separated into two circuits. One circuit appears to be for the basement level and a circuit for the ground and upper floors. Both systems require overhauling. The circuit fuse box for the ground floor would appear to have previously overheated and is showing signs of compromised components due to excessive heat. The client is advised to have this replaced. [Photograph 27](#)
- The electrical system on the ground and upper floor is governed by ceramic fuses and old wiring systems. We would advise that this is replaced in its entirety. [Photograph 28 and 29](#)

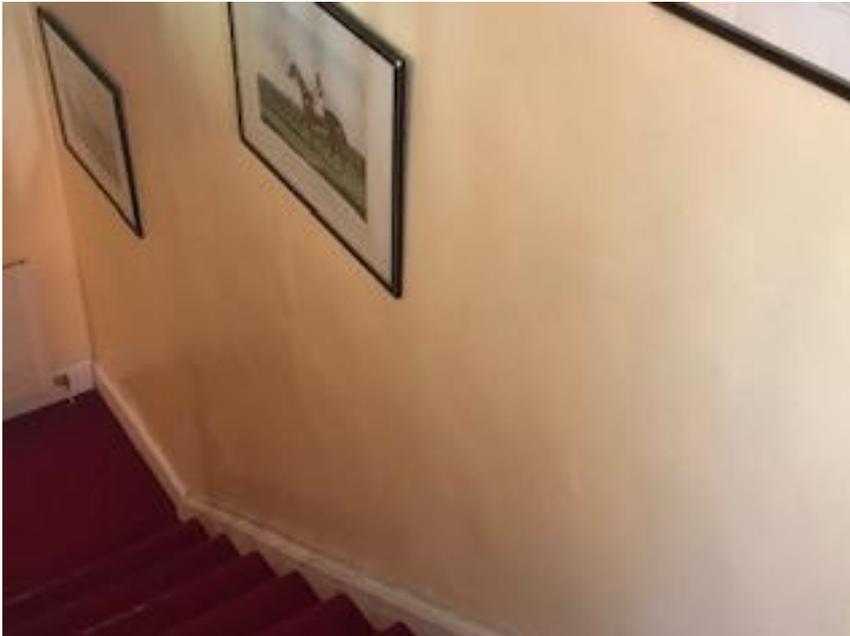
Photograph 30

- Structural cracking was noted on the ground floor hallway. Structural failure is unlikely due to the age of the property and the time that the property has existed however, we would advise the client to monitor same. [Photograph 30](#)

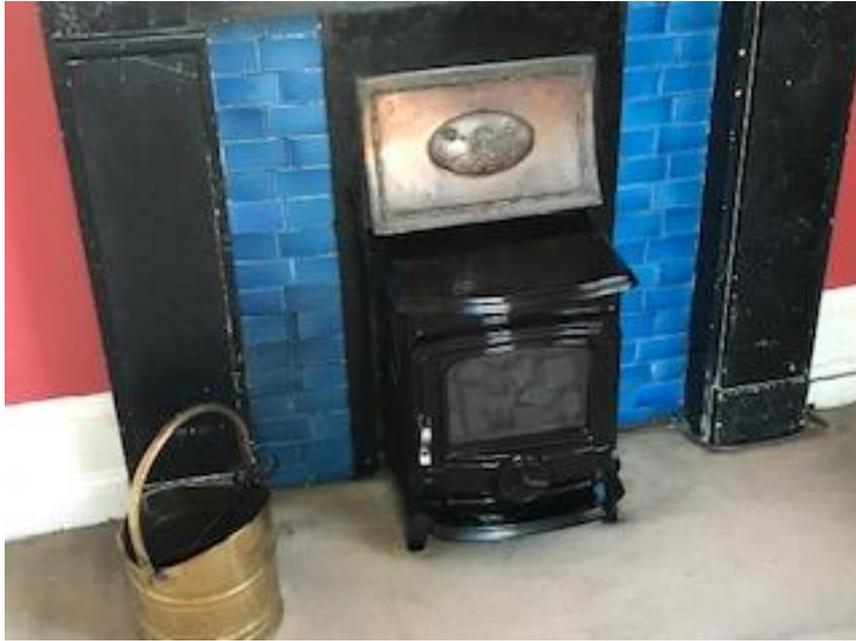
Photograph 31

- A stove has been retrospectively installed in the living room. The client is advised to obtain confirmation from the vendor that the correct flue liner has

been installed to cope with the high gas temperatures emitted by the stove when in operation. [Photograph 31](#)

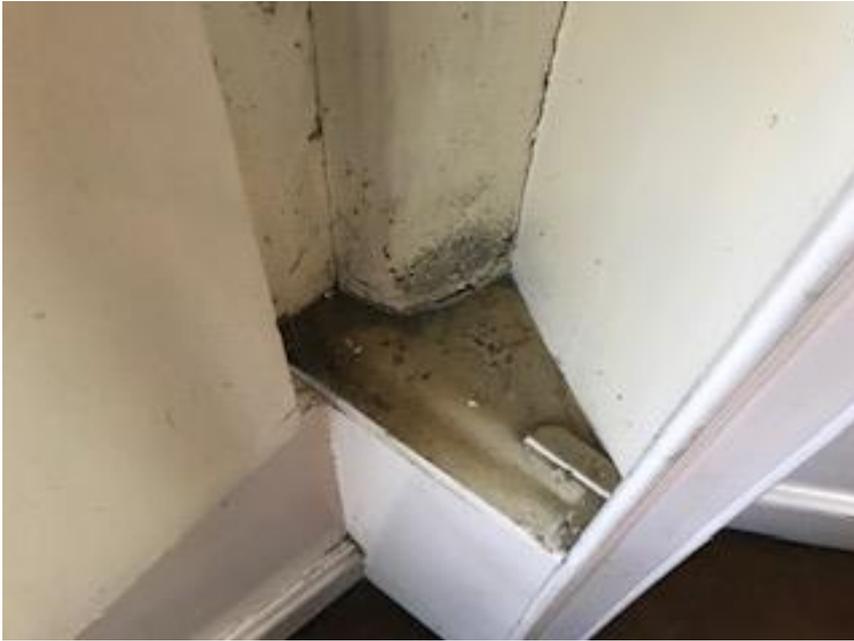
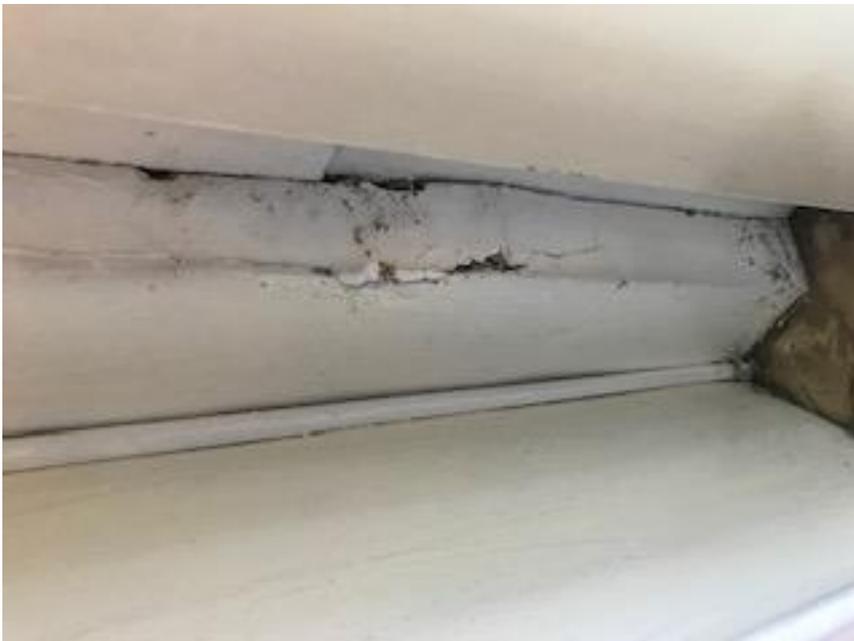
- The windows on the basement, ground and first-floor are showing signs of decay in several sections and should be overhauled. This building is a protected structure and therefore the client should seek consent from the planning authority, protected buildings department in order to progress same. [Photograph 32, 33 and 34](#)
- It was noted that decay has set in to some of the window sections where the ballast is maintained. This should be repaired however, this should be repaired under the consent of the planning authority, protected buildings department. [Photograph 35 and 36](#)

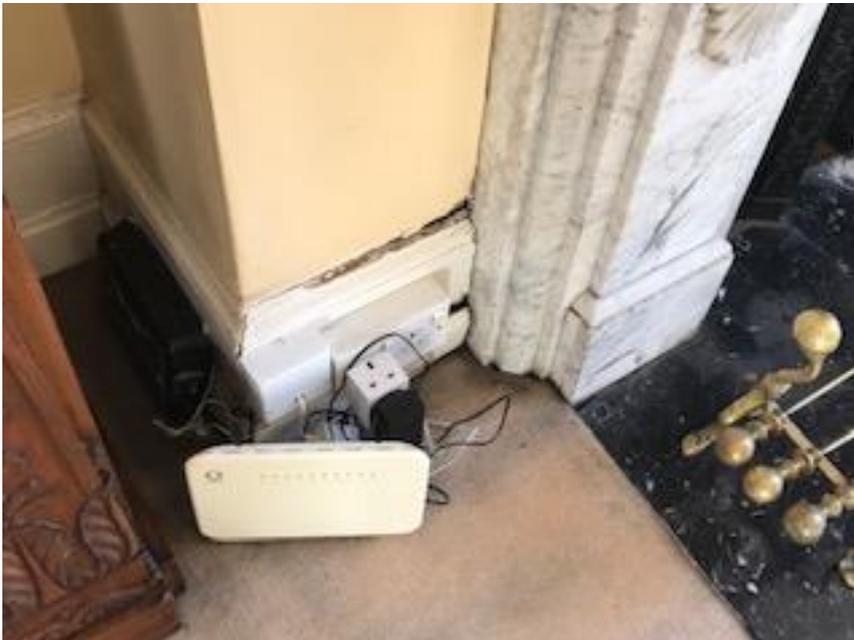
Photograph 40

- A mediocre draft was noted from the fireplace. The client is advised to have the chimney cleaned out and checked for obstruction prior to lighting. The firewall was also noted as being cracked. This should be sealed with a fire-based mortar system. [Photograph 37 and 38](#)
- Overhauling is required on the rendering at ceiling level. [Photograph 39](#)
- It was also noted that some of the timber at base level of the fireplace has decayed. This is most likely due to water ingress at the chimney stack level and migrating southward. We would advise that this point of entry of the water at the chimney is resolved and that all effected timber and plaster work is resolved. The client is advised that timber rot may be present at this location. If this is confirmed the affected timbers should be removed. [Photograph 40](#)

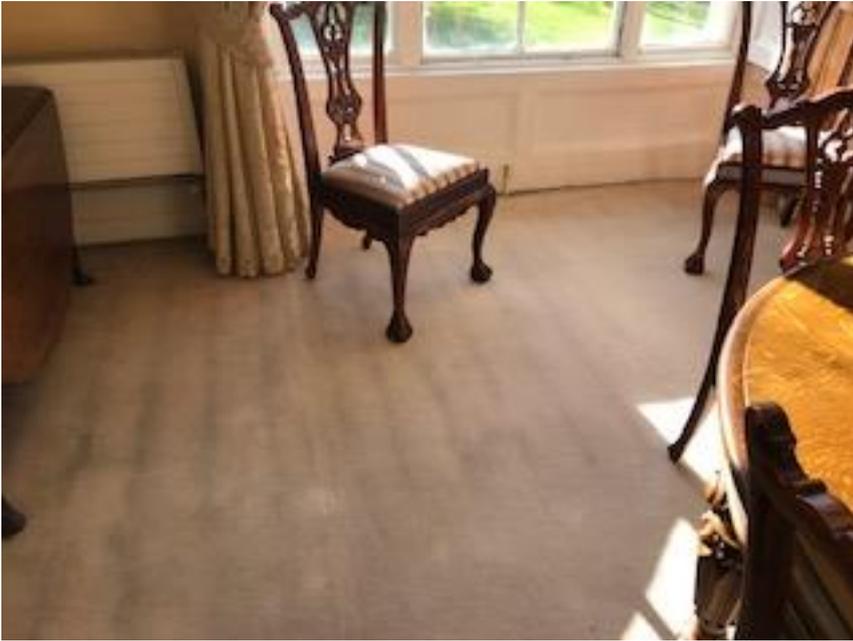
Photograph 41

- The client is advised that deviations were noted on the ground floor level however, structural failure is not anticipated as this is most likely due to settlement of the floor. [Photograph 41](#)

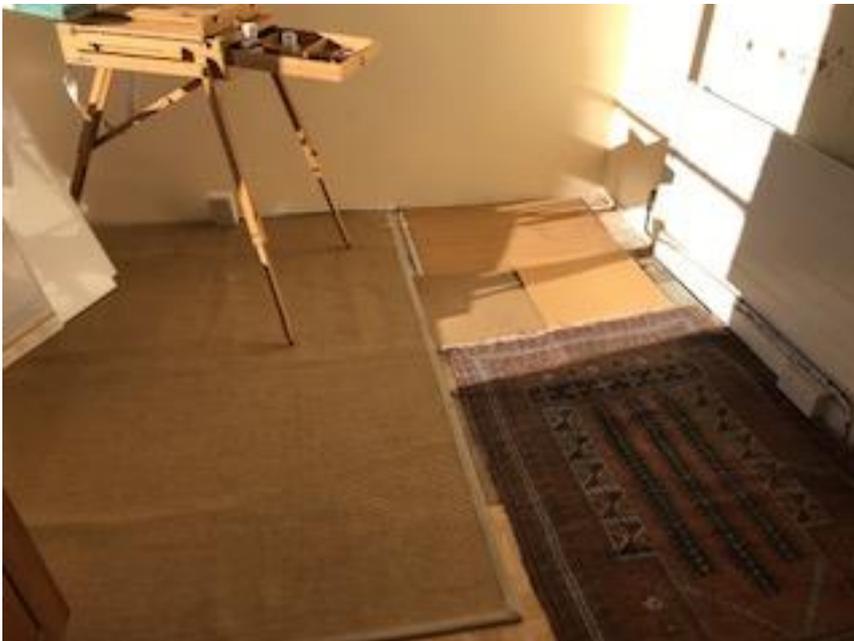
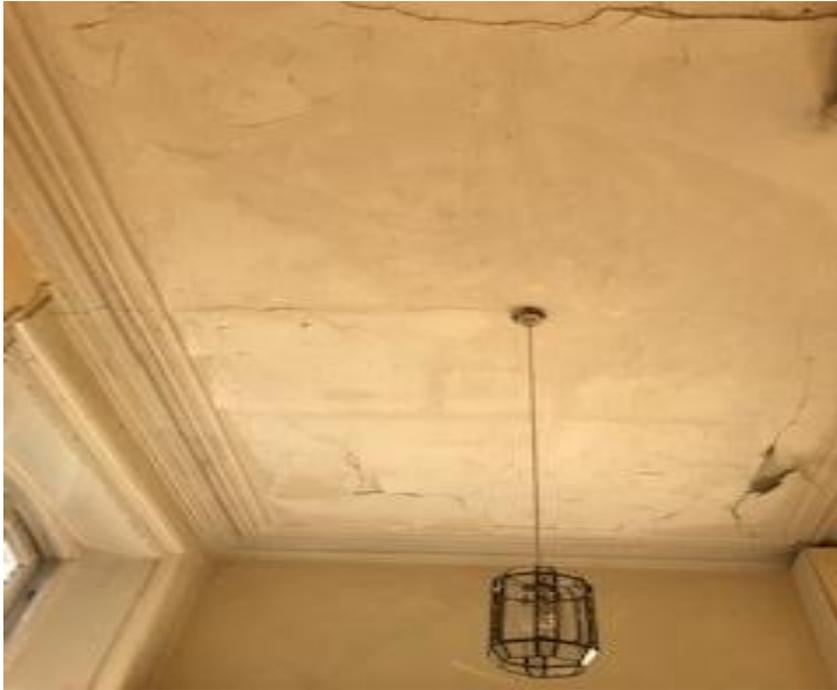
- The client is advised to replace the flooring surface in this room as the flooring surface has been compromised in areas. [Photograph 42](#)
- The ceiling in this room also requires overhauling. [Photograph 43](#)

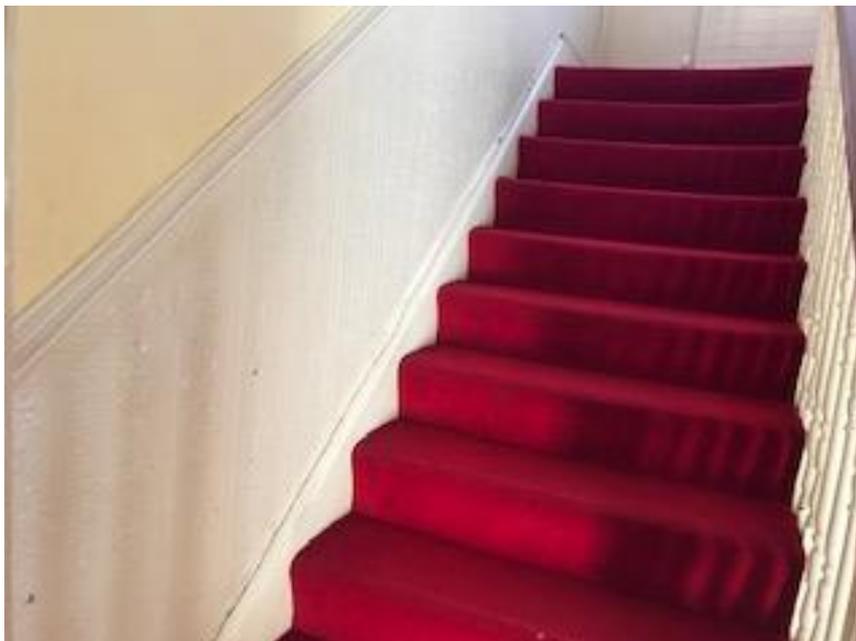
Photograph 44

- Cracking was noted at the junction of the stairs stringer and the wall. The cracking is most likely due to movement of the stairs away from the wall as the canter lever effect takes place over time. The canter lever effect is the leaning away of the stairs from its anchoring point at the wall. The client is advised to consider re-anchoring the stairs in the medium term. Structural failure is not expected in the short term. [Photograph 44](#)
