Colin Gamble & Associates
Consultant Engineers Ltd

Property Condition Report

Date of Inspection: Sunday 10th February 2019

Property Address: 123 The House, Naas, Co. Kildare

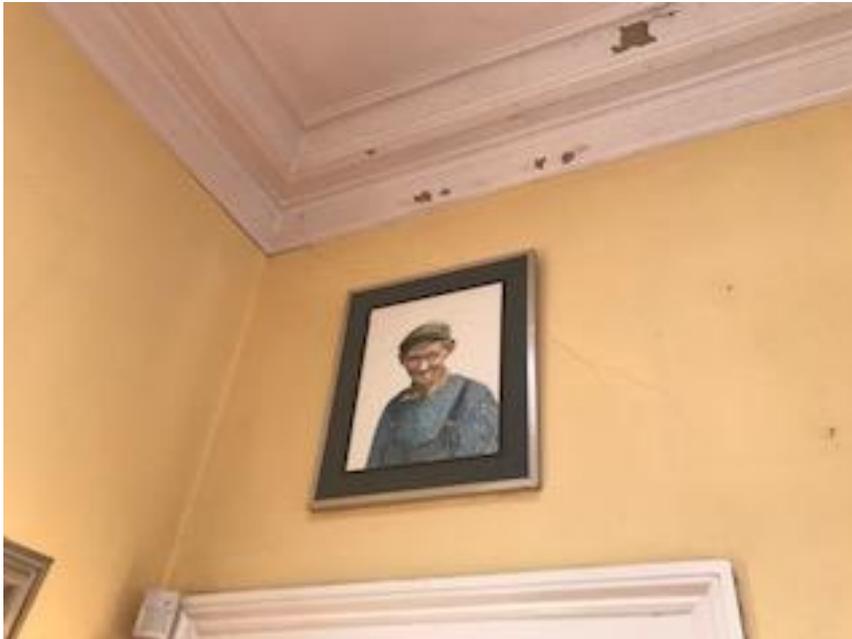
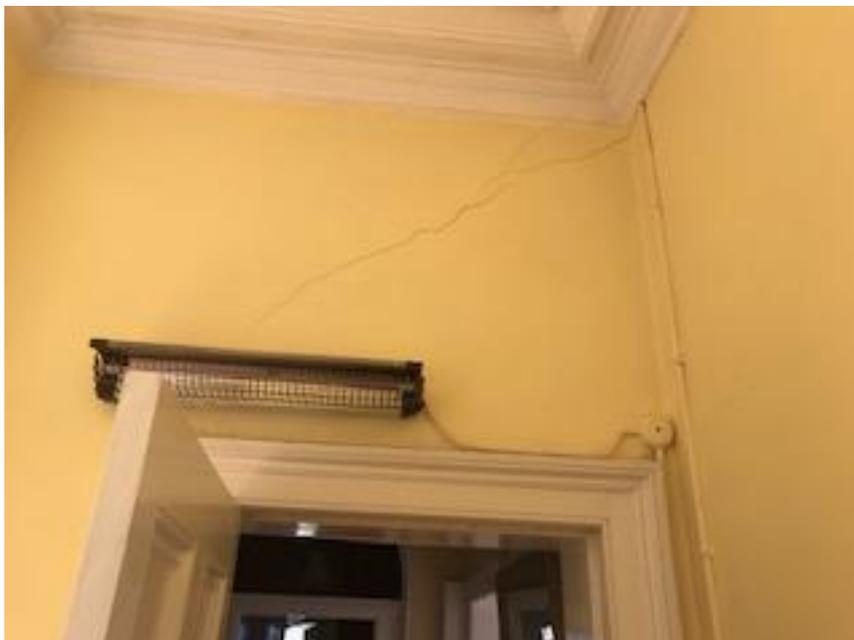
- Multiple structural cracks were noted on the load bearing wall on the second floor. This is most likely due to the roof being supported directly onto these walls. Structural failure is unlikely although the client is advised to monitor same. [Photograph 45 and 46](#)

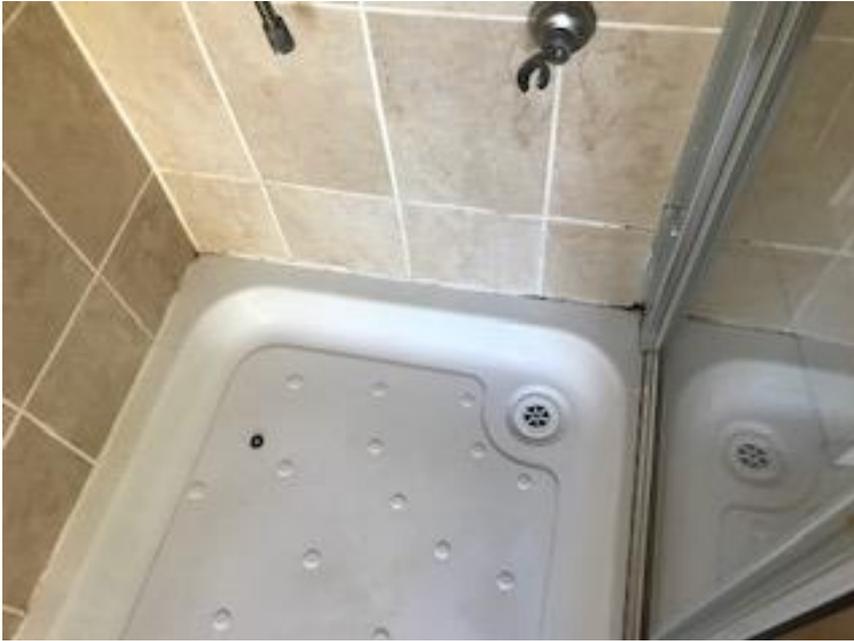
Photograph 47

- Water egress was noted from the shower. The client is advised to allow for the removal of the tiles and the localised reparation works to the affected timber and plaster work. [Photograph 47](#)

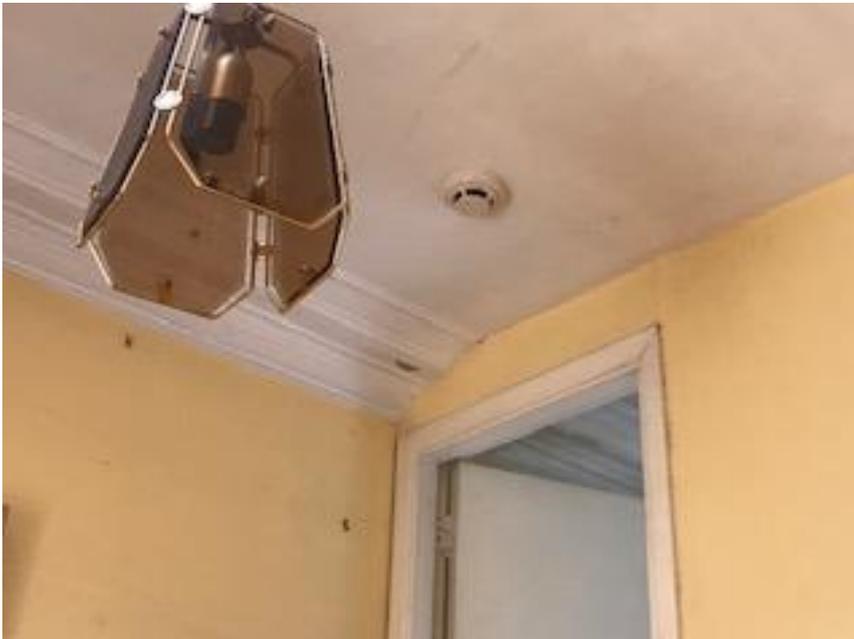
Photograph 48

- The client is advised to install hardwired fire and carbon monoxide alarms into all bedrooms and common areas. [Photograph 48](#)

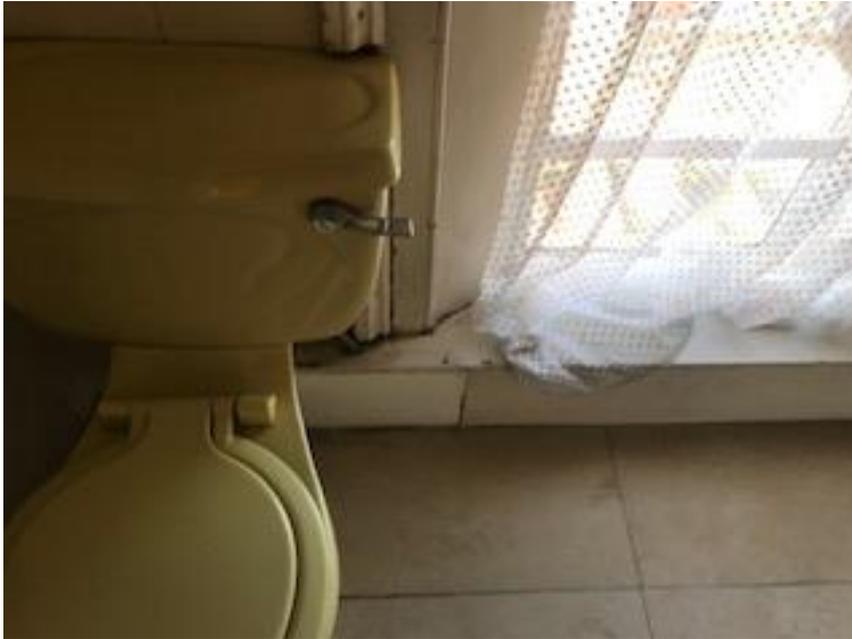
Photograph 49

- The second-floor bathroom showed signs of decay in the timber behind the toilets. The client is advised to remove and replace all of this timber work. [Photograph 49](#)

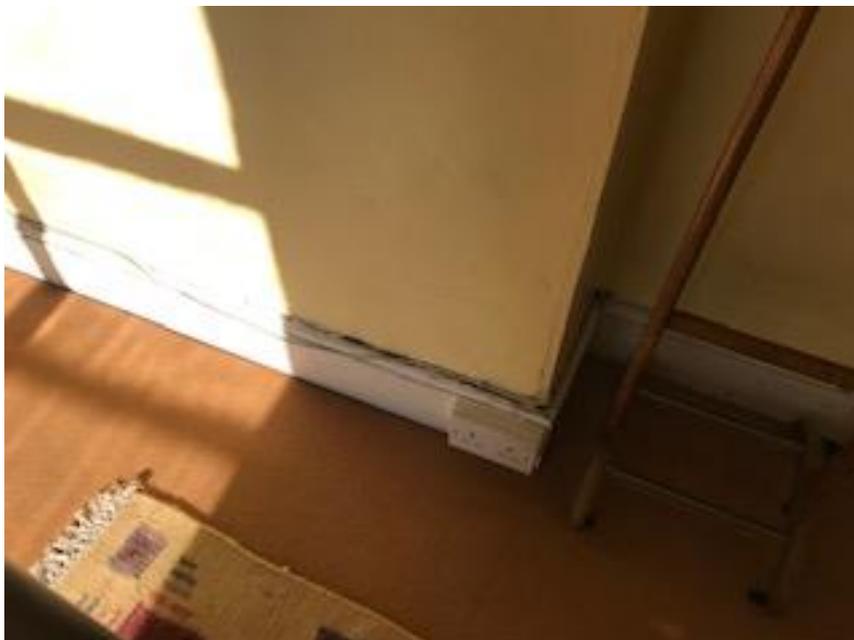
Photograph 50

- Moisture traversing southwards was noted at the chimney locations at the second floor. The client is advised to obtain the services of a roofer to seal the junction of the flashings and the roof and to address any localised affected timber and plaster work. The client is advised that timber rot may be present at this location. If this is confirmed the affected timbers should be removed. [Photograph 50](#)

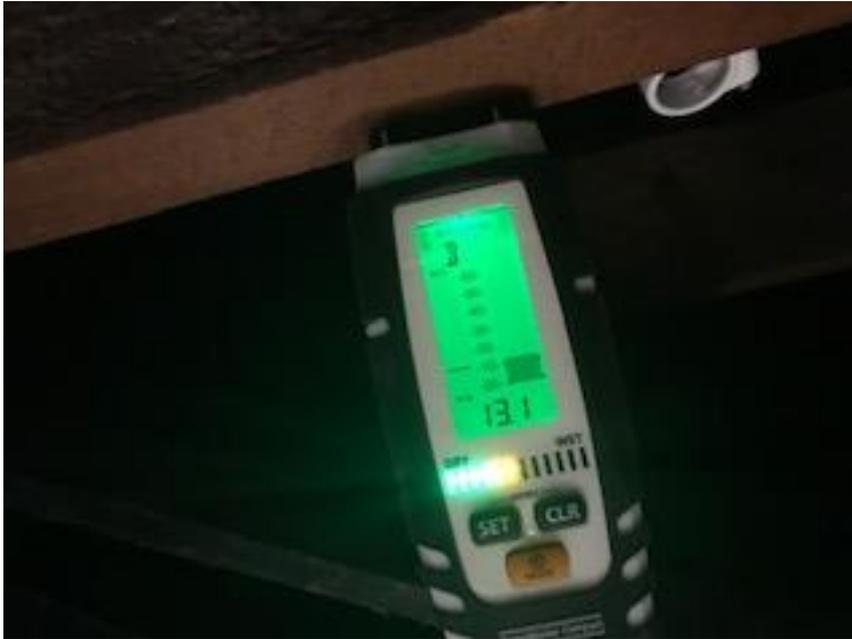
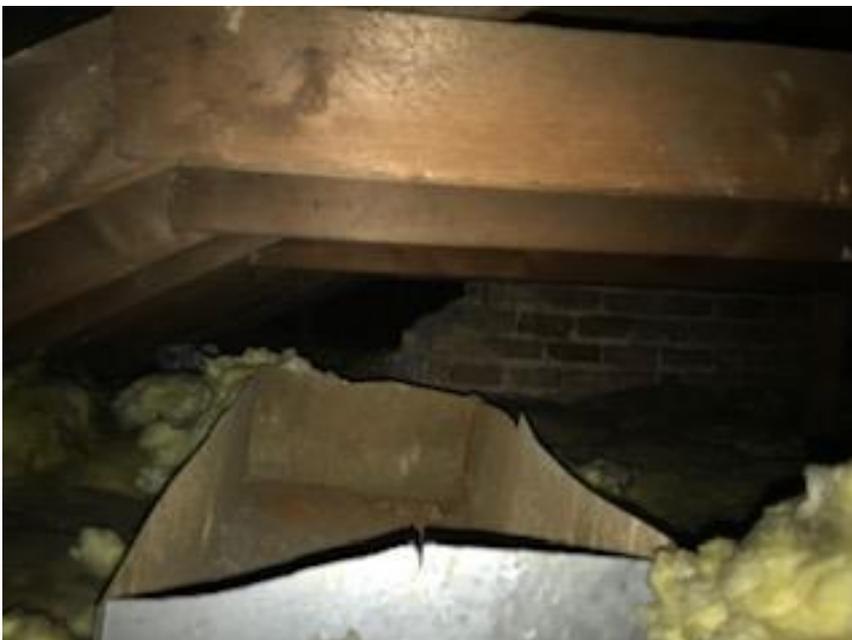
- Access to the attic was obtained via a access port in the ceiling. Access to the entire roof was restricted due to the construction of the roof. However, the writer did note that that a new breathable member had been placed in situ over the timbers and was allowing sufficient cross ventilation of the timbers. The moisture level in the timbers was noted at 13.1% which is considered acceptable. The client is advised to allow for increased cross ventilation to promote the life span of this roof. Additional horizontal reinforcement should be considered in the future as the roof ages. [Photograph 51 and 52](#)

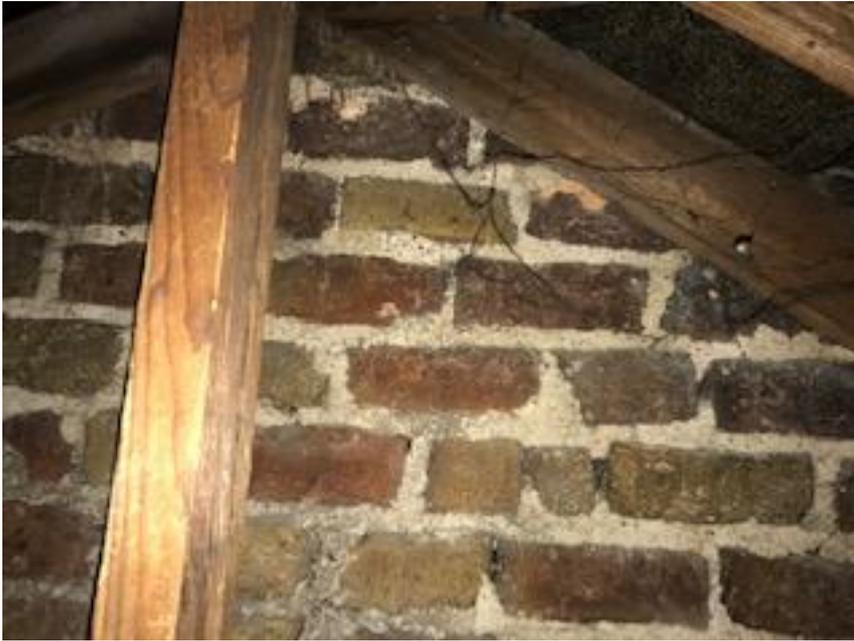
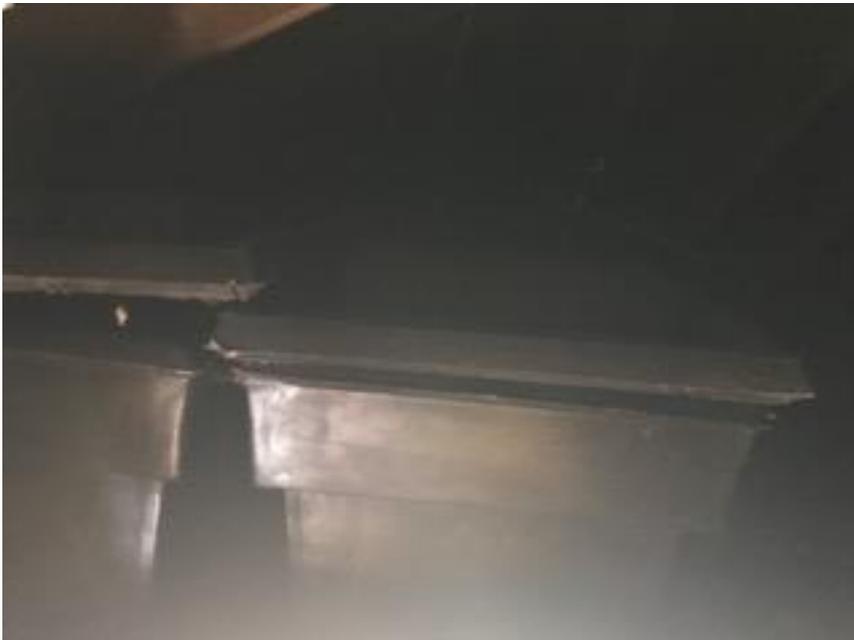
- Sections of the mortar pointing will require addressing on the chimney as the mortar has decayed over time. [Photograph 53](#)
- The client is also advised to insulate the water tanks as they are located in an uninsulated area. [Photograph 54](#)

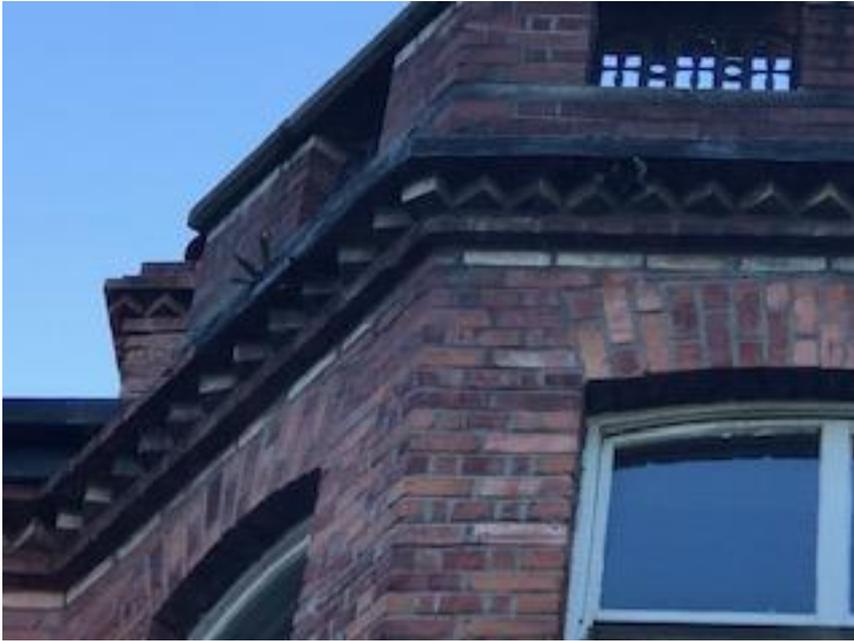
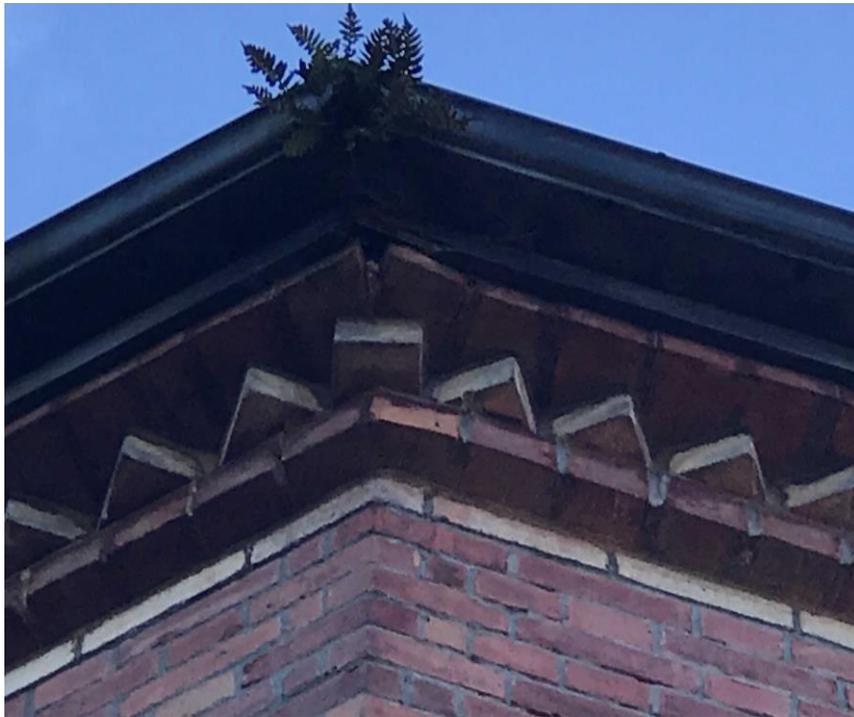
- In general, the front brick façade from a visual inspection from the ground, would appear to be in good condition. Sections of the detailing at the brick soffit level will require re-pointing and all flora requires removing. Flora will absorb the moisture from between the bricks and will cause the mortar to fail. [Photograph 55 and 56](#)

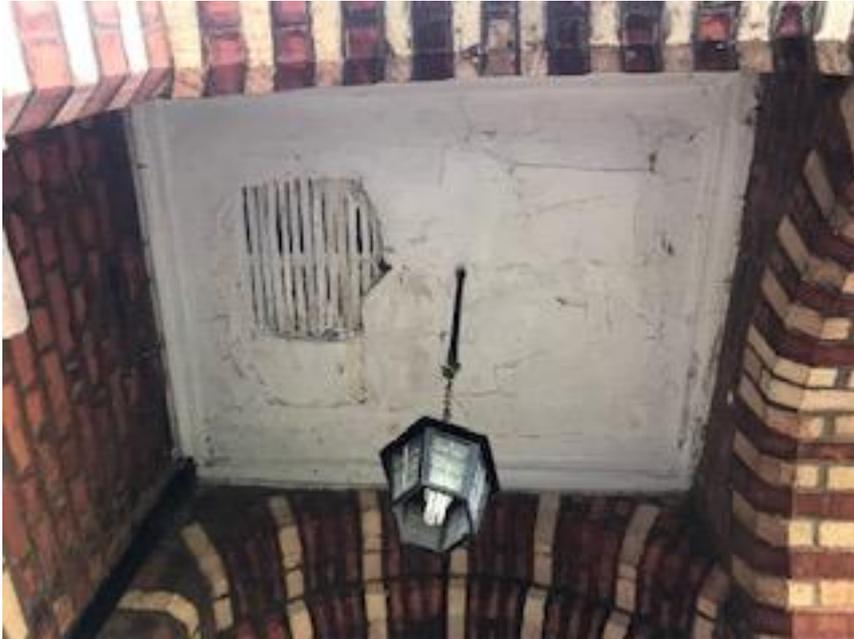
Photograph 57

- The underside of the porch ceiling requires replacing at the door as the timber here has decayed. [Photograph 57](#)

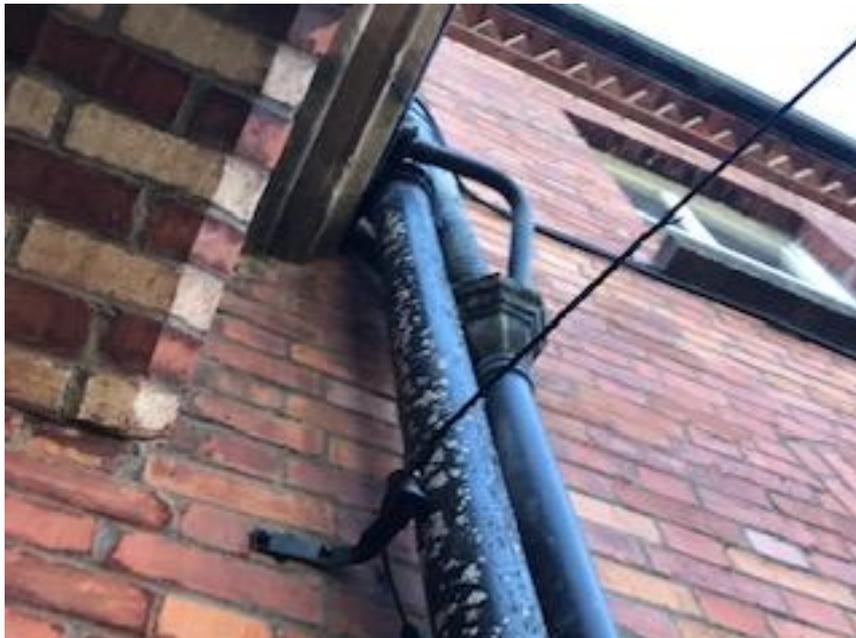
Photograph 58

- Multiple examples of the surface water and the foul water were noted to be mixing throughout the property on the day of the survey. The client is advised to separate these into their respective networks, both of which are available on the property. [Photograph 58](#)

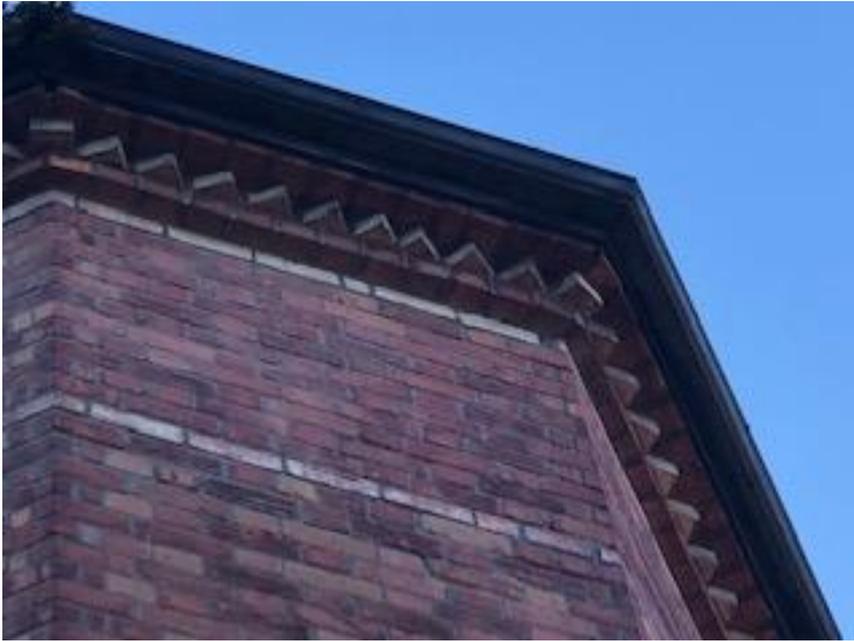
Photograph 59

- The client is advised to overhaul the sections of wooden areas on the soffits and fascia. [Photograph 59](#)

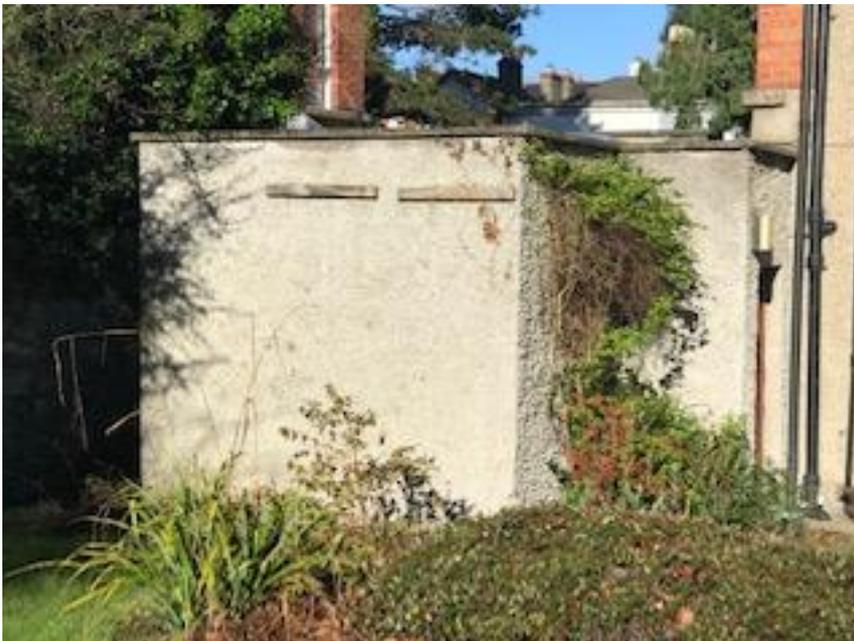
Photograph 60

- The client is advised to obtain a Certificate of Compliance/Exemption with the Planning and Building Regulations for the storage units to the rear. [Photograph 60](#)

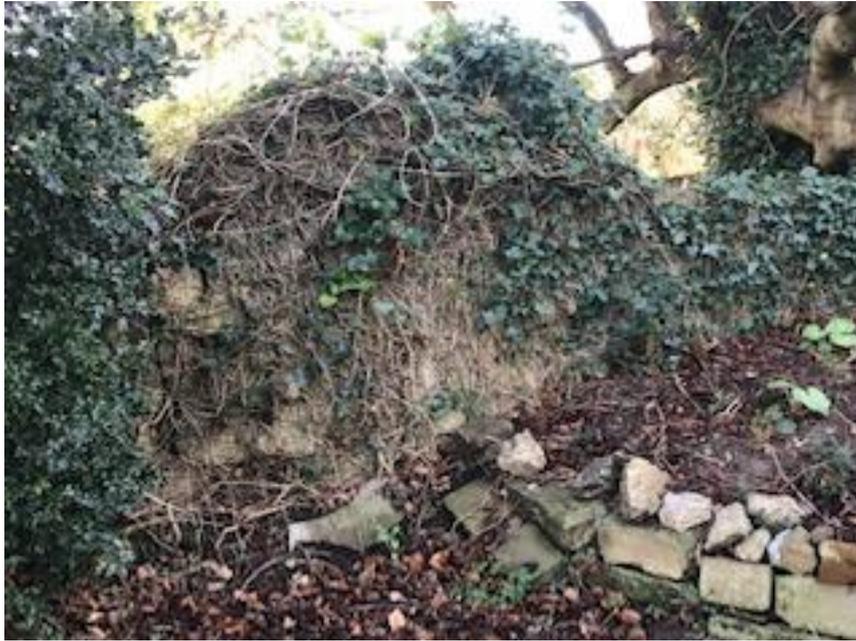
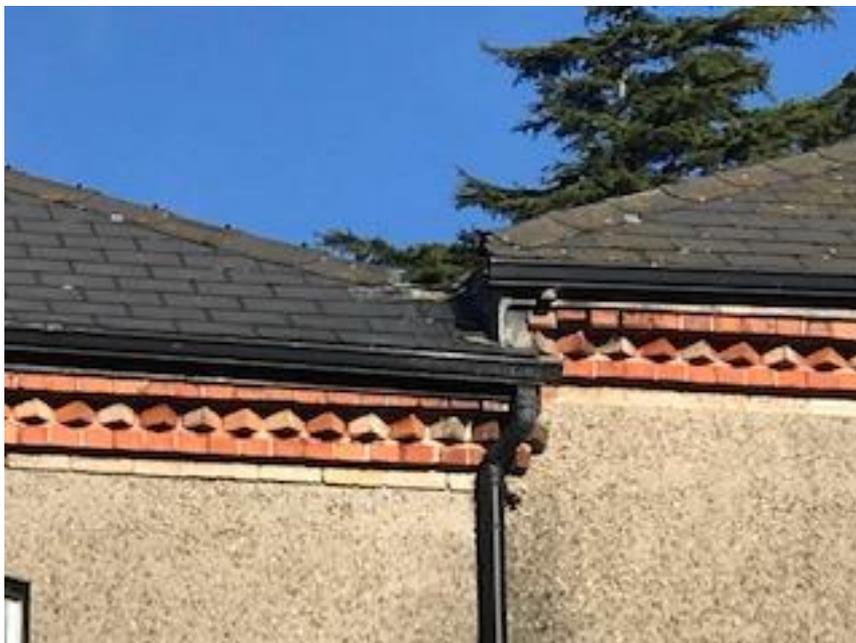
- The boundary wall was noted to be compromised in sections. Sections of this boundary wall to be reinforced. [Photograph 61](#)
- The junction between the two pitched hipped rooves should be sealed by a suitably qualified roofer. [Photograph 62](#)

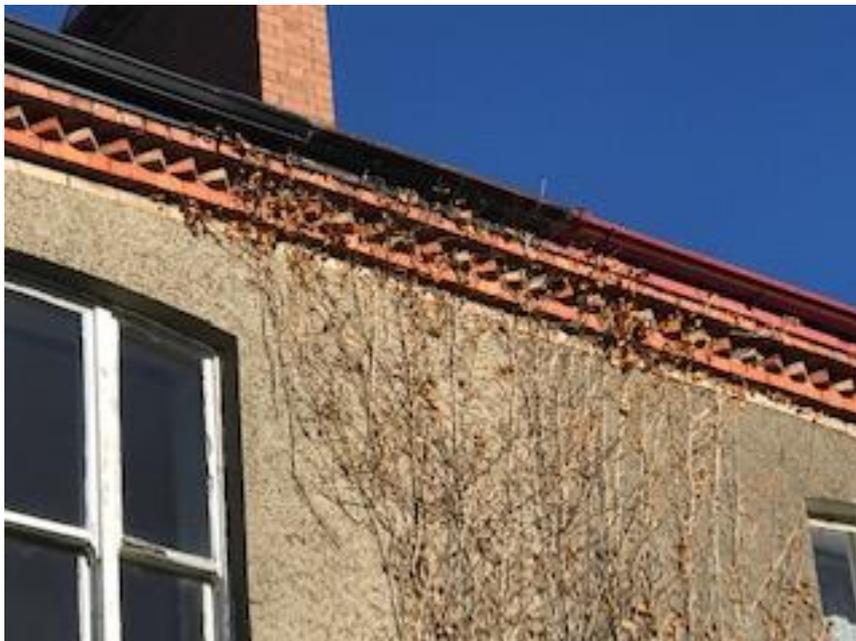
Photograph 64

- It would appear that the roof on the left-hand side as viewed from the rear elevation has been re-tiled recently and appeared to look newer than the tiled section to the right-hand side. Deviations were noted on the slope lines of the left-hand side roof which is most likely due to settlement over time. [Photograph 63](#)
- Sections of the soffits and fascia on the roof on the right-hand side which is adjoining the semi-detached property connected to same requires overhauling. [Photograph 64](#)

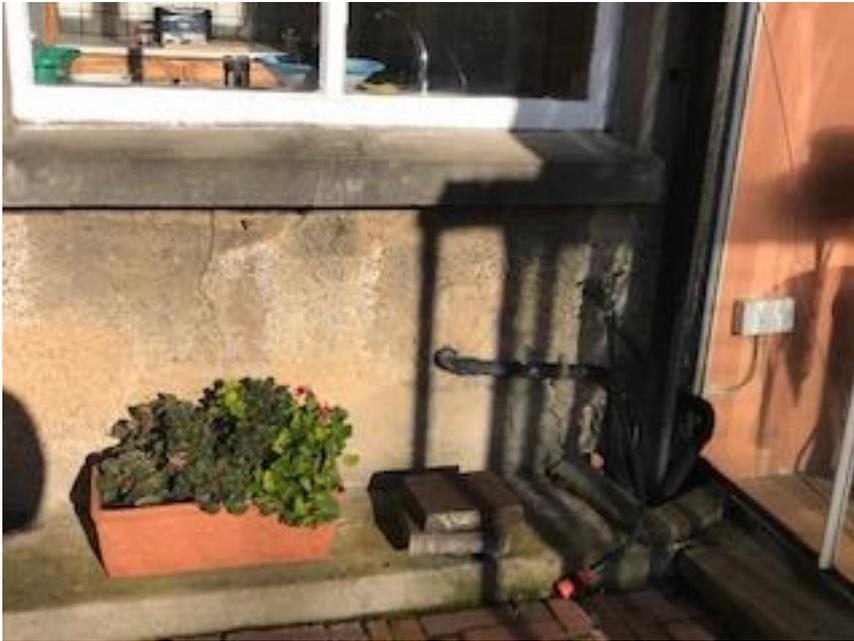
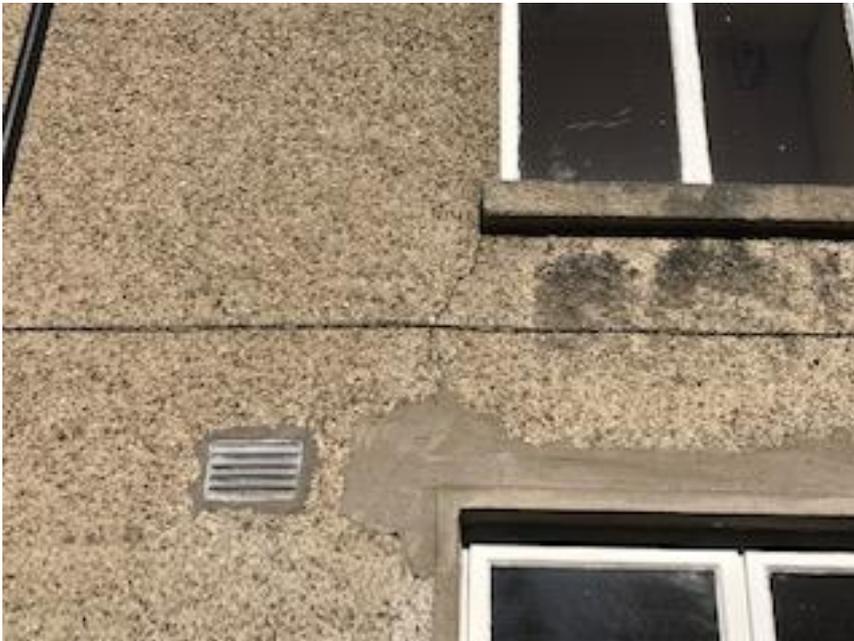
- Structural crack was noted on the rear elevation wall. The structural crack has permeated through to the interior. The client is advised to monitor same. Structural failure is not expected due to the length of time that this property has been in situ. [Photograph 65 and 66](#)

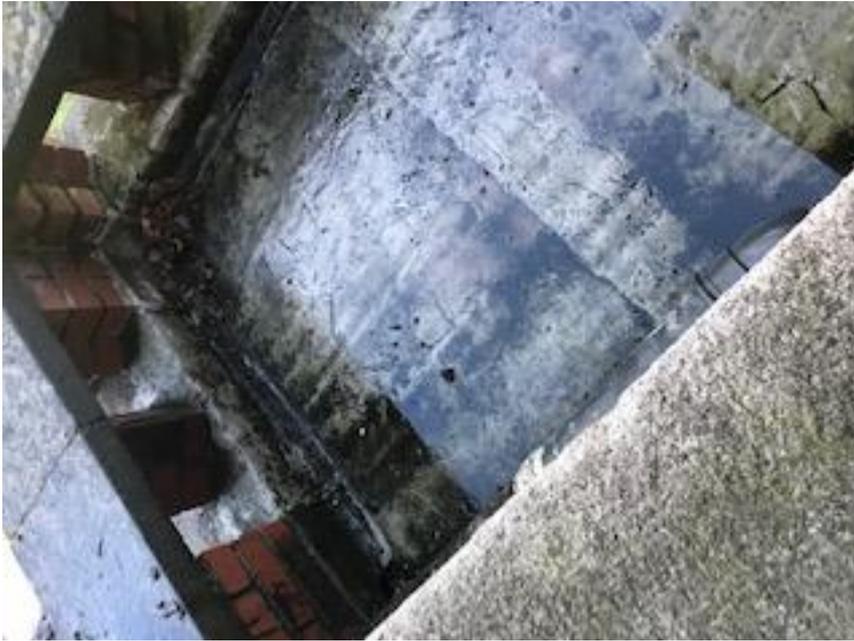
Photograph 67

- The flat roof was viewed from above the porch area and water was noted to be ponding on same. We would advise the client to alter the slope on the roof to promote water runoff and to prevent water ingress into the property. [Photograph 67](#)

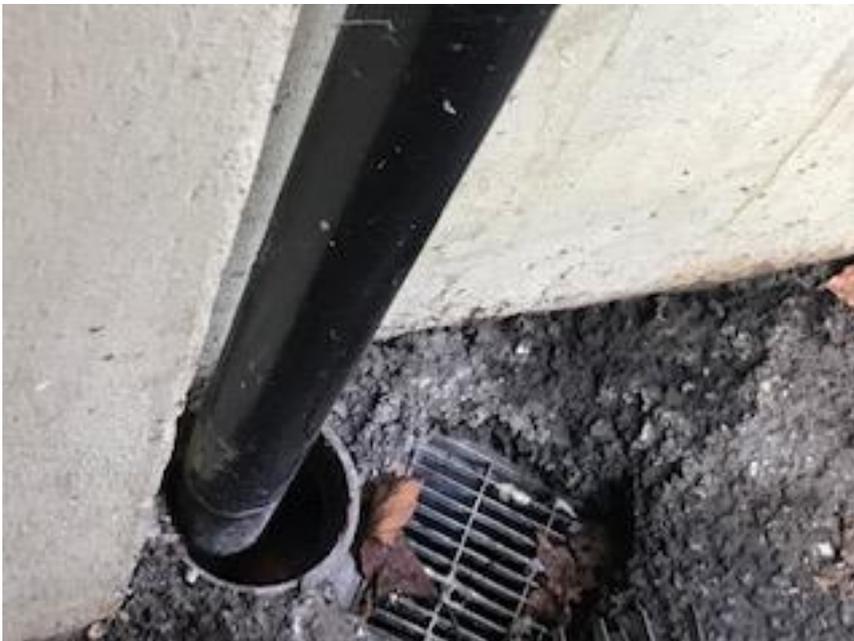
Photograph 68

- Some of the surface drainage was noted as having high levels of water. The client is advised to obtain the services of a CCTV company to unblock these drains. [Photograph 68](#)
