Colin Gamble & Associates
Consultants ltd

Engineers Inspection Report

Sunday 10th February 2019

123 The House, Naas, Co. Kildare

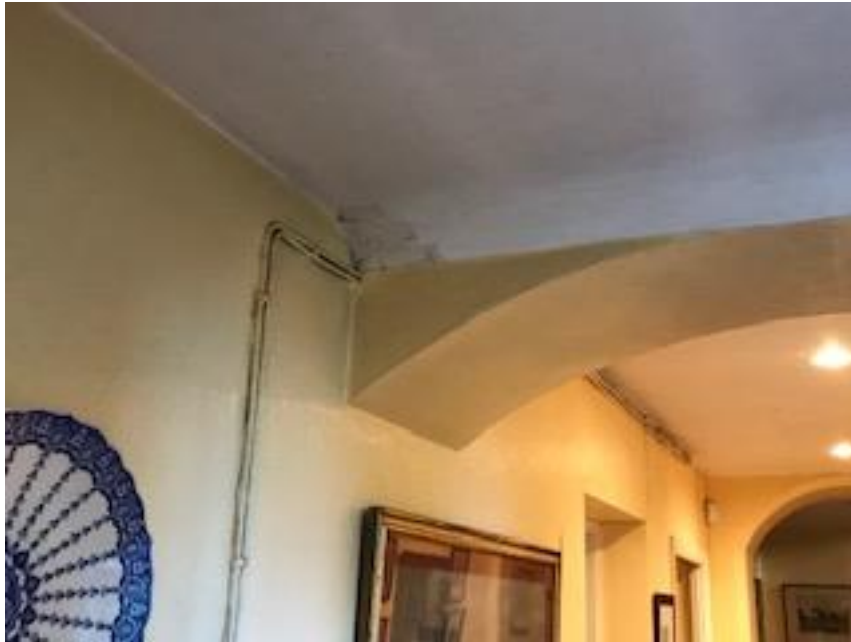
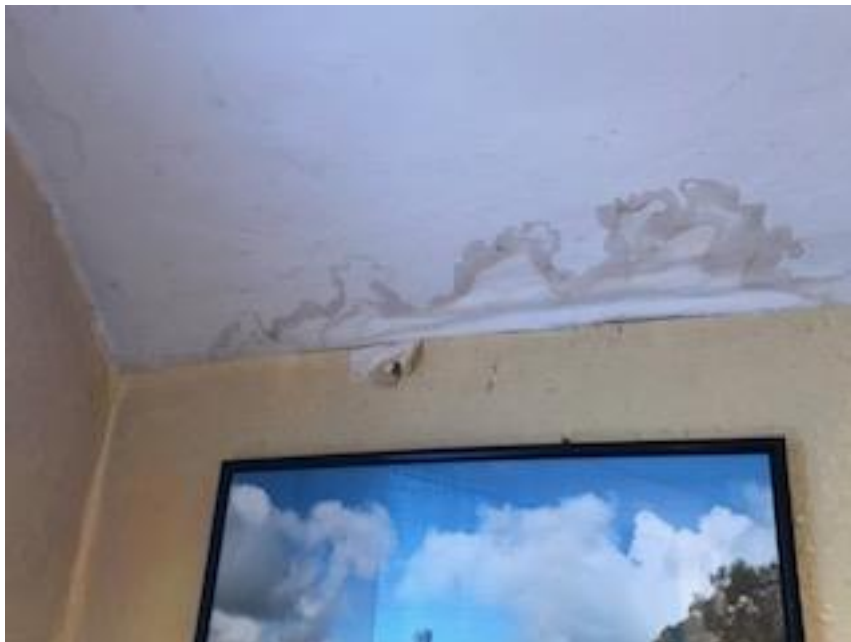
- Leaks were noted from the ceiling at the basement level entrance hall. These leaks are from the junction of the entrance steps to the front door and the area underneath. The client is advised to obtain the services of a general contractor to seal these sections and to replace any effected plaster and timber work. The client is advised that timber rot may be present at this location. If this is confirmed the affected timbers should be removed. [Photograph 1 and 2](#)

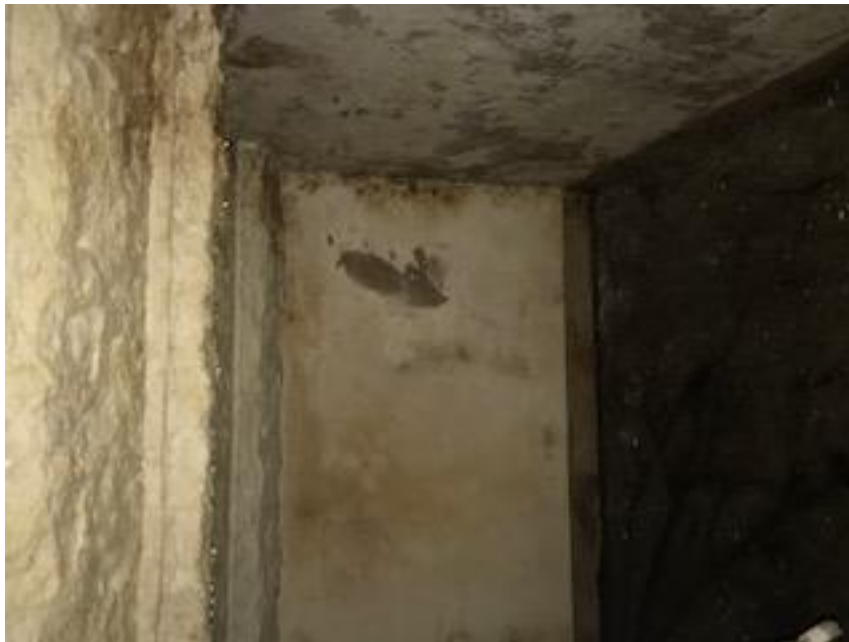
Photograph 3

- The under section of the stairs would appear to be best suited as a storage area however, the client is advised that the levels of moisture noted in the walls and floor here are relatively high. These levels of moisture could be addressed by installing a chemical damp proof course. Any rendering of the walls should be completed with a lime-based render that allows for the historical construction of this wall to migrate water up and down and allows the walls to breath. [Photograph 3](#)

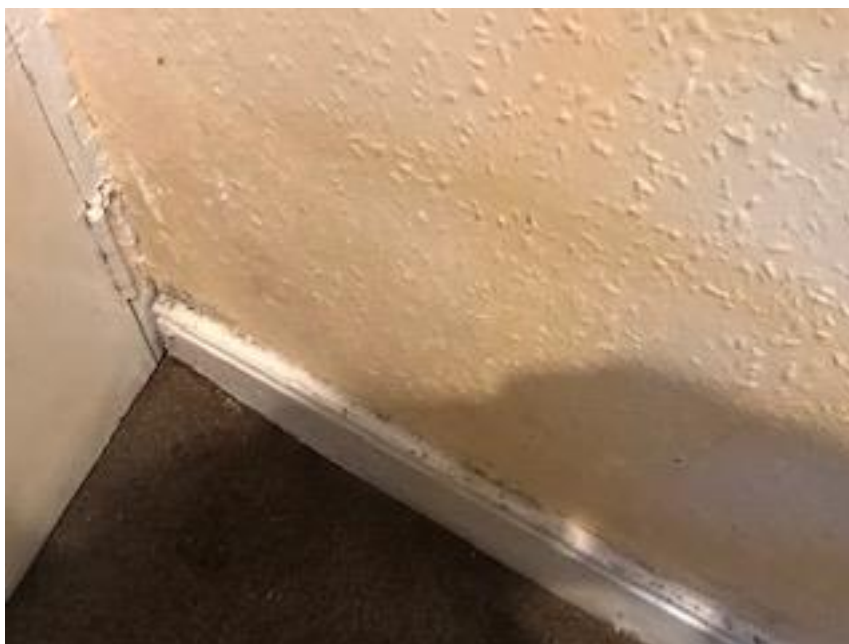
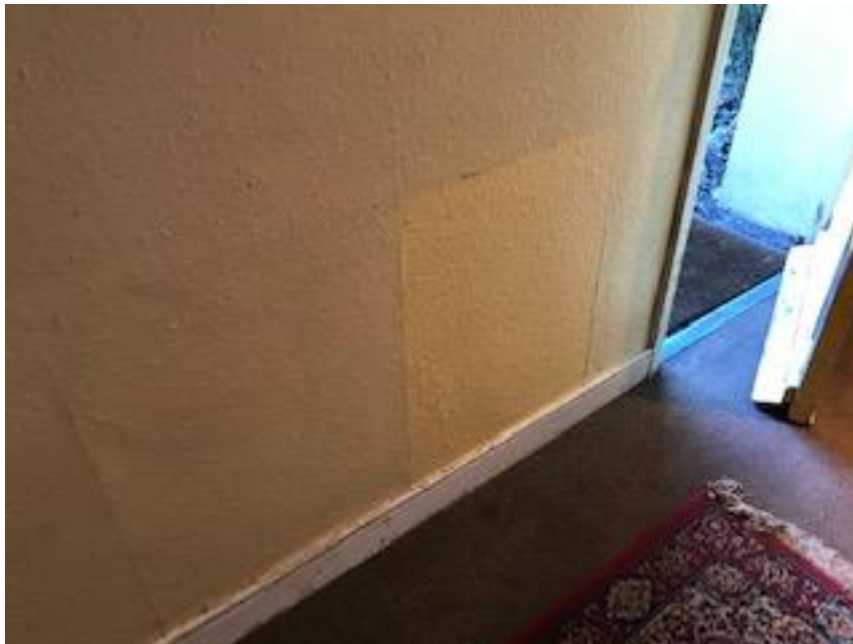
- Moisture readings approaching 1.5% were noted in many of the external walls at basement level on the internal side. Although this property would be expected to have a higher moisture reading in the external walls than a modern construction due to the fact that dwellings constructed in this era were constructed with a design philosophy that moisture would rise and drop on the external walls. We would advise the client to insert a chemical damp proof course and an appropriate internal lime-based render to promote the preservation of the wall and extend the lifetime of the wall. This is a commonly completed task on buildings of this type in the Naas area. [Photograph 4 and 5](#)

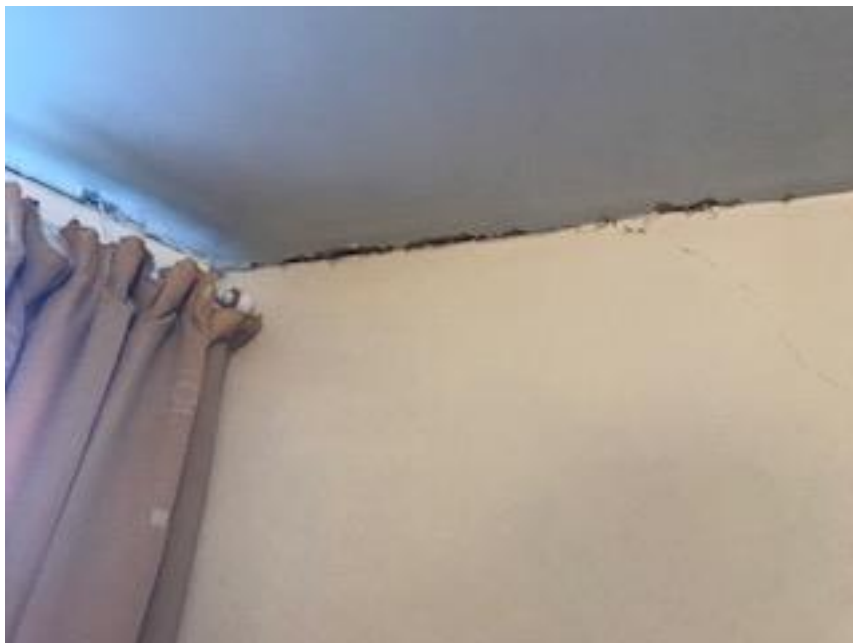
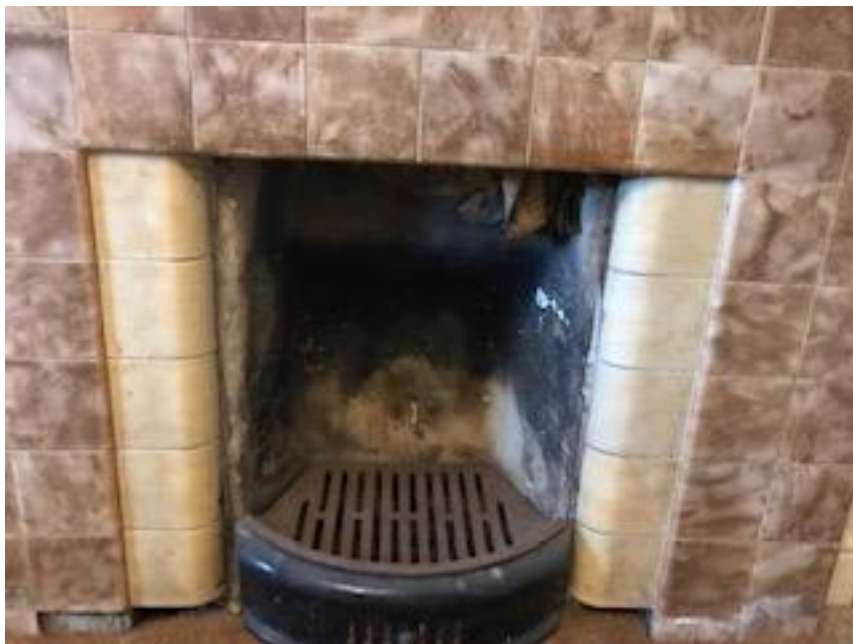
- Cracking was noted at the junction of the ceiling and the walls and water ingress is most likely due to water traversing through the chimney. The client is advised to allow for the sealing of the flashing at the chimney and to allow for localised reparation works to any affected plaster work and timber. The

client is advised that timber rot may be present at this location. If this is confirmed the affected timbers should be removed. [Photograph 6 and 7](#)

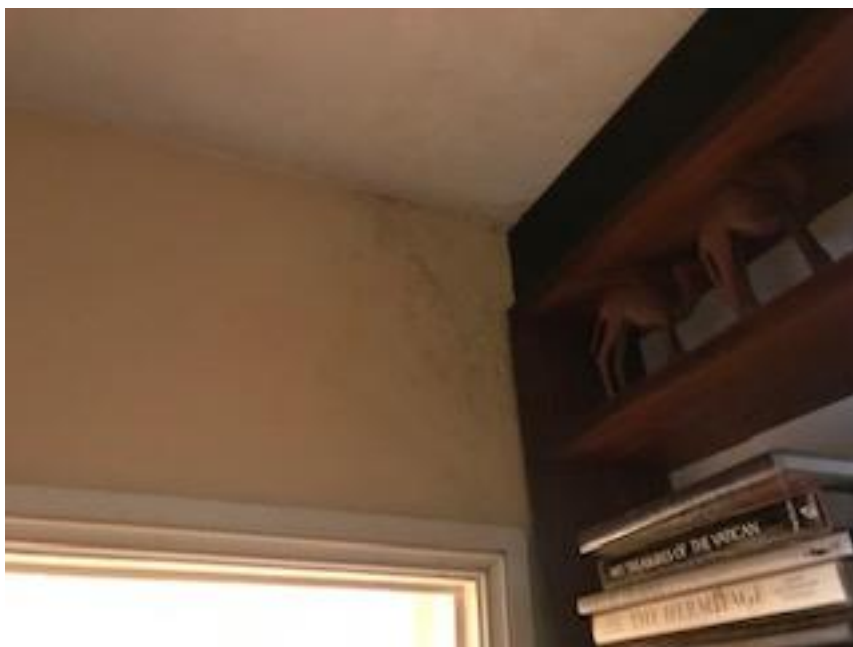
Photograph 8

- Leakage was noted from the floor above which has permeated into the reading room area. The client is advised to obtain the services of a general contractor to repair the leak from above which has most likely emanated from one of the flashings. The client is advised to allow for localised reparation work to any affected timber and plaster work. Timber rot may be present at this location. If this is confirmed the affected timbers should be removed [Photograph 8](#)

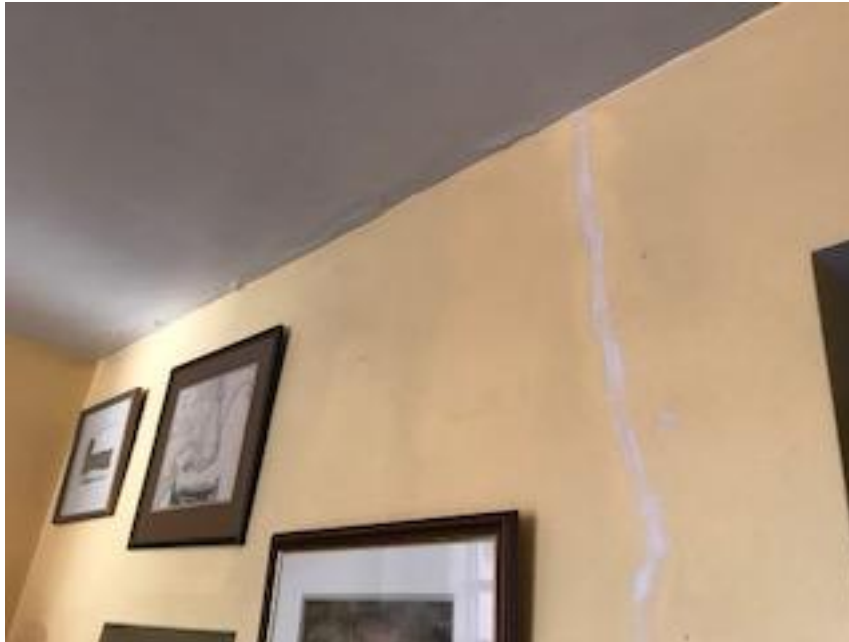
Photograph 9

- Structural cracking was noted on some of the support walls in the living room at basement level. Some of the cracks were noted as having a magnitude of up to 4-5 millimetres in diameter. It is unlikely that structural failure will occur however, the client is advised to monitor this structural crack. If propagation of the crack does occur, reinforcement would be required at this location. The client is advised to note that the property has been in situ for quite some time and structural failure is most unlikely. [Photograph 9](#)

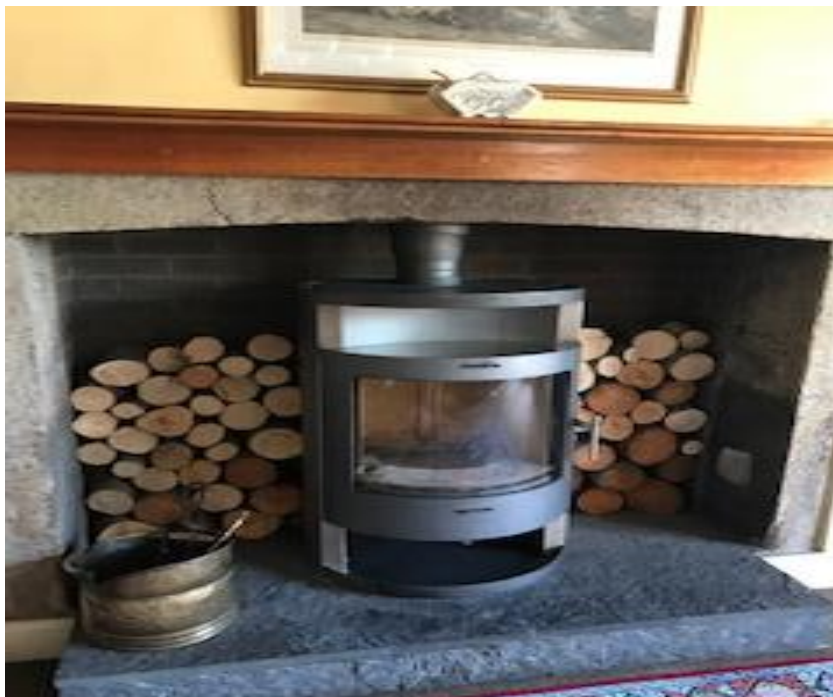
Photograph 10

- A retrospective wood burning stove was noted in situ. The client is advised to obtain confirmation from the vendor that the correct flue liner has been installed to cope with the high gas temperatures produced by the stove when it is operated. [Photograph 10](#)

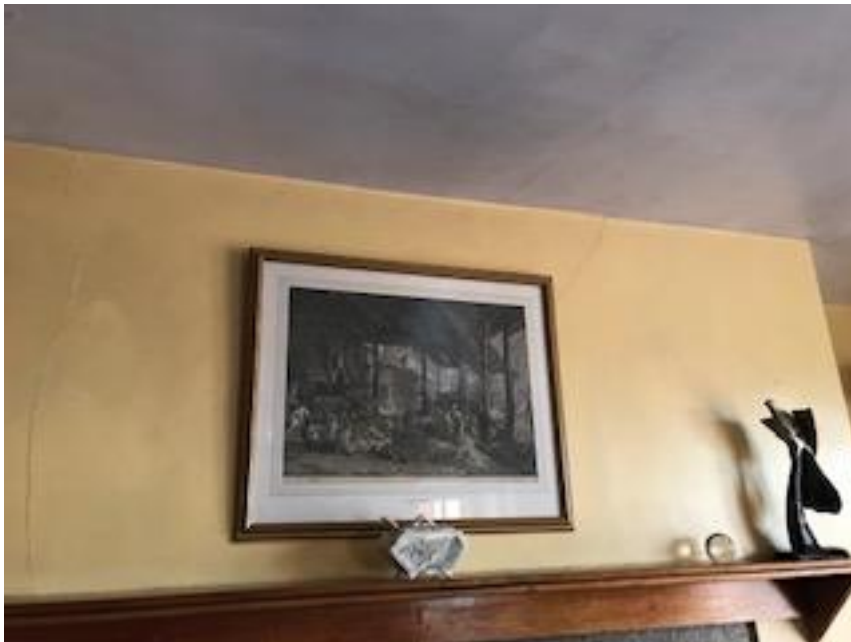
Photograph 11

- Thermal cracking was noted on the chimney breast as a result of the high temperatures. This is most likely due to the heat radiating from the flue. [Photograph 11](#)

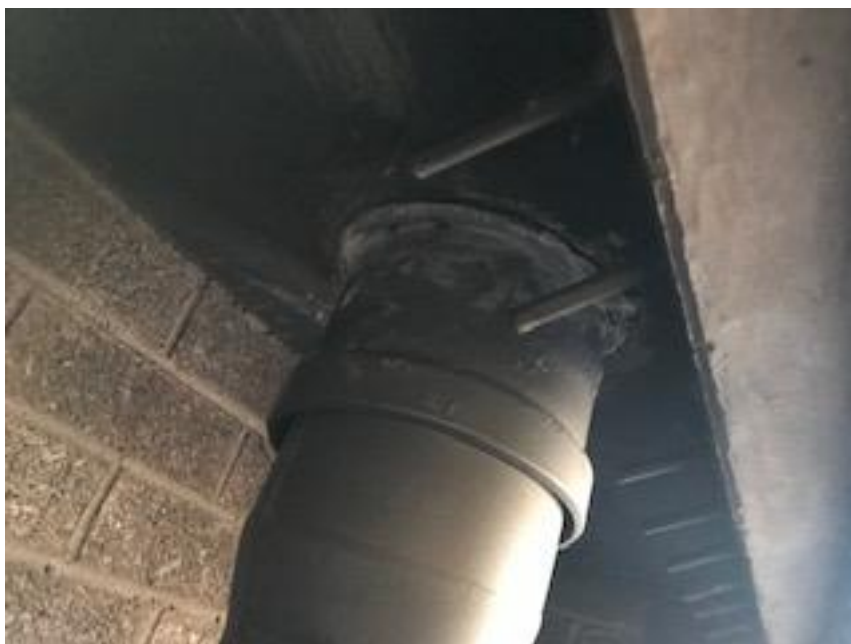
Photograph 12

- The client is advised to seal the junction of the flue with the manifold. [Photograph 12](#)

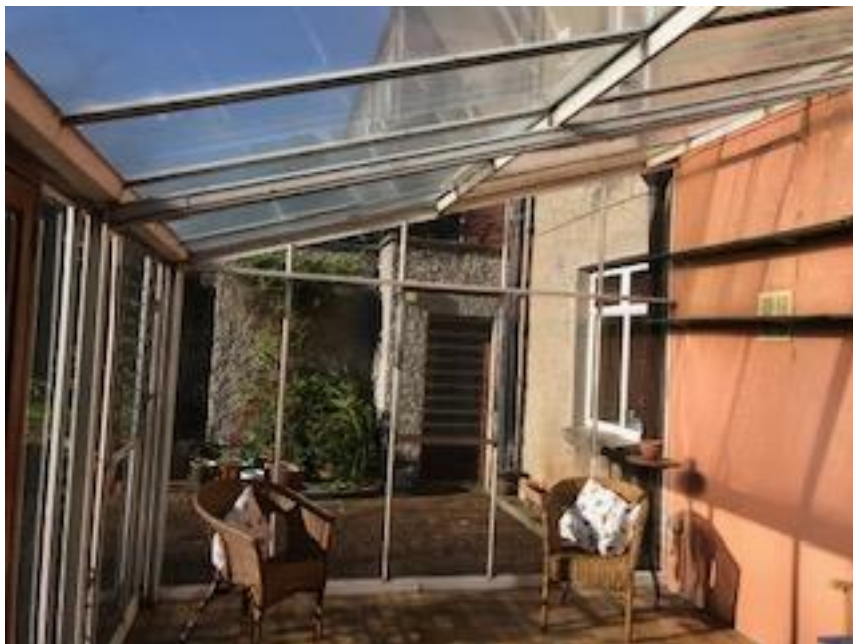
Photograph 13

- The client is advised to obtain a Certificate of Compliance/Exemption with the Planning and Building Regulations for the glass conservatory extension to the rear. [Photograph 13](#)
- The conservatory roof is poor and should be replaced as signs of water ingress were noted. [Photograph 14](#)
- Evidence of rising damp was noted on the external conservatory wall which would appear to be the original boundary wall. [Photograph 15](#)

- The client is advised that 123 The House, Naas, Co. Kildare is recorded on the Protected Structures of Kildare County Council. As such we would advise the client to ensure that the appropriate certificates are in place for the addition of any structures including the glass conservatory. [Photograph 13](#)

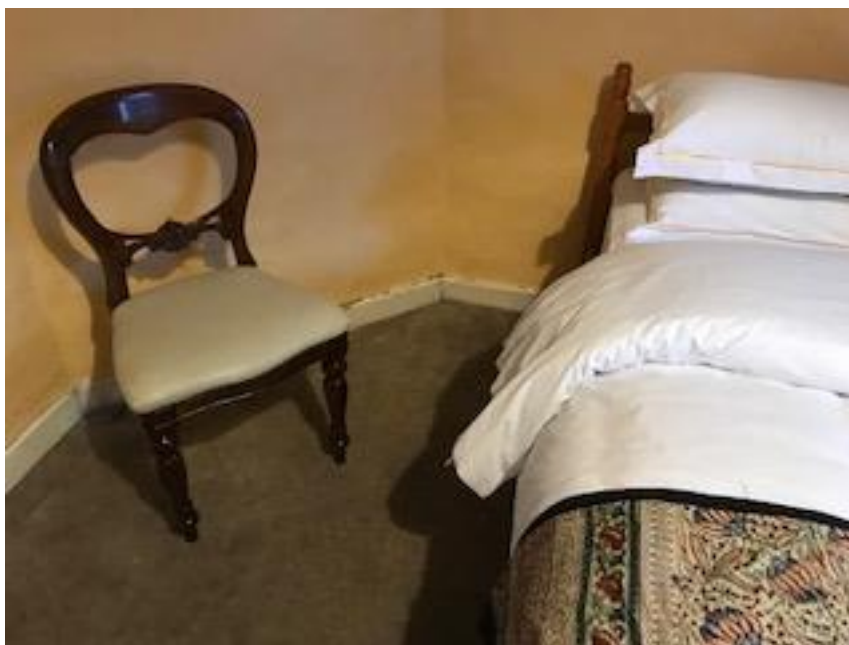
Photograph 16

- Evidence of rising damp was noted on the walls. [Photograph 16](#)

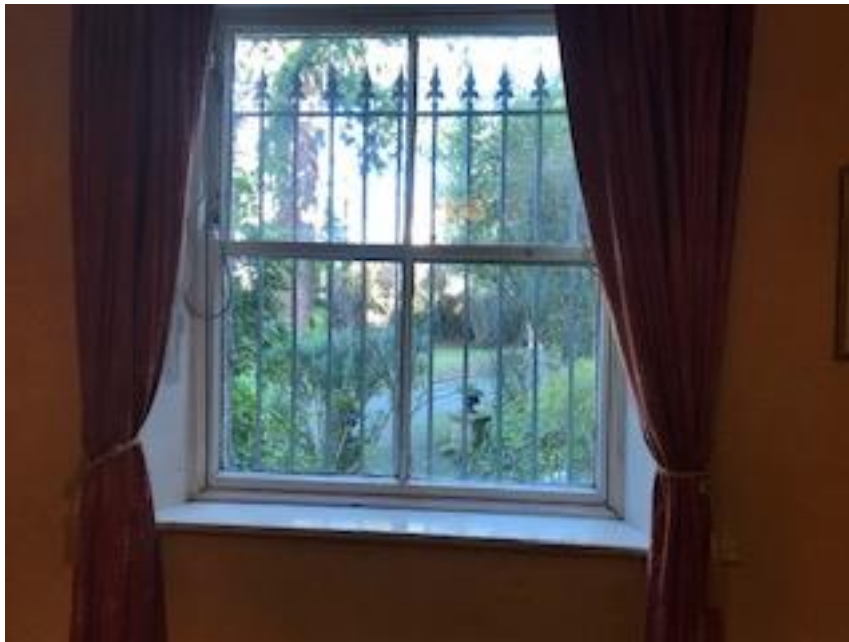
Photograph 17

- In the interests of fire safety, the client is advised that the security precautions are removed from the bedroom windows. [Photograph 17](#)

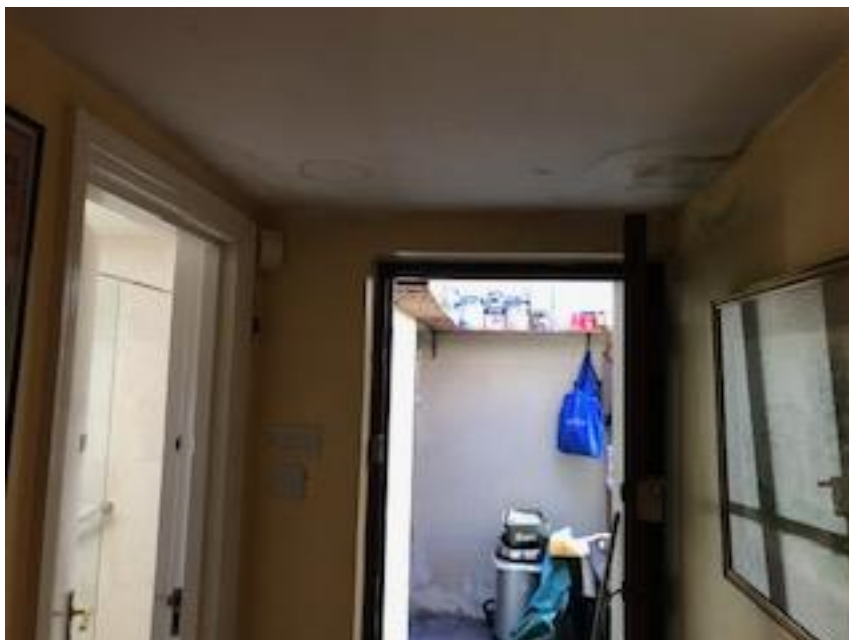
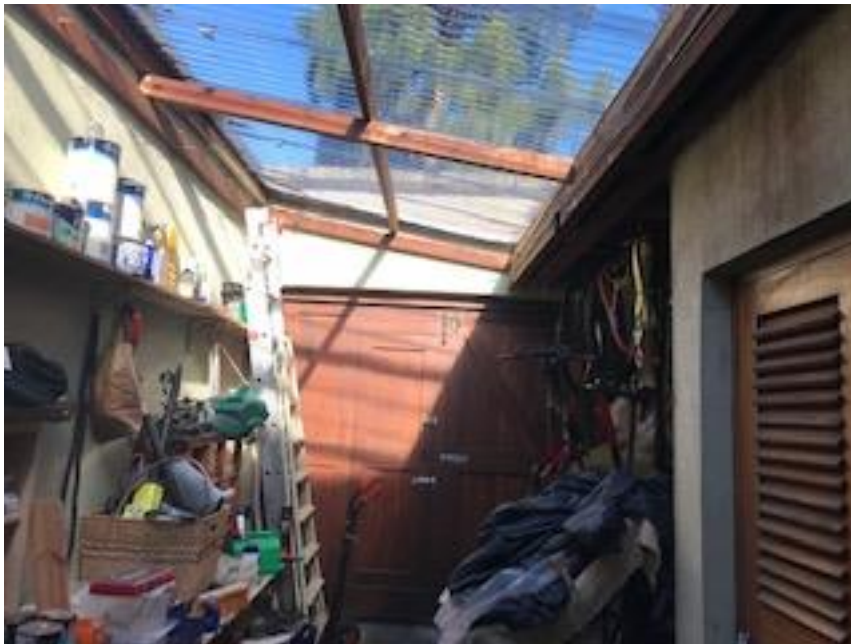
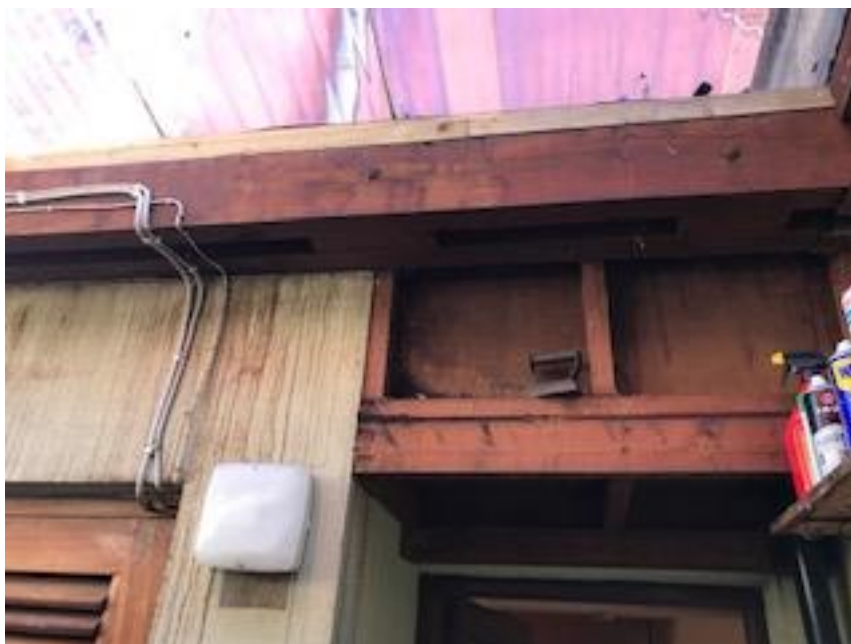
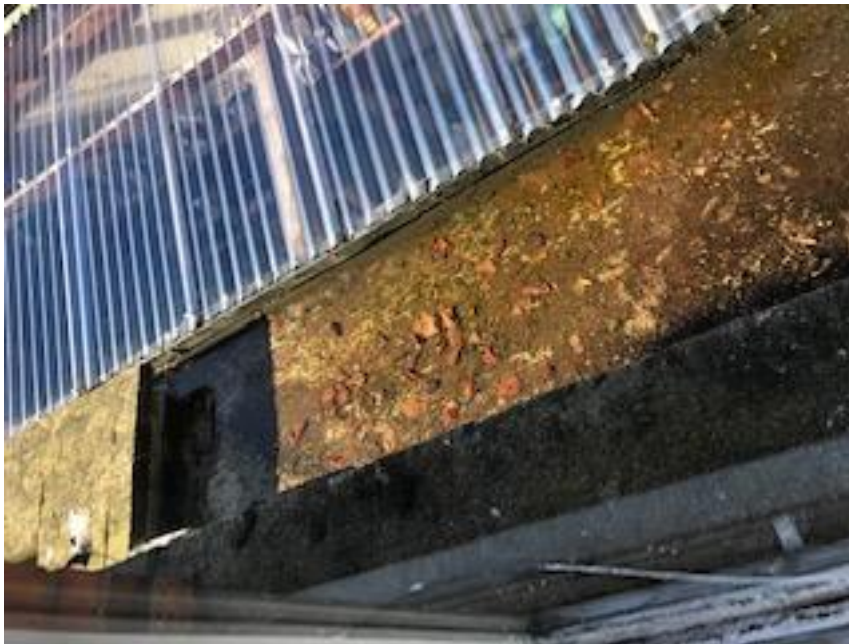
- Multiple leaks were noted in the basement hallway ceiling that leads onto the garage/storage area to the side of the dwelling. These leaks correlate with the valley that has been constructed above and joins the roof of the dwelling and the roof of the storage area. The client is advised that this valley is re-designed and re-laid. The client is advised that timber rot may be present at this location. If this is confirmed the affected timbers should be removed. [Photograph 18, 19, 20 and 21](#)

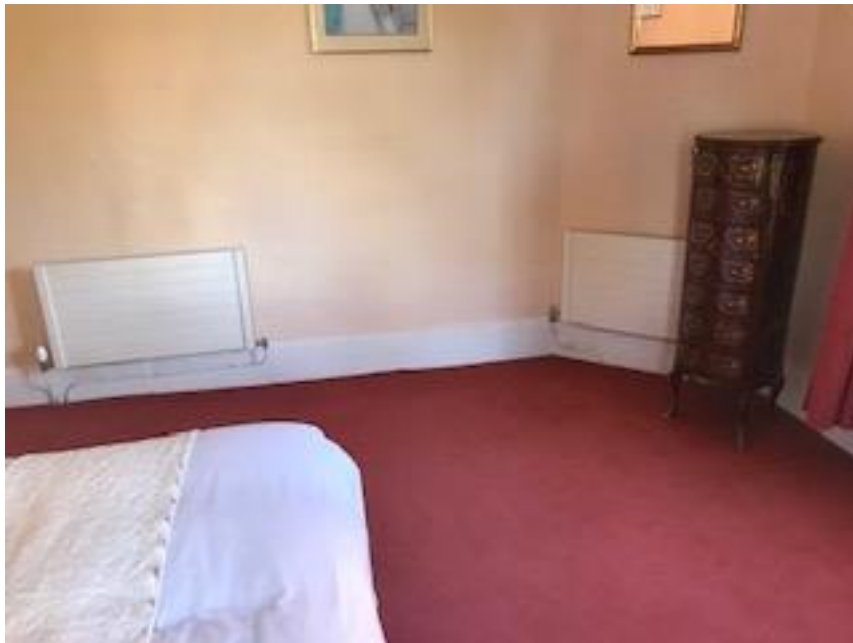
Photograph 24

- The heating system activated on the day of the survey and the boiler appeared to work well. The boiler appeared to be a relatively new entity. We would advise the client to seal the exhaust flue from the boiler with the ceiling to avoid the build-up of carbon monoxide in the boiler room. [Photograph 22](#)
- The client is also advised that the actuator valves are anchored appropriately to the wall to avoid failure of same. [Photograph 23](#)
- It was noted that the basement level and ground floor radiators reached acceptable temperature within one to two hours. The radiators on the second

floor did not warm up quickly. The client is advised to allow for flushing out of the systems and possibly de-zoning the systems. The capacity of the boiler may also require reviewing to allow for greater heat output. [Photograph 24](#)

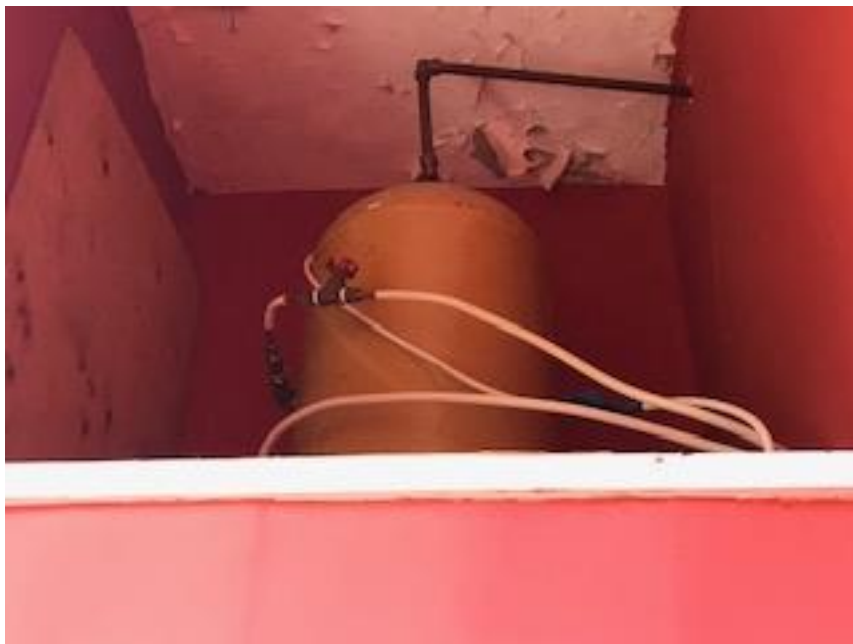
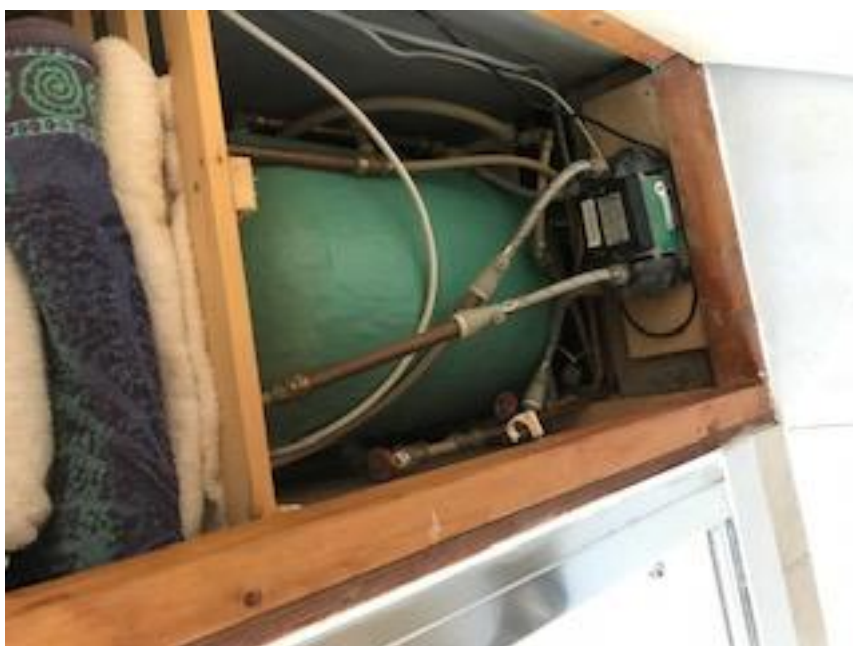
- It would appear that there is a separate cylinder on each level for the domestic hot water system. The client is advised to consider replacing the separate hot water cylinders on each level with a single high efficiency domestic hot water system complete with solar heating panels or air to heat pump. [Photograph 25 and 26](#)

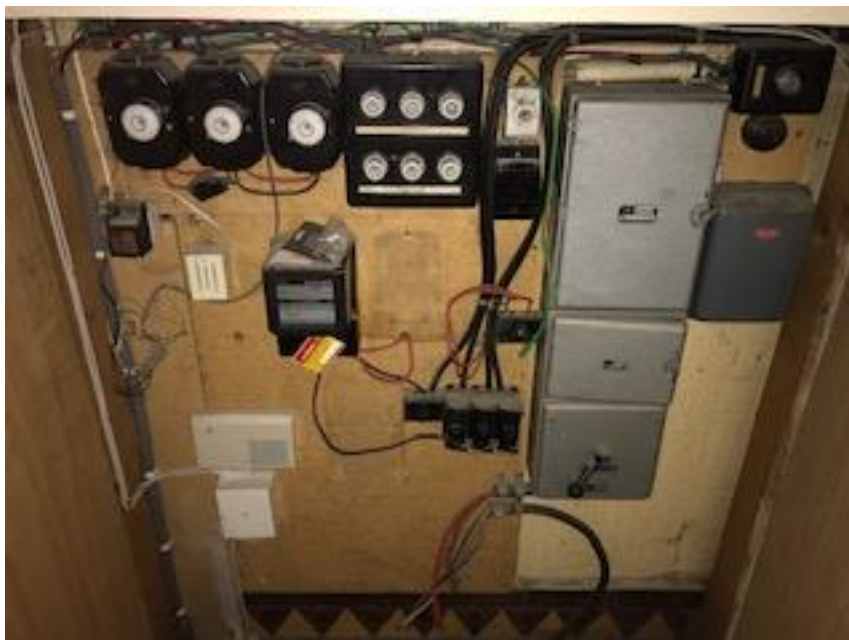
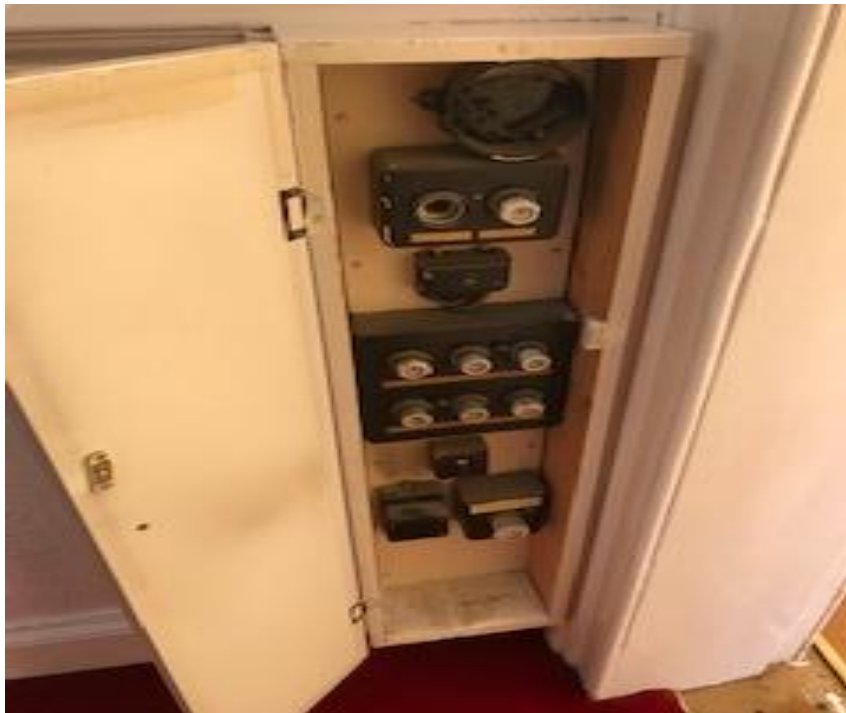
- The electrical system would appear from a visual survey to be separated into two circuits. One circuit appears to be for the basement level and a circuit for the ground and upper floors. Both systems require overhauling. The circuit fuse box for the ground floor would appear to have previously overheated and is showing signs of compromised components due to excessive heat. The client is advised to have this replaced. [Photograph 27](#)
- The electrical system on the ground and upper floor is governed by ceramic fuses and old wiring systems. We would advise that this is replaced in its entirety. [Photograph 28 and 29](#)

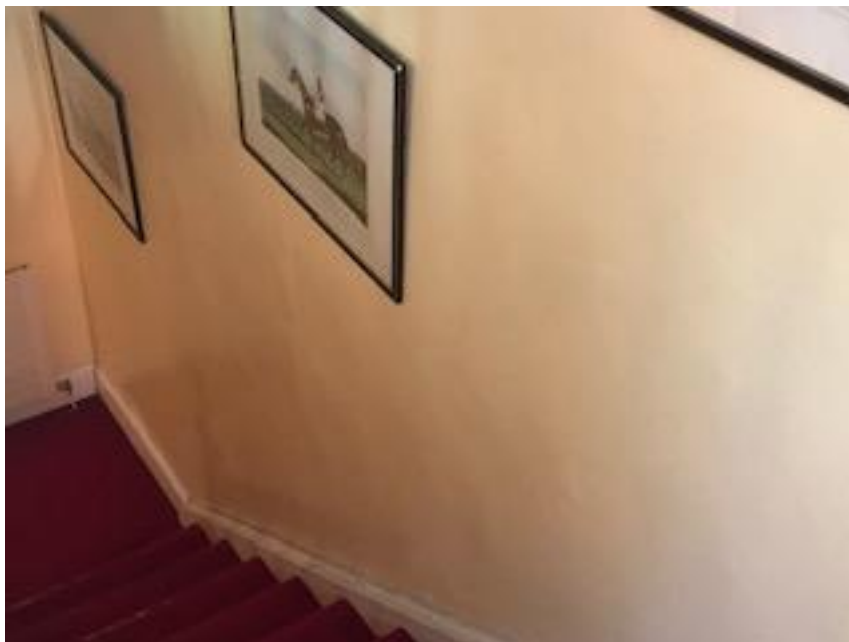
Photograph 30

- Structural cracking was noted on the ground floor hallway. Structural failure is unlikely due to the age of the property and the time that the property has existed however, we would advise the client to monitor same. [Photograph 30](#)

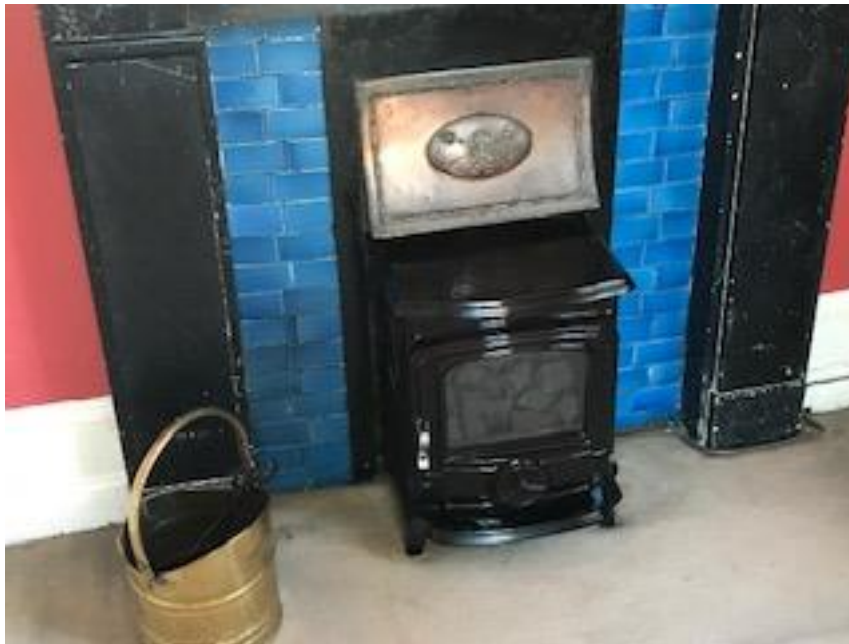
Photograph 31

- A stove has been retrospectively installed in the living room. The client is advised to obtain confirmation from the vendor that the correct flue liner has been installed to cope with the high gas temperatures emitted by the stove when in operation. [Photograph 31](#)

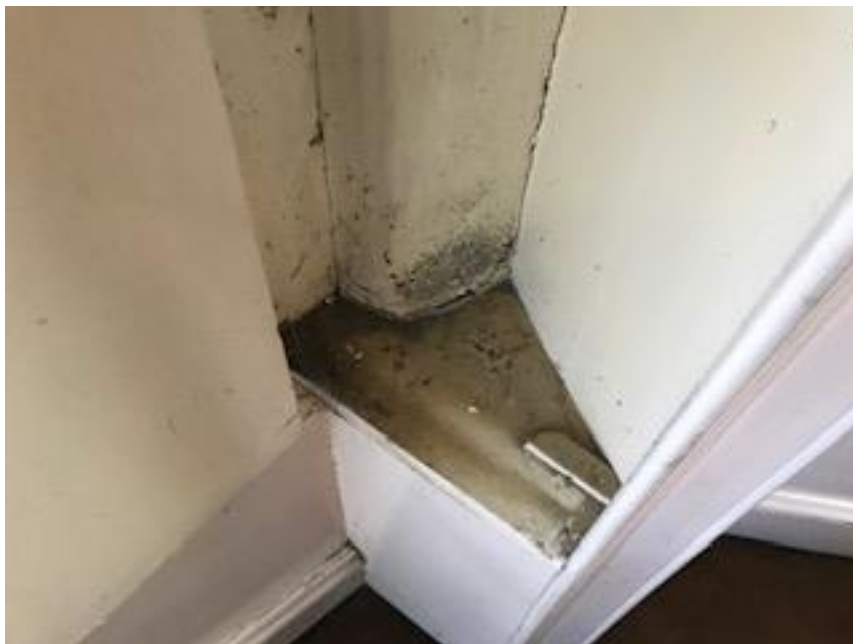
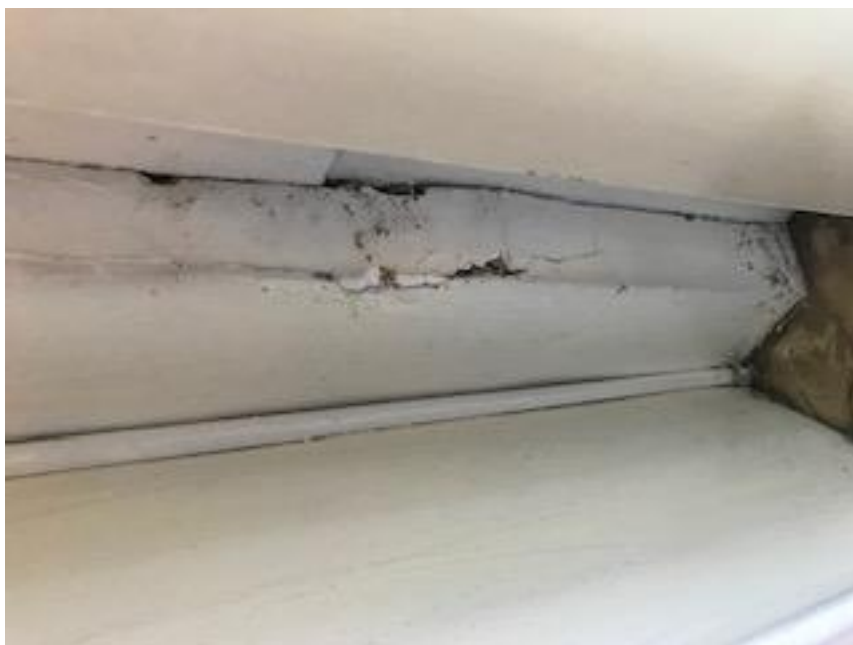
- The windows on the basement, ground and first-floor are showing signs of decay in several sections and should be overhauled. This building is a protected structure and therefore the client should seek consent from the planning authority, protected buildings department in order to progress same. [Photograph 32, 33 and 34](#)
- It was noted that decay has set in to some of the window sections where the ballast is maintained. This should be repaired however, this should be repaired under the consent of the planning authority, protected buildings department. [Photograph 35 and 36](#)

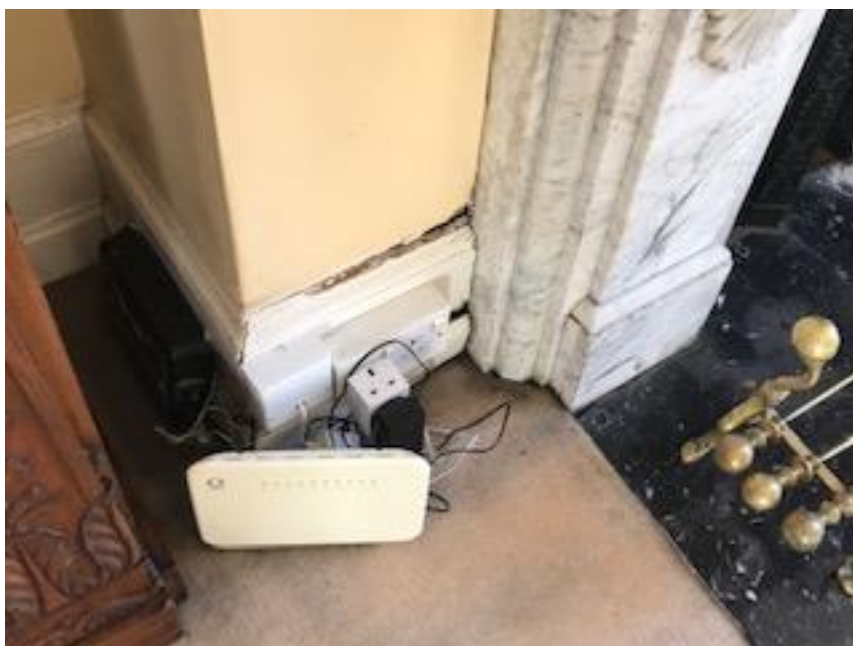
Photograph 40

- A mediocre draft was noted from the fireplace. The client is advised to have the chimney cleaned out and checked for obstruction prior to lighting. The firewall was also noted as being cracked. This should be sealed with a fire-based mortar system. [Photograph 37 and 38](#)
- Overhauling is required on the rendering at ceiling level. [Photograph 39](#)
- It was also noted that some of the timber at base level of the fireplace has decayed. This is most likely due to water ingress at the chimney stack level and migrating southward. We would advise that this point of entry of the water at the chimney is resolved and that all effected timber and plaster work is resolved. The client is advised that timber rot may be present at this location. If this is confirmed the affected timbers should be removed. [Photograph 40](#)

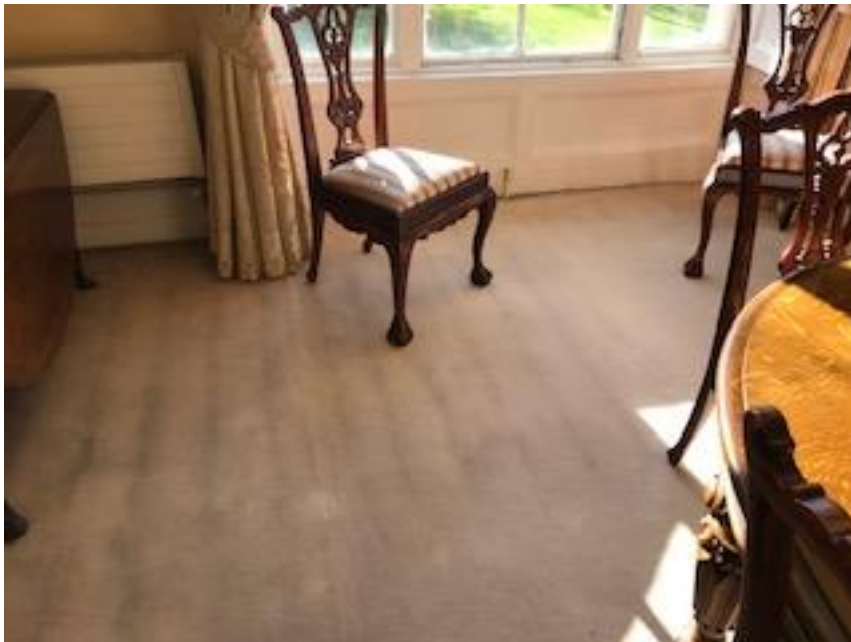
Photograph 41

- The client is advised that deviations were noted on the ground floor level however, structural failure is not anticipated as this is most likely due to settlement of the floor. [Photograph 41](#)

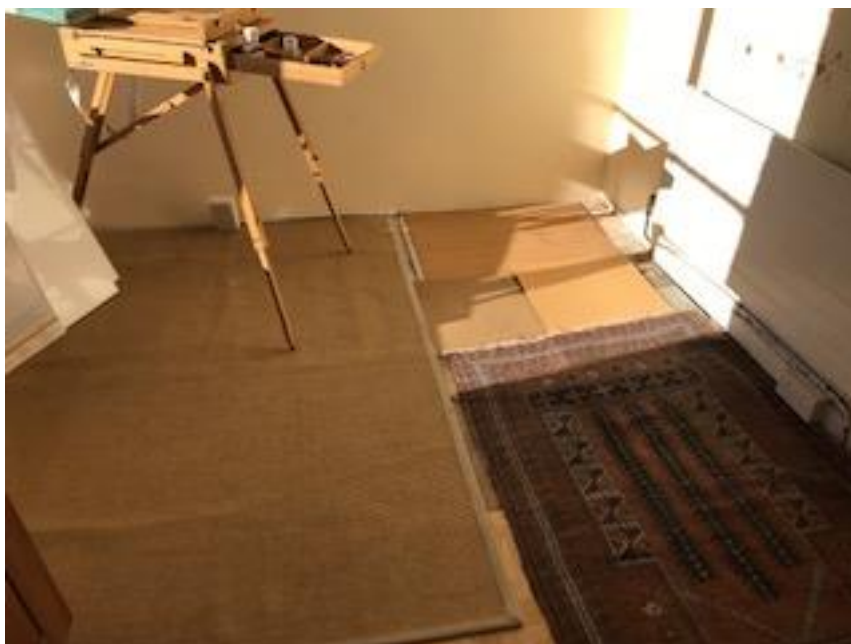
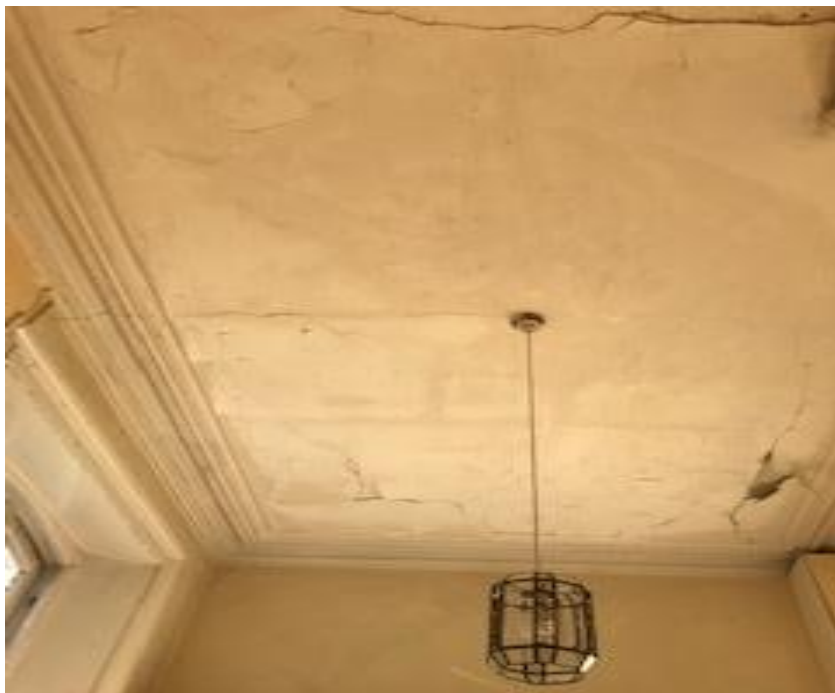
- The client is advised to replace the flooring surface in this room as the flooring surface has been compromised in areas. [Photograph 42](#)
- The ceiling in this room also requires overhauling. [Photograph 43](#)

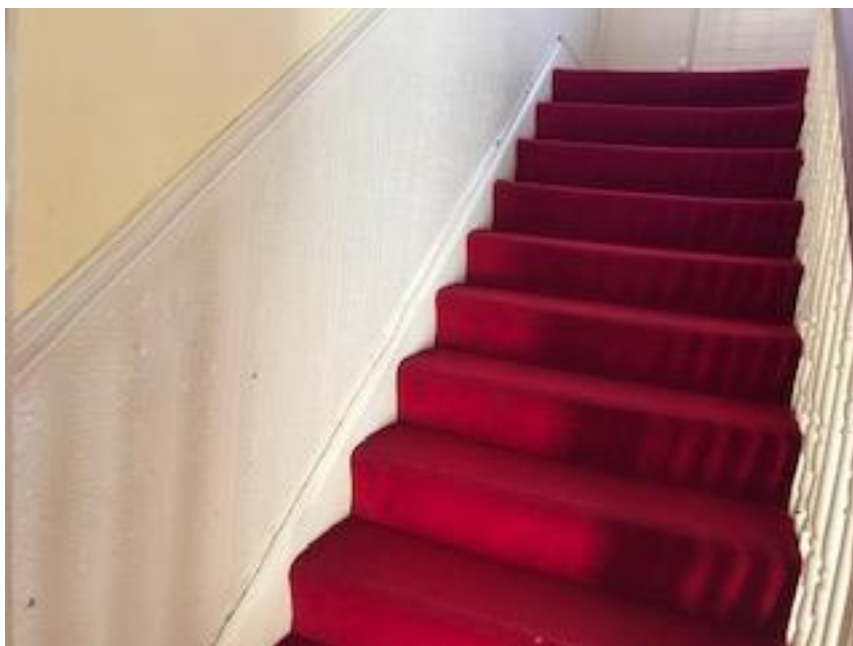
Photograph 44

- Cracking was noted at the junction of the stairs stringer and the wall. The cracking is most likely due to movement of the stairs away from the wall as the canter lever effect takes place over time. The canter lever effect is the leaning away of the stairs from its anchoring point at the wall. The client is advised to consider re-anchoring the stairs in the medium term. Structural failure is not expected in the short term. [Photograph 44](#)

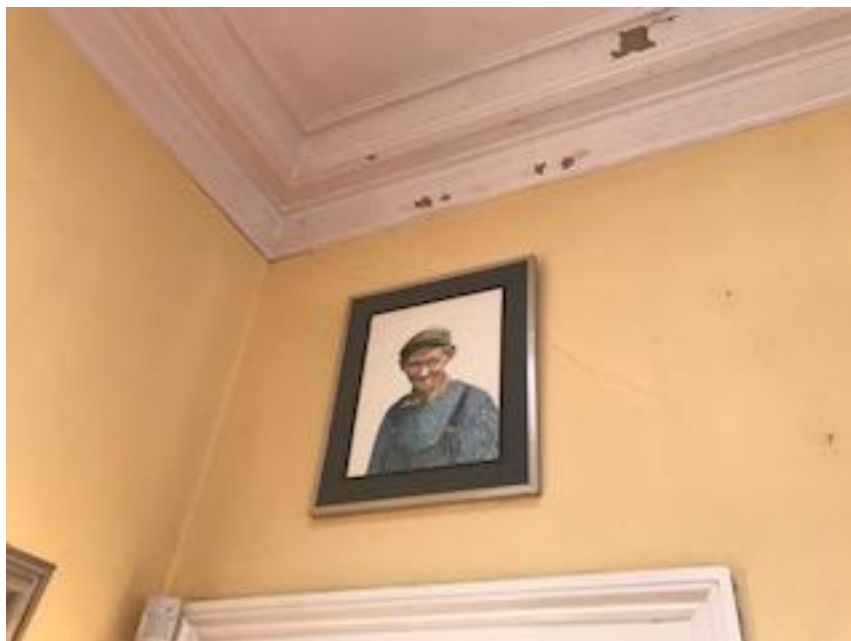
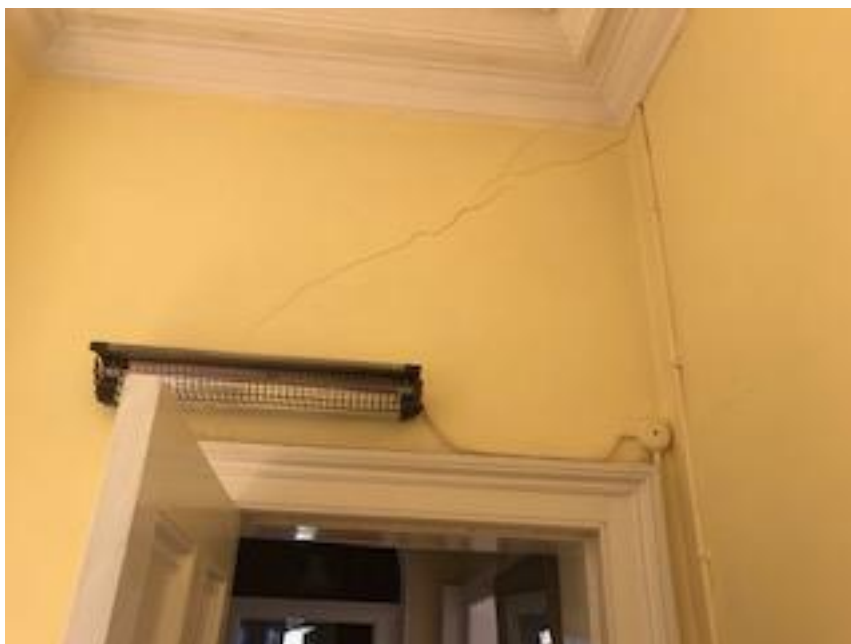
- Multiple structural cracks were noted on the load bearing wall on the second floor. This is most likely due to the roof being supported directly onto these walls. Structural failure is unlikely although the client is advised to monitor same. [Photograph 45 and 46](#)

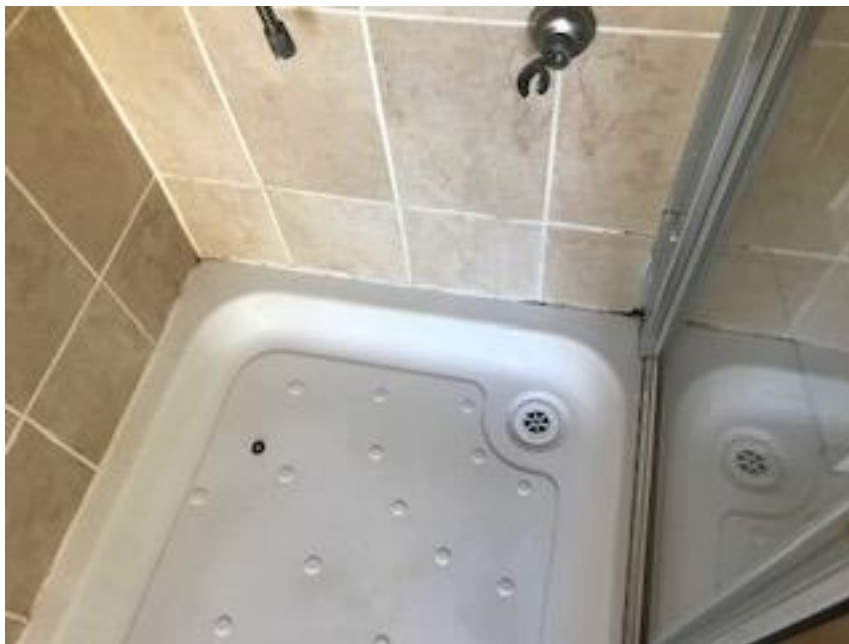
Photograph 47

- Water egress was noted from the shower. The client is advised to allow for the removal of the tiles and the localised reparation works to the affected timber and plaster work. [Photograph 47](#)
