Colin Gamble & Associates
Consultants ltd

Engineers Inspection Report

Sunday 10th February 2019

123 The House, Naas, Co. Kildare

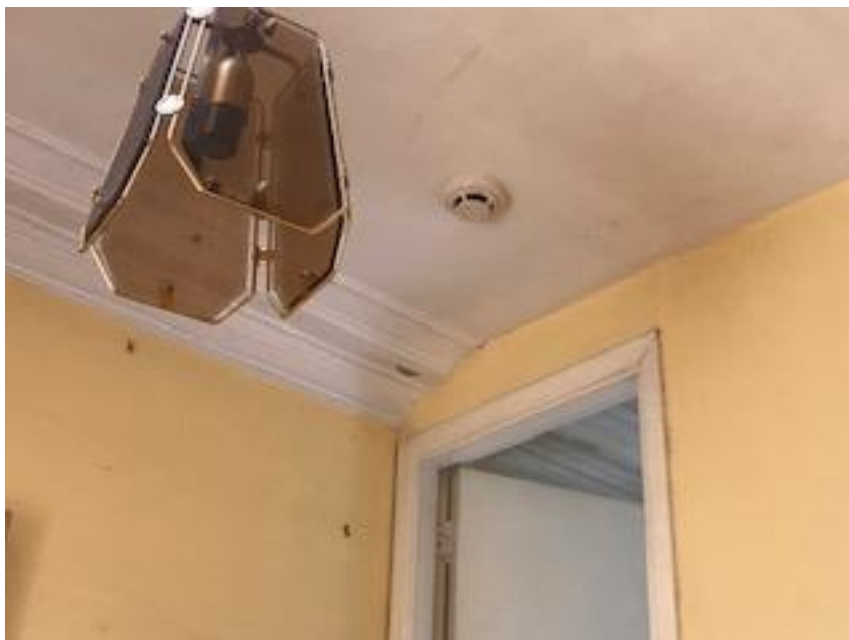
Photograph 48

- The client is advised to install hardwired fire and carbon monoxide alarms into all bedrooms and common areas. [Photograph 48](#)

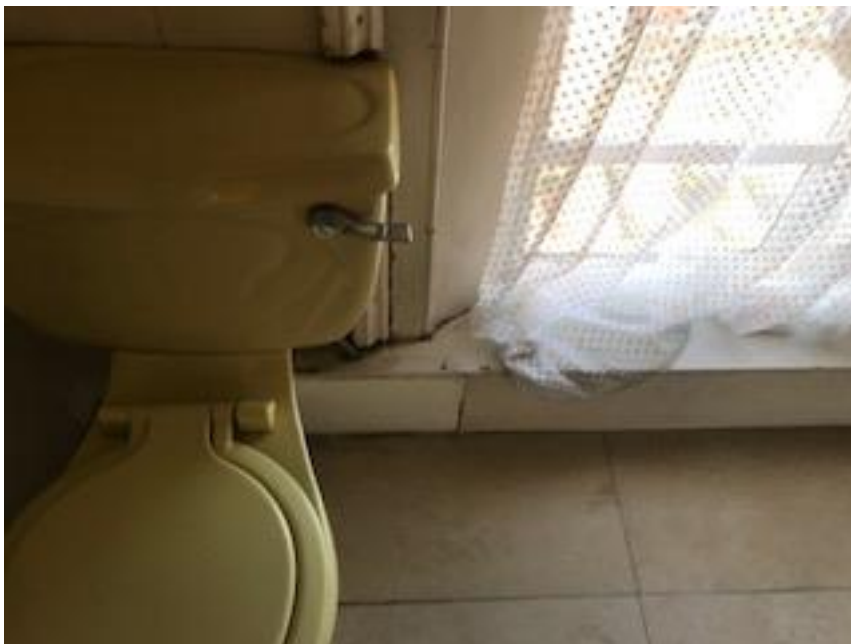
Photograph 49

- The second-floor bathroom showed signs of decay in the timber behind the toilets. The client is advised to remove and replace all of this timber work. [Photograph 49](#)

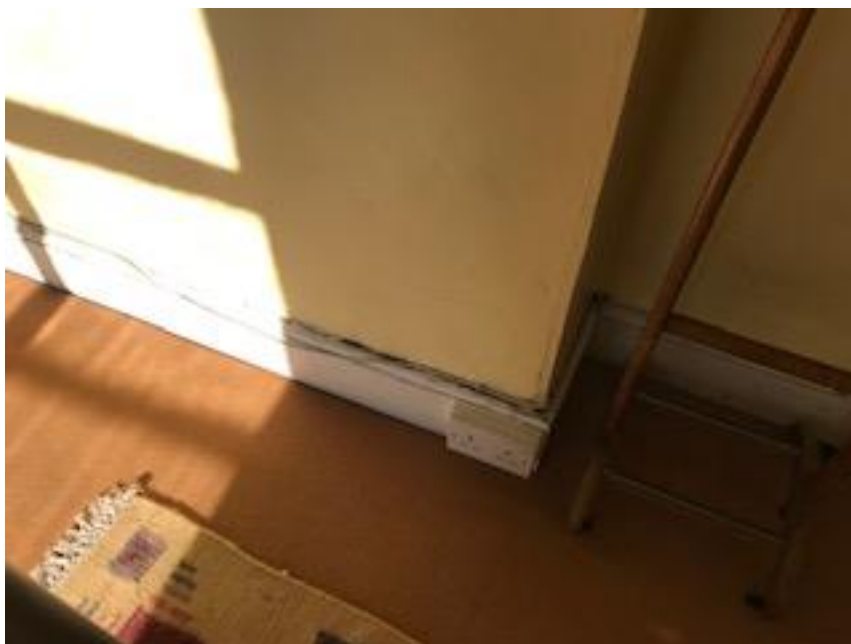
Photograph 50

- Moisture traversing southwards was noted at the chimney locations at the second floor. The client is advised to obtain the services of a roofer to seal the

junction of the flashings and the roof and to address any localised affected timber and plaster work. The client is advised that timber rot may be present at this location. If this is confirmed the affected timbers should be removed.

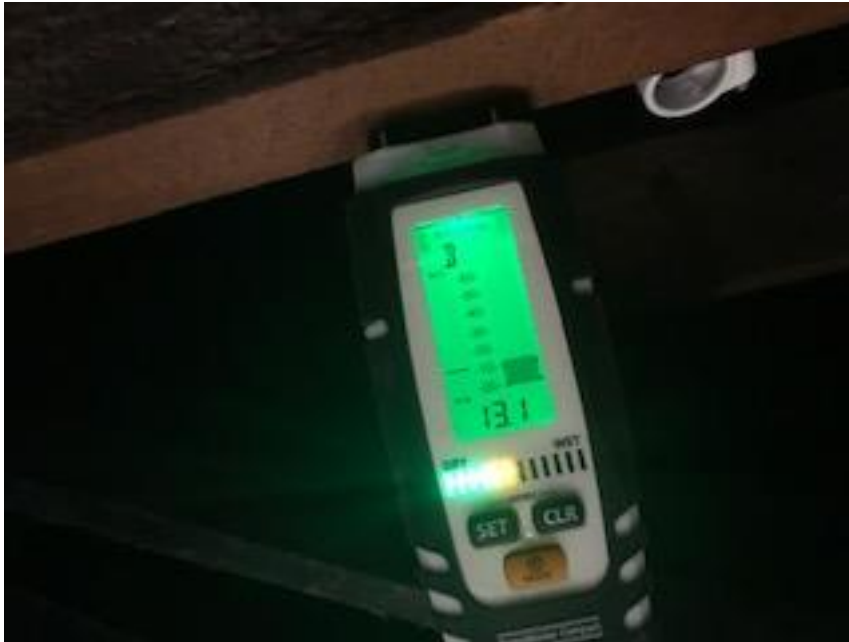
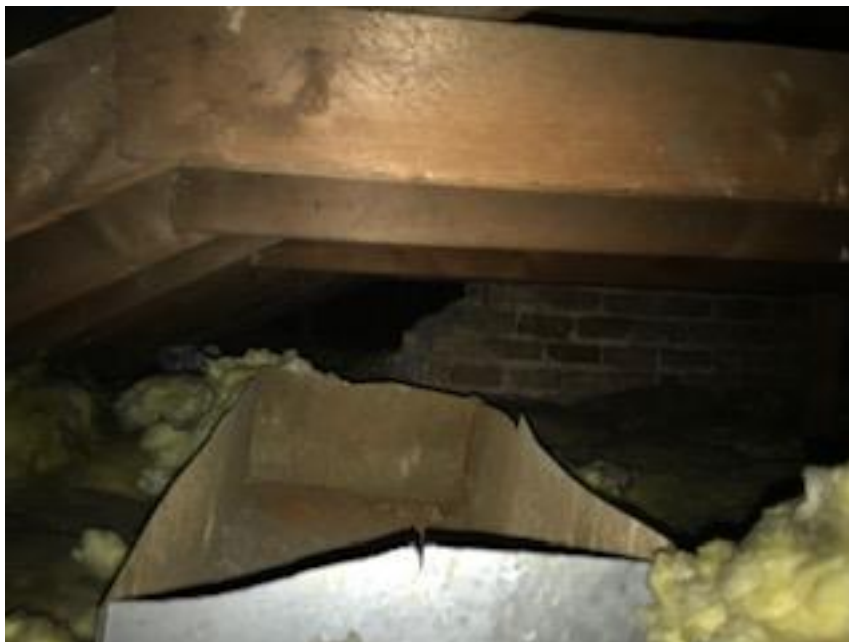
- Access to the attic was obtained via a access port in the ceiling. Access to the entire roof was restricted due to the construction of the roof. However, the writer did note that that a new breathable member had been placed in situ over the timbers and was allowing sufficient cross ventilation of the timbers. The moisture level in the timbers was noted at 13.1% which is considered acceptable. The client is advised to allow for increased cross ventilation to promote the life span of this roof. Additional horizontal reinforcement should be considered in the future as the roof ages. [Photograph 51 and 52](#)

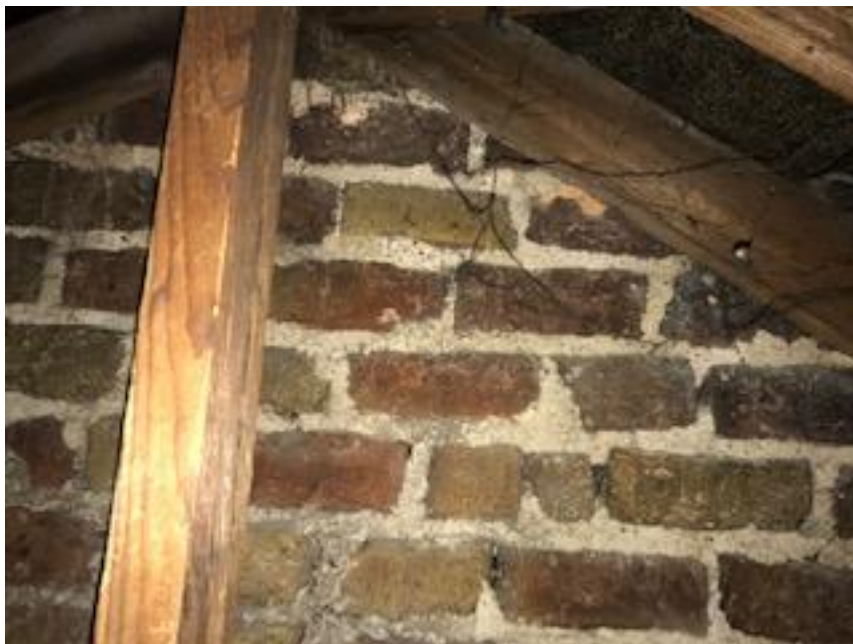
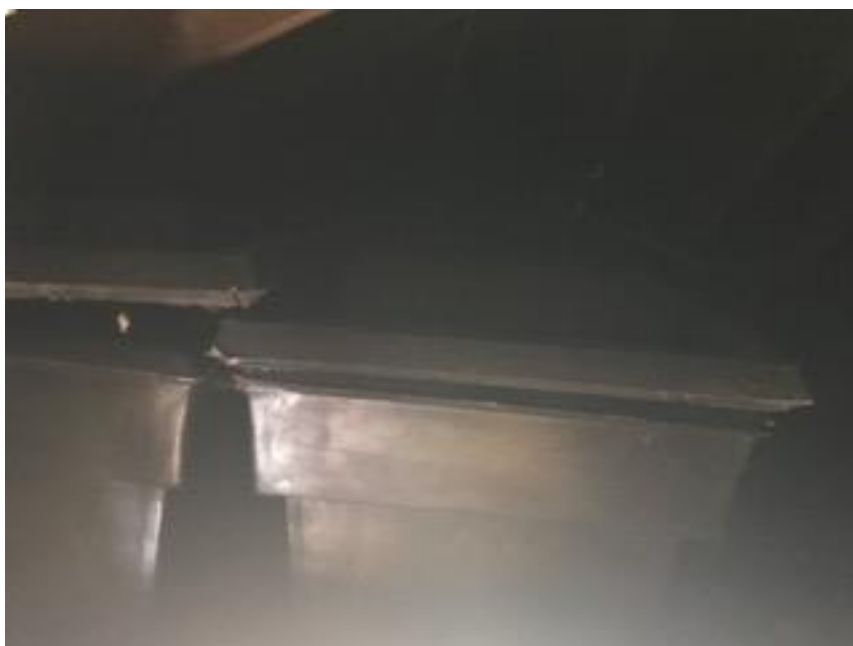
- Sections of the mortar pointing will require addressing on the chimney as the mortar has decayed over time. [Photograph 53](#)
- The client is also advised to insulate the water tanks as they are located in an uninsulated area. [Photograph 54](#)

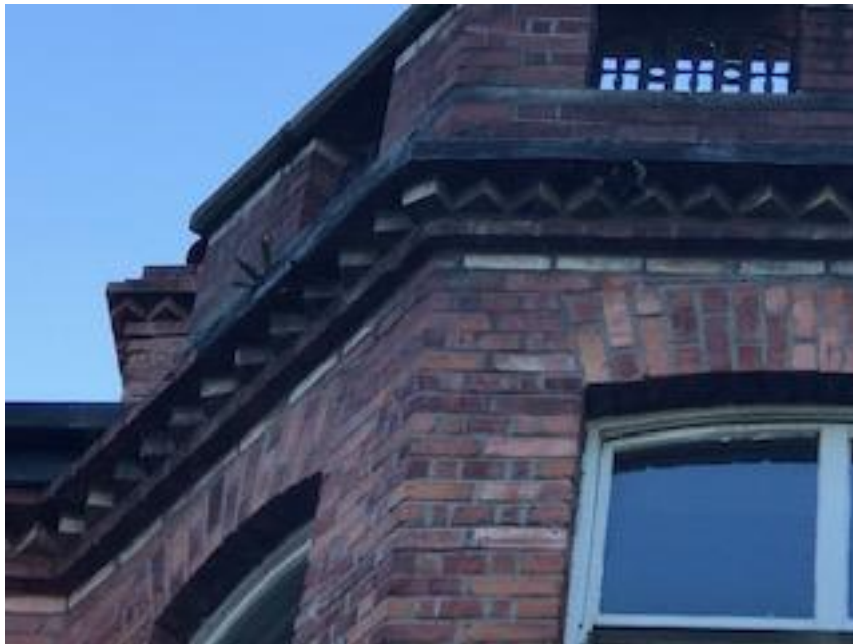
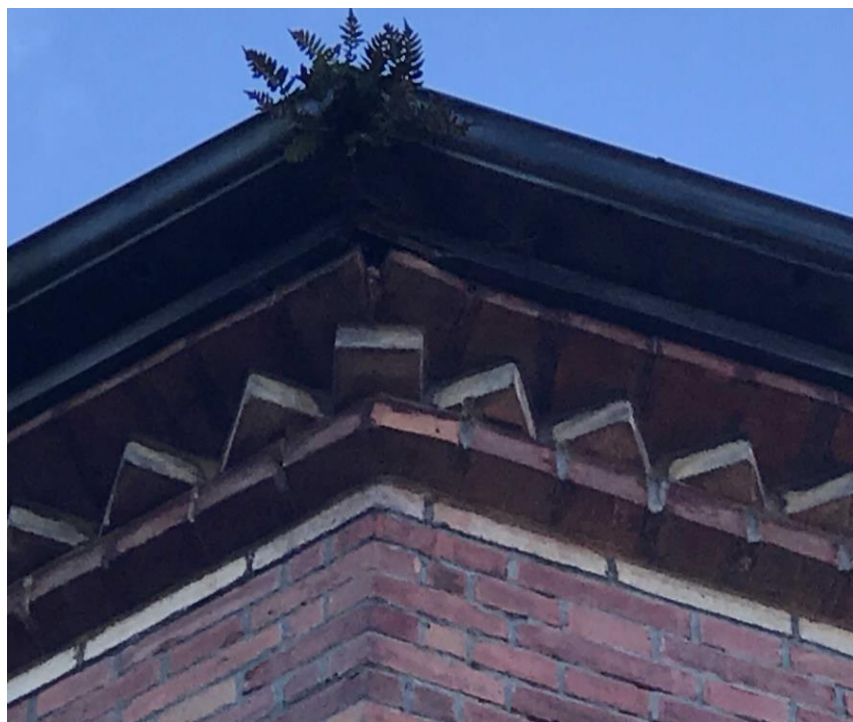
- In general, the front brick façade from a visual inspection from the ground, would appear to be in good condition. Sections of the detailing at the brick soffit level will require re-pointing and all flora requires removing. Flora will absorb the moisture from between the bricks and will cause the mortar to fail. [Photograph 55 and 56](#)

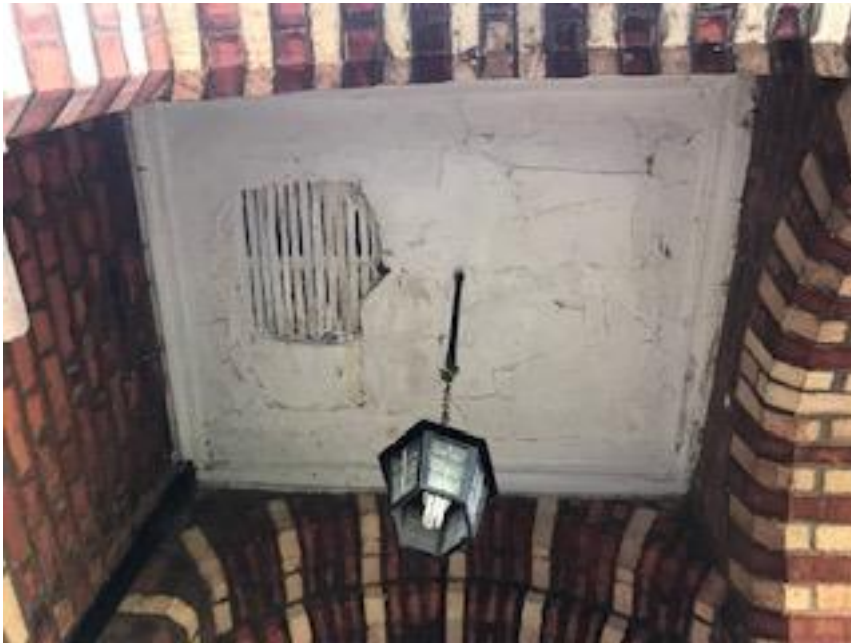
Photograph 57

- The underside of the porch ceiling requires replacing at the door as the timber here has decayed. [Photograph 57](#)

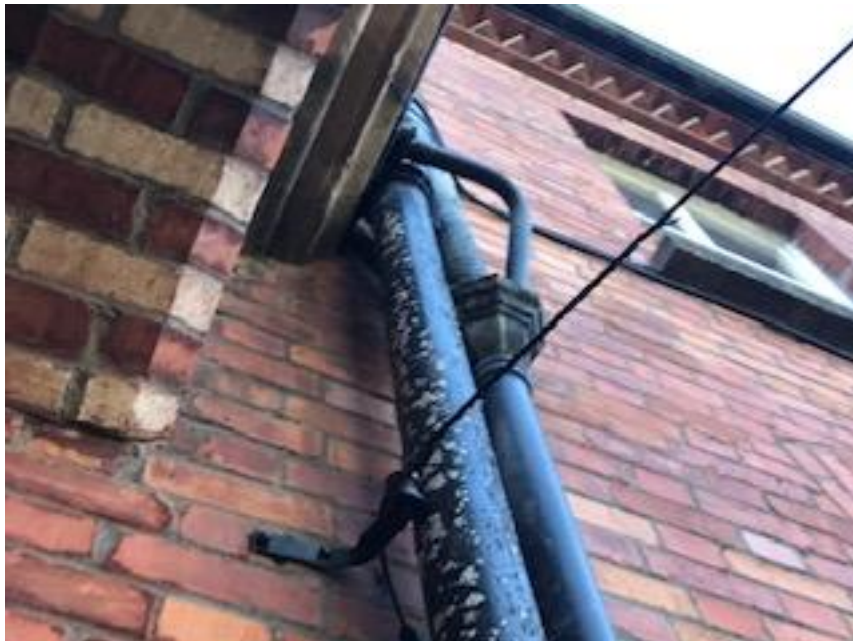
Photograph 58

- Multiple examples of the surface water and the foul water were noted to be mixing throughout the property on the day of the survey. The client is advised to separate these into their respective networks, both of which are available on the property. [Photograph 58](#)

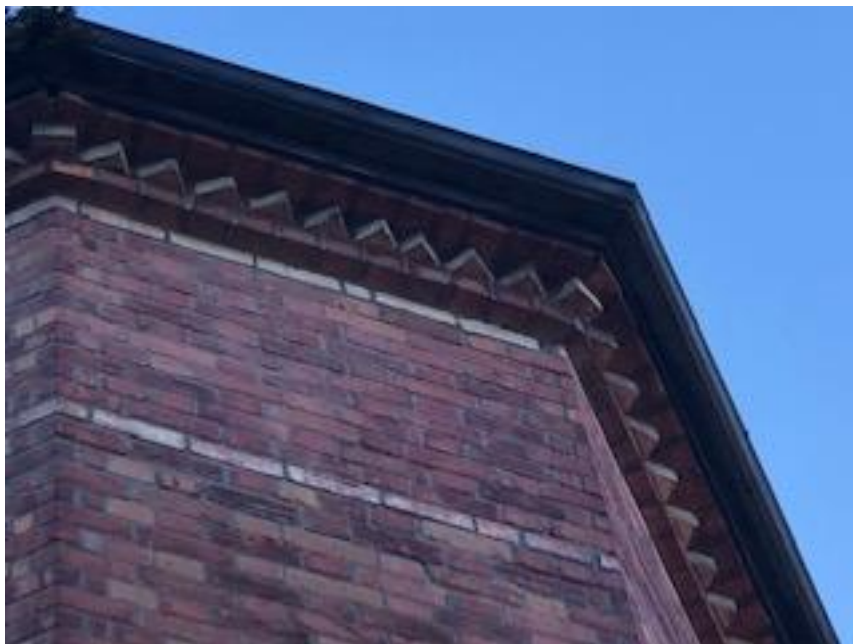
Photograph 59

- The client is advised to overhaul the sections of wooden areas on the soffits and fascia. [Photograph 59](#)

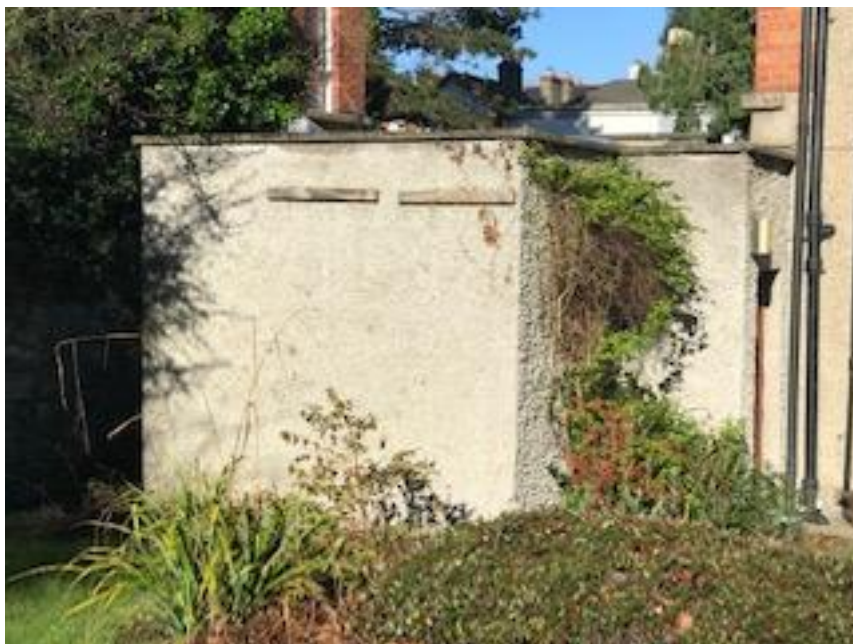
Photograph 60

- The client is advised to obtain a Certificate of Compliance/Exemption with the Planning and Building Regulations for the storage units to the rear. [Photograph 60](#)

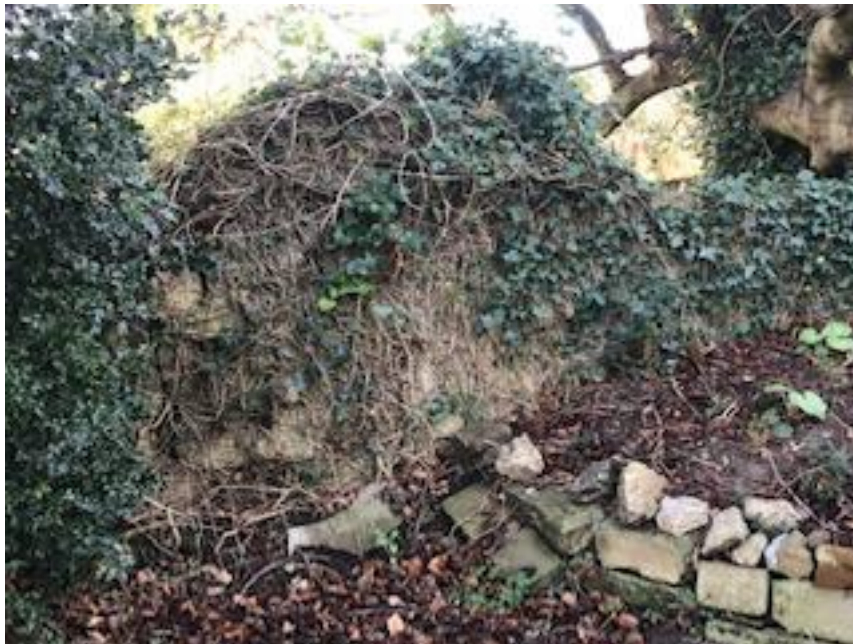
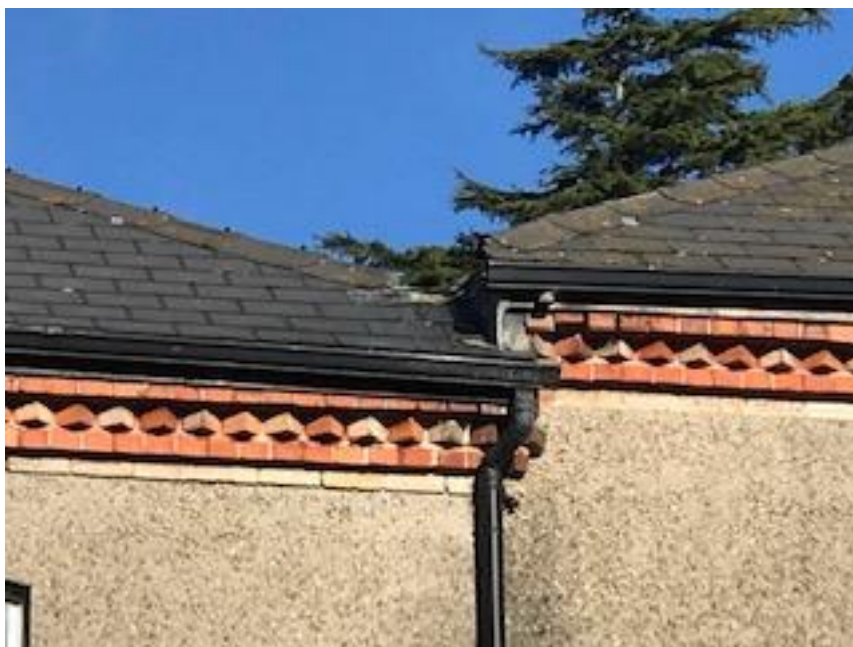
- The boundary wall was noted to be compromised in sections. Sections of this boundary wall to be reinforced. [Photograph 61](#)
- The junction between the two pitched hipped rooves should be sealed by a suitably qualified roofer. [Photograph 62](#)

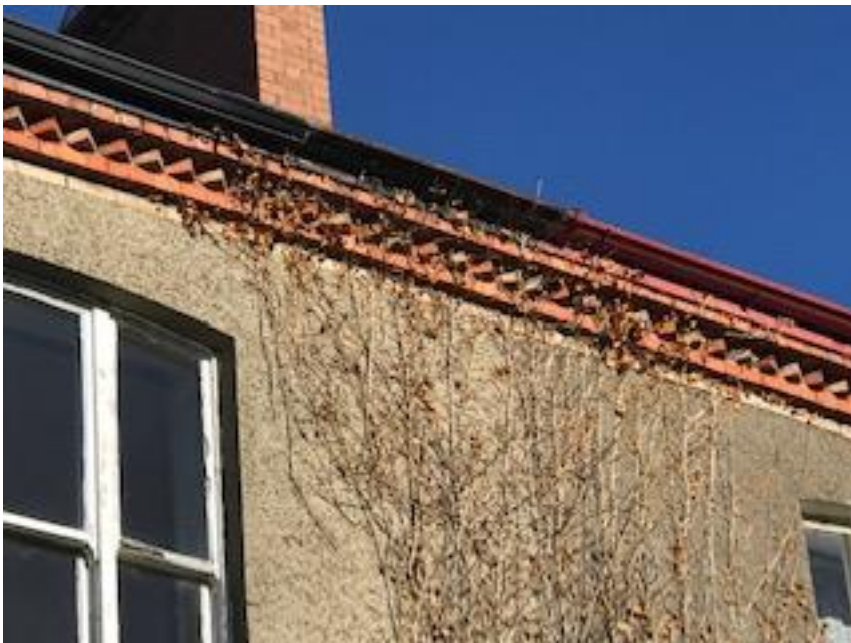
Photograph 64

- It would appear that the roof on the left-hand side as viewed from the rear elevation has been re-tiled recently and appeared to look newer than the tiled section to the right-hand side. Deviations were noted on the slope lines of the left-hand side roof which is most likely due to settlement over time. [Photograph 63](#)
- Sections of the soffits and fascia on the roof on the right-hand side which is adjoining the semi-detached property connected to same requires overhauling. [Photograph 64](#)

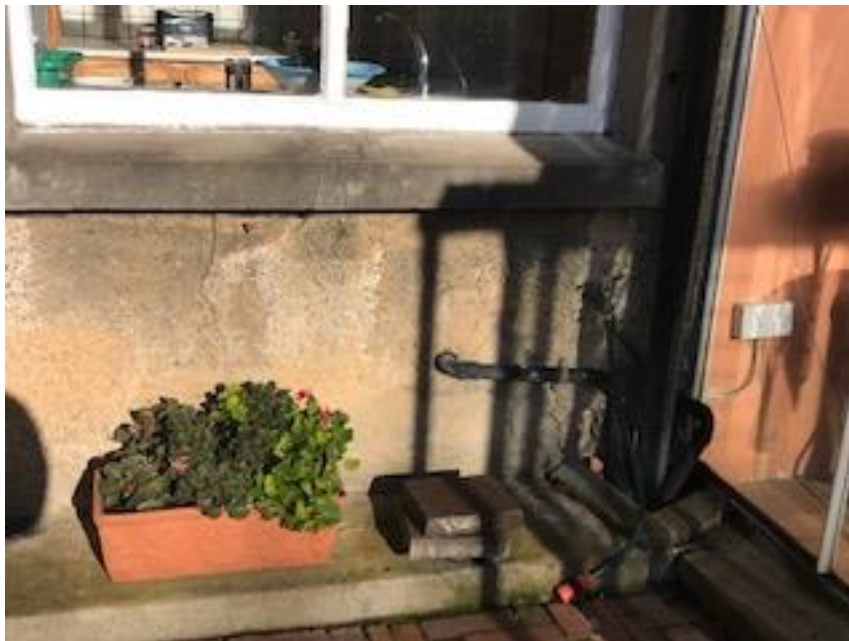
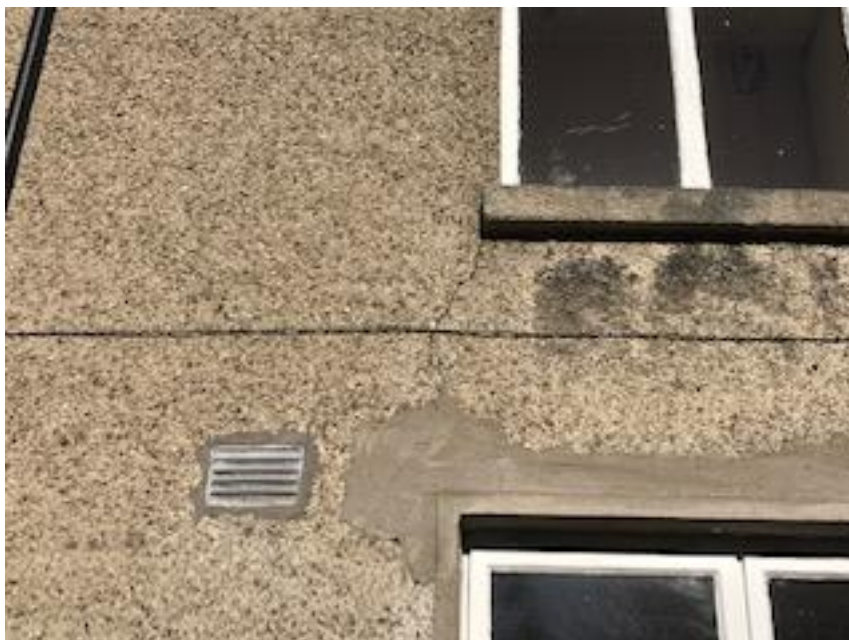
- Structural crack was noted on the rear elevation wall. The structural crack has permeated through to the interior. The client is advised to monitor same. Structural failure is not expected due to the length of time that this property has been in situ. [Photograph 65 and 66](#)

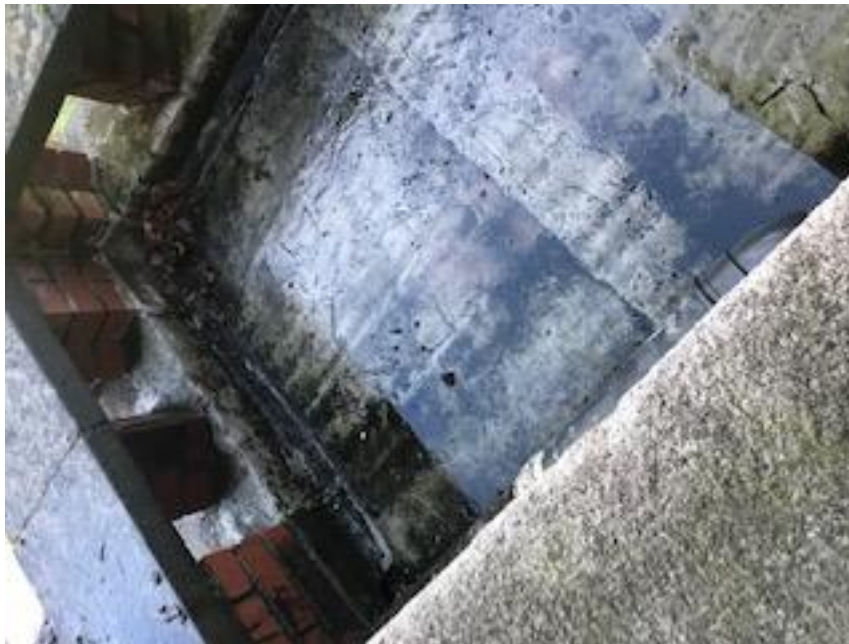
Photograph 67

- The flat roof was viewed from above the porch area and water was noted to be ponding on same. We would advise the client to alter the slope on the roof to promote water runoff and to prevent water ingress into the property. [Photograph 67](#)

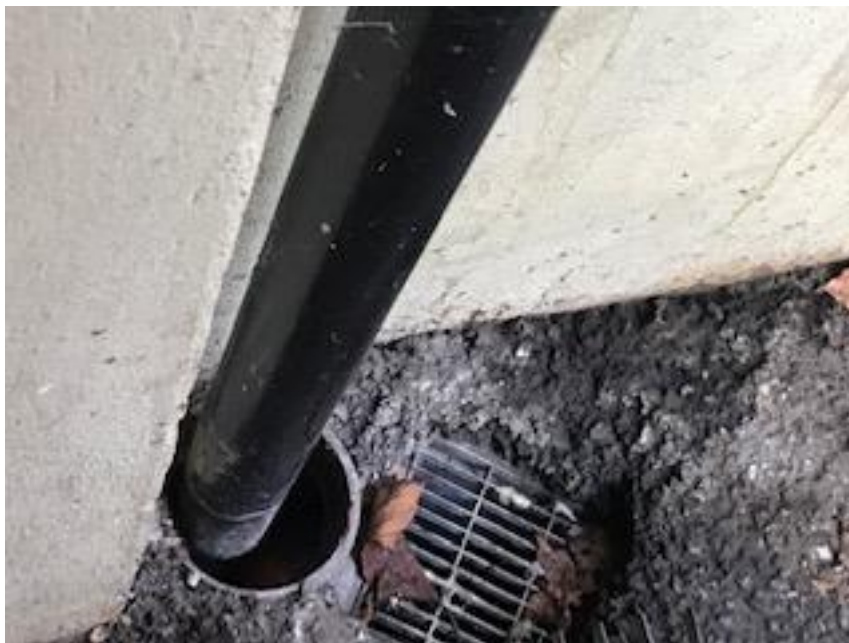
Photograph 68

- Some of the surface drainage was noted as having high levels of water. The client is advised to obtain the services of a CCTV company to unblock these drains. [Photograph 68](#)
