Colin Gamble & Associates
Consultant Engineers Ltd

Property Condition Report

Date of Inspection: Sunday 10th February 2019

Property Address: 123 The House, Naas, Co. Kildare

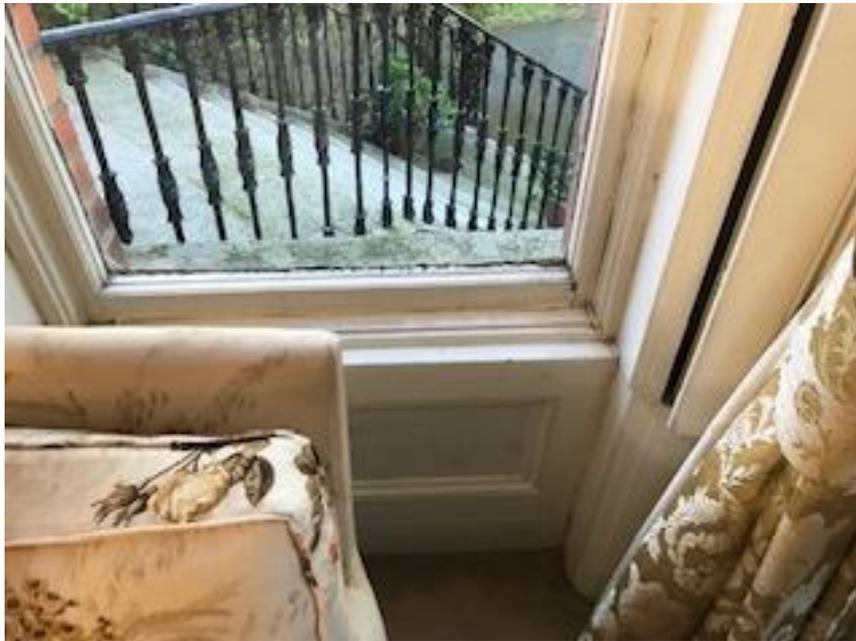
Photograph 32

- The windows on the basement, ground and first-floor are showing signs of decay in several sections and should be overhauled. This building is a protected structure and therefore the client should seek consent from the planning authority, protected buildings department in order to progress same. [Photograph 32, 33 and 34](#)
- It was noted that decay has set in to some of the window sections where the ballast is maintained. This should be repaired however, this should be repaired under the consent of the planning authority, protected buildings department. [Photograph 35 and 36](#)

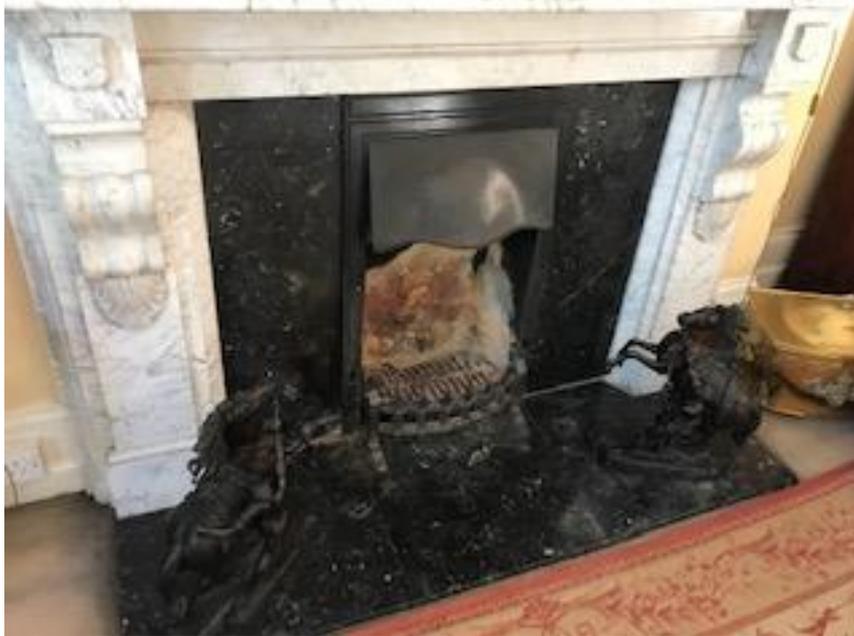
Photograph 37

- A mediocre draft was noted from the fireplace. The client is advised to have the chimney cleaned out and checked for obstruction prior to lighting. The firewall was also noted as being cracked. This should be sealed with a fire-based mortar system. [Photograph 37 and 38](#)
- Overhauling is required on the rendering at ceiling level. [Photograph 39](#)
- It was also noted that some of the timber at base level of the fireplace has decayed. This is most likely due to water ingress at the chimney stack level and migrating southward. We would advise that this point of entry of the water at the chimney is resolved and that all effected timber and plaster work is resolved. The client is advised that timber rot may be present at this location. If this is confirmed the affected timbers should be removed. [Photograph 40](#)

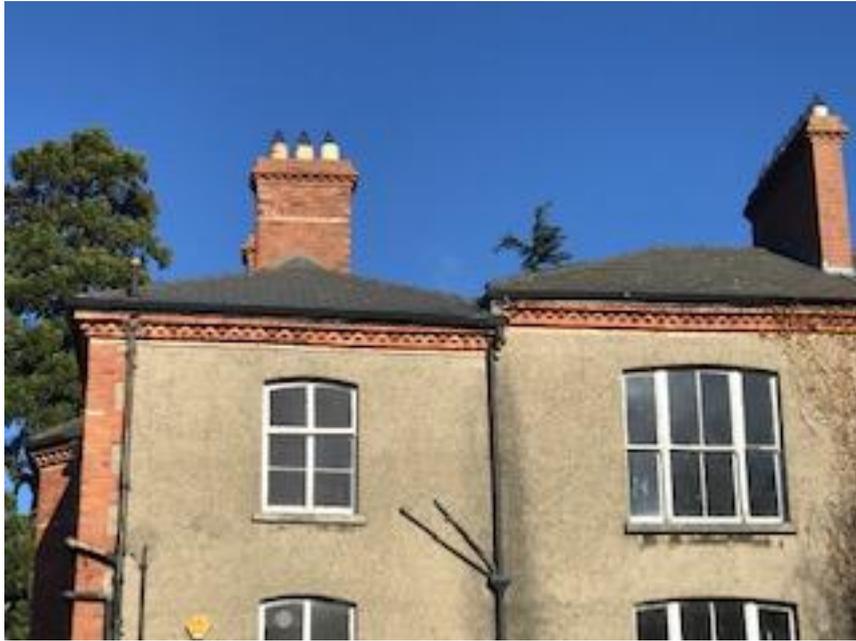
Photograph 63

- It would appear that the roof on the left-hand side as viewed from the rear elevation has been re-tiled recently and appeared to look newer than the tiled section to the right-hand side. Deviations were noted on the slope lines of the left-hand side roof which is most likely due to settlement over time. [Photograph 63](#)
- Sections of the soffits and fascia on the roof on the right-hand side which is adjoining the semi-detached property connected to same requires overhauling. [Photograph 64](#)
