Colin Gamble & Associates
Consultants ltd

Engineers Inspection Report

Sunday 10th February 2019

123 The House, Naas, Co. Kildare

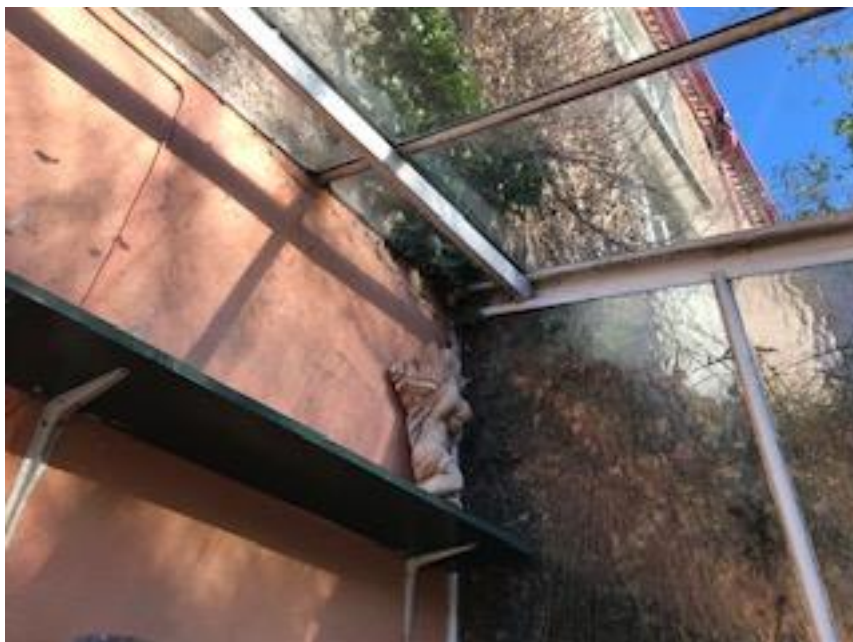
Photograph 13

- The client is advised to obtain a Certificate of Compliance/Exemption with the Planning and Building Regulations for the glass conservatory extension to the rear. [Photograph 13](#)
- The conservatory roof is poor and should be replaced as signs of water ingress were noted. [Photograph 14](#)
- Evidence of rising damp was noted on the external conservatory wall which would appear to be the original boundary wall. [Photograph 15](#)

- The client is advised that 123 The House, Naas, Co. Kildare is recorded on the Protected Structures of Kildare County Council. As such we would advise the client to ensure that the appropriate certificates are in place for the addition of any structures including the glass conservatory. [Photograph 13](#)

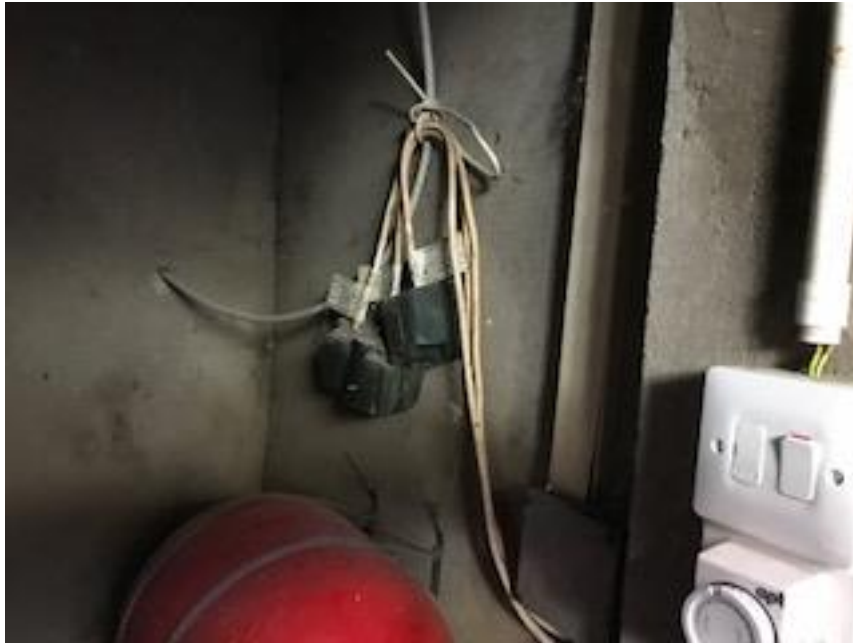
Photograph 22

- The heating system activated on the day of the survey and the boiler appeared to work well. The boiler appeared to be a relatively new entity. We would advise the client to seal the exhaust flue from the boiler with the ceiling to avoid the build-up of carbon monoxide in the boiler room. [Photograph 22](#)
- The client is also advised that the actuator valves are anchored appropriately to the wall to avoid failure of same. [Photograph 23](#)
- It was noted that the basement level and ground floor radiators reached acceptable temperature within one to two hours. The radiators on the second

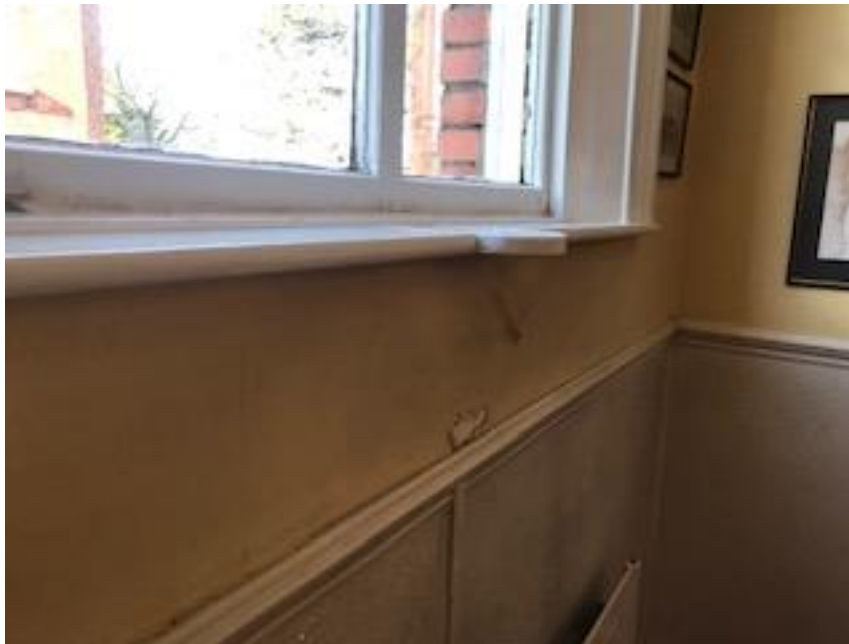
Photograph 32

- The windows on the basement, ground and first-floor are showing signs of decay in several sections and should be overhauled. This building is a protected structure and therefore the client should seek consent from the planning authority, protected buildings department in order to progress same. [Photograph 32, 33 and 34](#)
- It was noted that decay has set in to some of the window sections where the ballast is maintained. This should be repaired however, this should be repaired under the consent of the planning authority, protected buildings department. [Photograph 35 and 36](#)

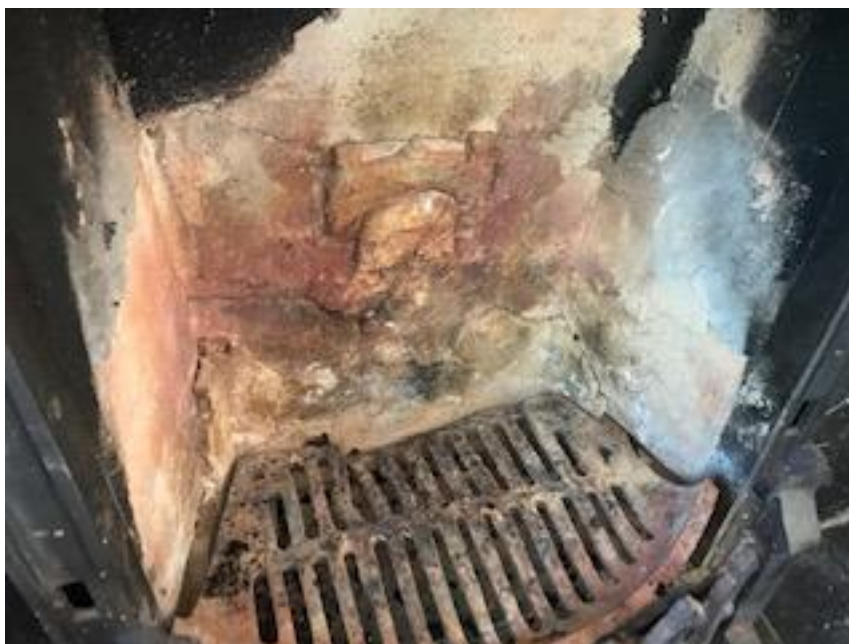
Photograph 37

- A mediocre draft was noted from the fireplace. The client is advised to have the chimney cleaned out and checked for obstruction prior to lighting. The firewall was also noted as being cracked. This should be sealed with a fire-based mortar system. [Photograph 37 and 38](#)
- Overhauling is required on the rendering at ceiling level. [Photograph 39](#)
- It was also noted that some of the timber at base level of the fireplace has decayed. This is most likely due to water ingress at the chimney stack level and migrating southward. We would advise that this point of entry of the water at the chimney is resolved and that all effected timber and plaster work is resolved. The client is advised that timber rot may be present at this location. If this is confirmed the affected timbers should be removed. [Photograph 40](#)

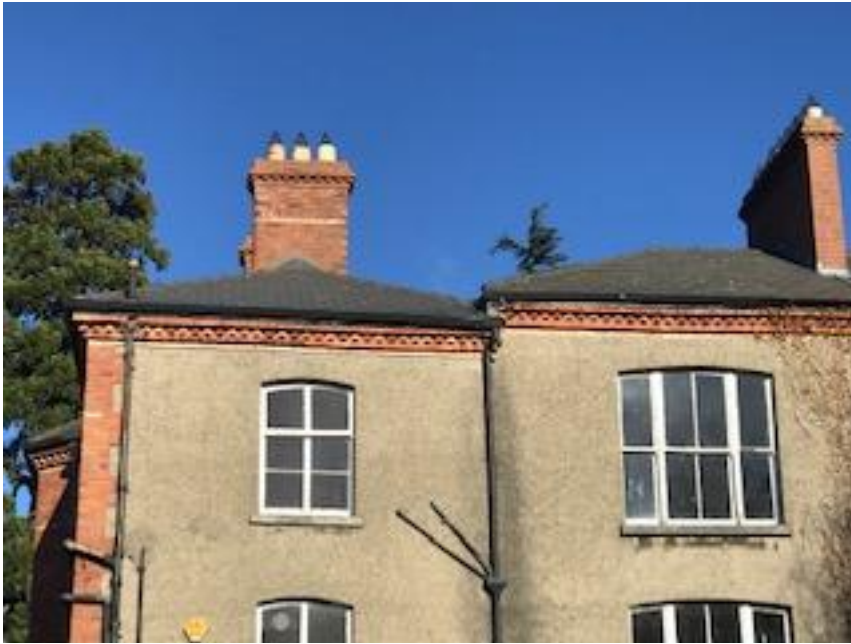
Photograph 62

- The boundary wall was noted to be compromised in sections. Sections of this boundary wall to be reinforced. [Photograph 61](#)
- The junction between the two pitched hipped rooves should be sealed by a suitably qualified roofer. [Photograph 62](#)
